THE SHELL PETROLEUM DEVELOPMENT COMPANY OF NIGERIA LIMITED.

JOINT INVESTIGATION REPORT FOR INCIDENT NO: 1039415 Report S/N: 0253

A. GENERAL INFORMATION:

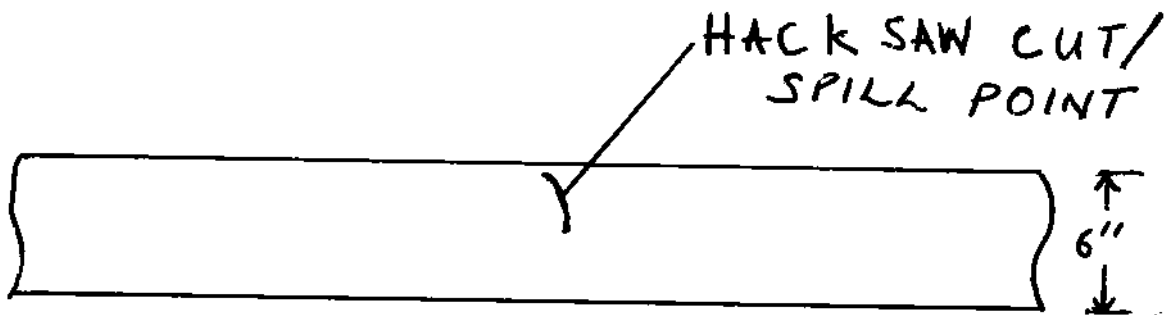
| <input type="checkbox"/> Drilled hole | <input checked="" type="checkbox"/> Hack saw cut | <input type="checkbox"/> Tear (_____), |

- Third party interference (Sabotage ; crude theft ; Line theft ; Accidental 3rd party damage
 Operational Others (including Mystery spills) _____

SECTION OF 6" IMDRIVER 1 30L FLOW LINE AT GIRIUKWU SHOWING A HACK SAW CUT AT 2 O'CLOCK POSITION
