THE SHELL PETROLEUM DEVELOPMENT COMPANY OF NIGERIA LIMITED.

JOINT INVESTIGATION REPORT FOR INCIDENT NO: 1038249 JIV report S/N: 0249

1. Spill incident Number: 1038249 2. Type of incident: Oil Spill
 3. Name of Location: 6" IMO RIVER 59T FLOW LINE
 4. Name of nearest community: IRIRIKWU 5. State: ABIA 6. LGA: UKWA WEST
 7. Type of Production facility/Installation: FLOW LINE 8. Asset owner/District: LAND ONE (I)

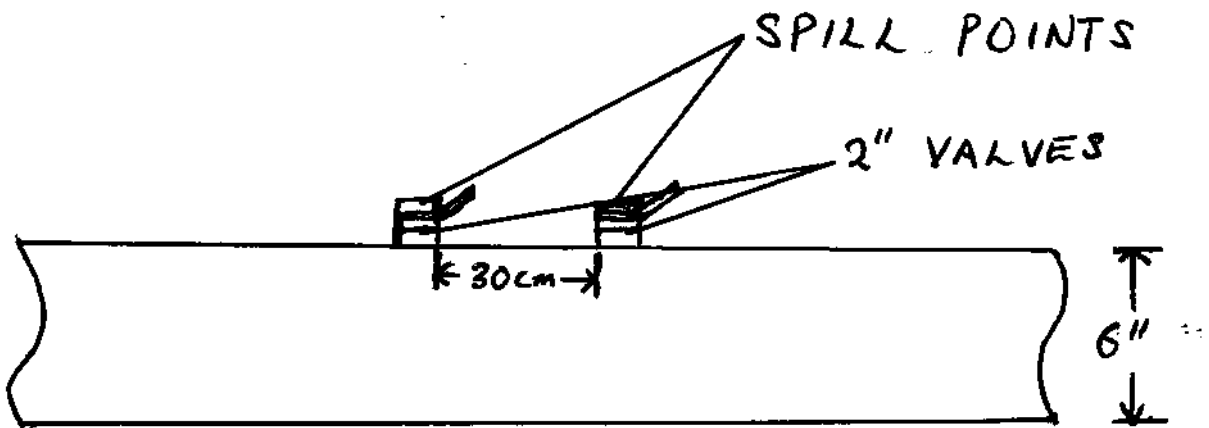
A SECTION OF 6" IMO RIVER 1 59T FLOW LINE AT GIRIUKWU SHOWING ILLEGAL BUNKERING POINT INSTALLED AT 2 O'CLOCK POSITION.
