THE SHELL PETROLEUM DEVELOPMENT COMPANY OF NIGERIA LIMITED.

JOINT INVESTIGATION REPORT FOR INCIDENT NO: 1049857 JIV report S/N: 0191

1. Spill incident Number: 1049857 2. Type of incident*: OIL SPILL
 3. Name of Location 20 INCH OTUMARA - ESCRAVOS TRUNKLINE
 4. Name of nearest community AJUDAIBO 5. State: DELTA 6. LGA WARRI - SOUTH WEST
 7. Type of Production facility/Installation TRUNKLINE 8. Asset owner/District PIPELINE

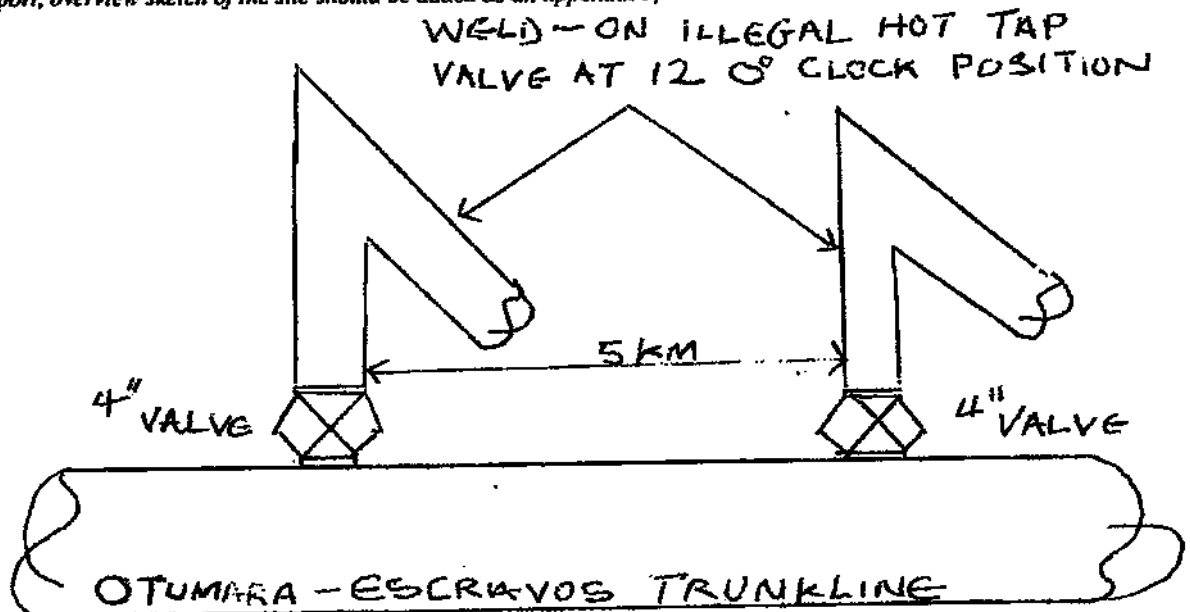
E. GRAPHIC DESCRIPTION OF LEAK POINT (while detail report of the leak point should be contained in the leak report, overview sketch of the site should be added as an appendix 1)

d. Description of spill point environment

- | | | |

| <input type="checkbox"/> Firmed soil | <input checked="" type="checkbox"/> Loose soil | <input type="checkbox"/> Recently excavated area |
| <input type="checkbox"/> Under water | <input checked="" type="checkbox"/> Swampy | <input type="checkbox"/> Exposed pipe surface |

| <input type="checkbox"/> Relief valve failure | <input checked="" type="checkbox"/> Others (specify) <u>WELD - ON ILLEGAL HOT TAP VALVE</u> | |
