THE SHELL PETROLEUM DEVELOPMENT COMPANY OF NIGERIA LIMITED.

JOINT INVESTIGATION REPORT FOR INCIDENT NO: 1154177 JIV report S/N: 0496

1. Spill incident Number: 1154177 2. Type of incident* OIL SPILL
 3. Name of Location 8" OBIGBO NORTH - KOM-KOM PIPELINE
 4. Name of nearest community OYIGBO 5. State: RIVERS 6. LGA OYIGBO
 7. Type of Production facility/Installation OIL PIPELINE Asset owner/District PIPELINE

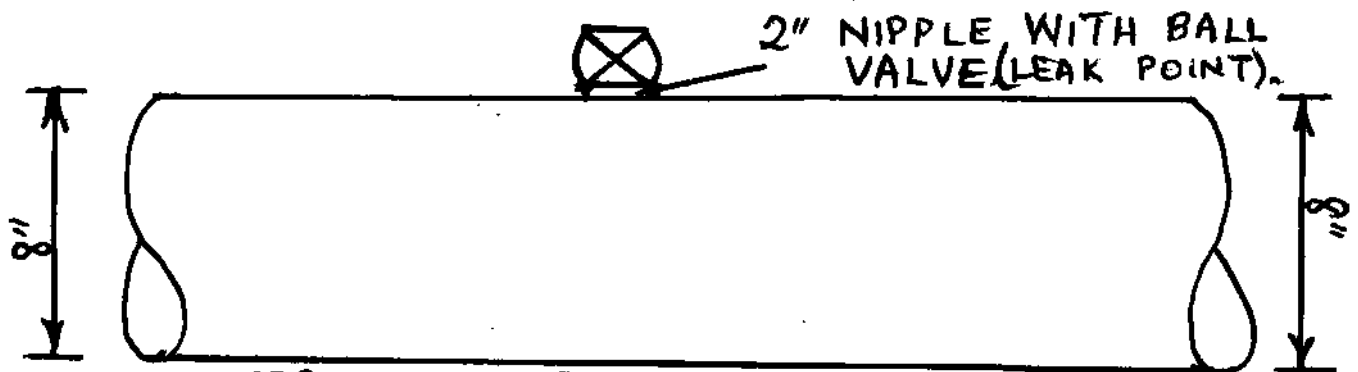
SECTION OF 8" OYIGBO NORTH - KOM-KOM PIPELINE AT OYIGBO SHOWING ONE NO. CRUDE OIL THEFT POINT AT 12 O' CLOCK POSITION.

FROM OYIGBO NORTH TO KOM-KOM.

MAPPING OF OIL IMPACT WAS DONE WITH ABSORBENT PADS WHILE REPAIRS WERE EFFECTED ON AFFECTED PIPELINE SECTION.
