THE SHELL PETROLEUM DEVELOPMENT COMPANY OF NIGERIA LIMITED.

JOINT INVESTIGATION REPORT FOR INCIDENT NO: 1153511 JIV report S/N: 0498

1. Spill incident Number: 1153511 2. Type of incident* OIL SPILL
 3. Name of Location 4" OBELE - IBAA PIPELINE
 4. Name of nearest community OMUEZE-IBAA 5. State: RIVERS 6. LGA EMOHUA
 7. Type of Production facility/Installation OIL PIPELINE 8. Asset owner/District PIPELINE

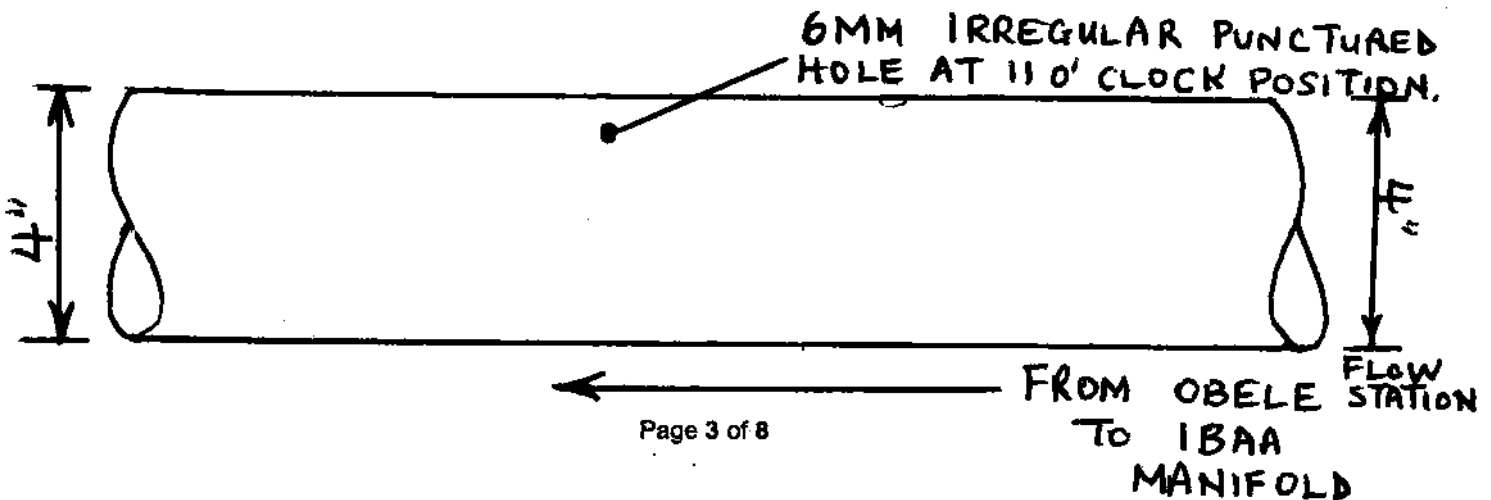
SECTION OF 4" OBELE - IBAA PIPELINE AT OMUEZE-IBAA SHOWING POSITION OF IRREGULARLY SHAPED LEAK POINT.

RECOVERY OF FREE-PHASE OIL WAS DONE SIMULTANEOUSLY WITH REPAIRS ON AFFECTED SECTION OF PIPELINE.

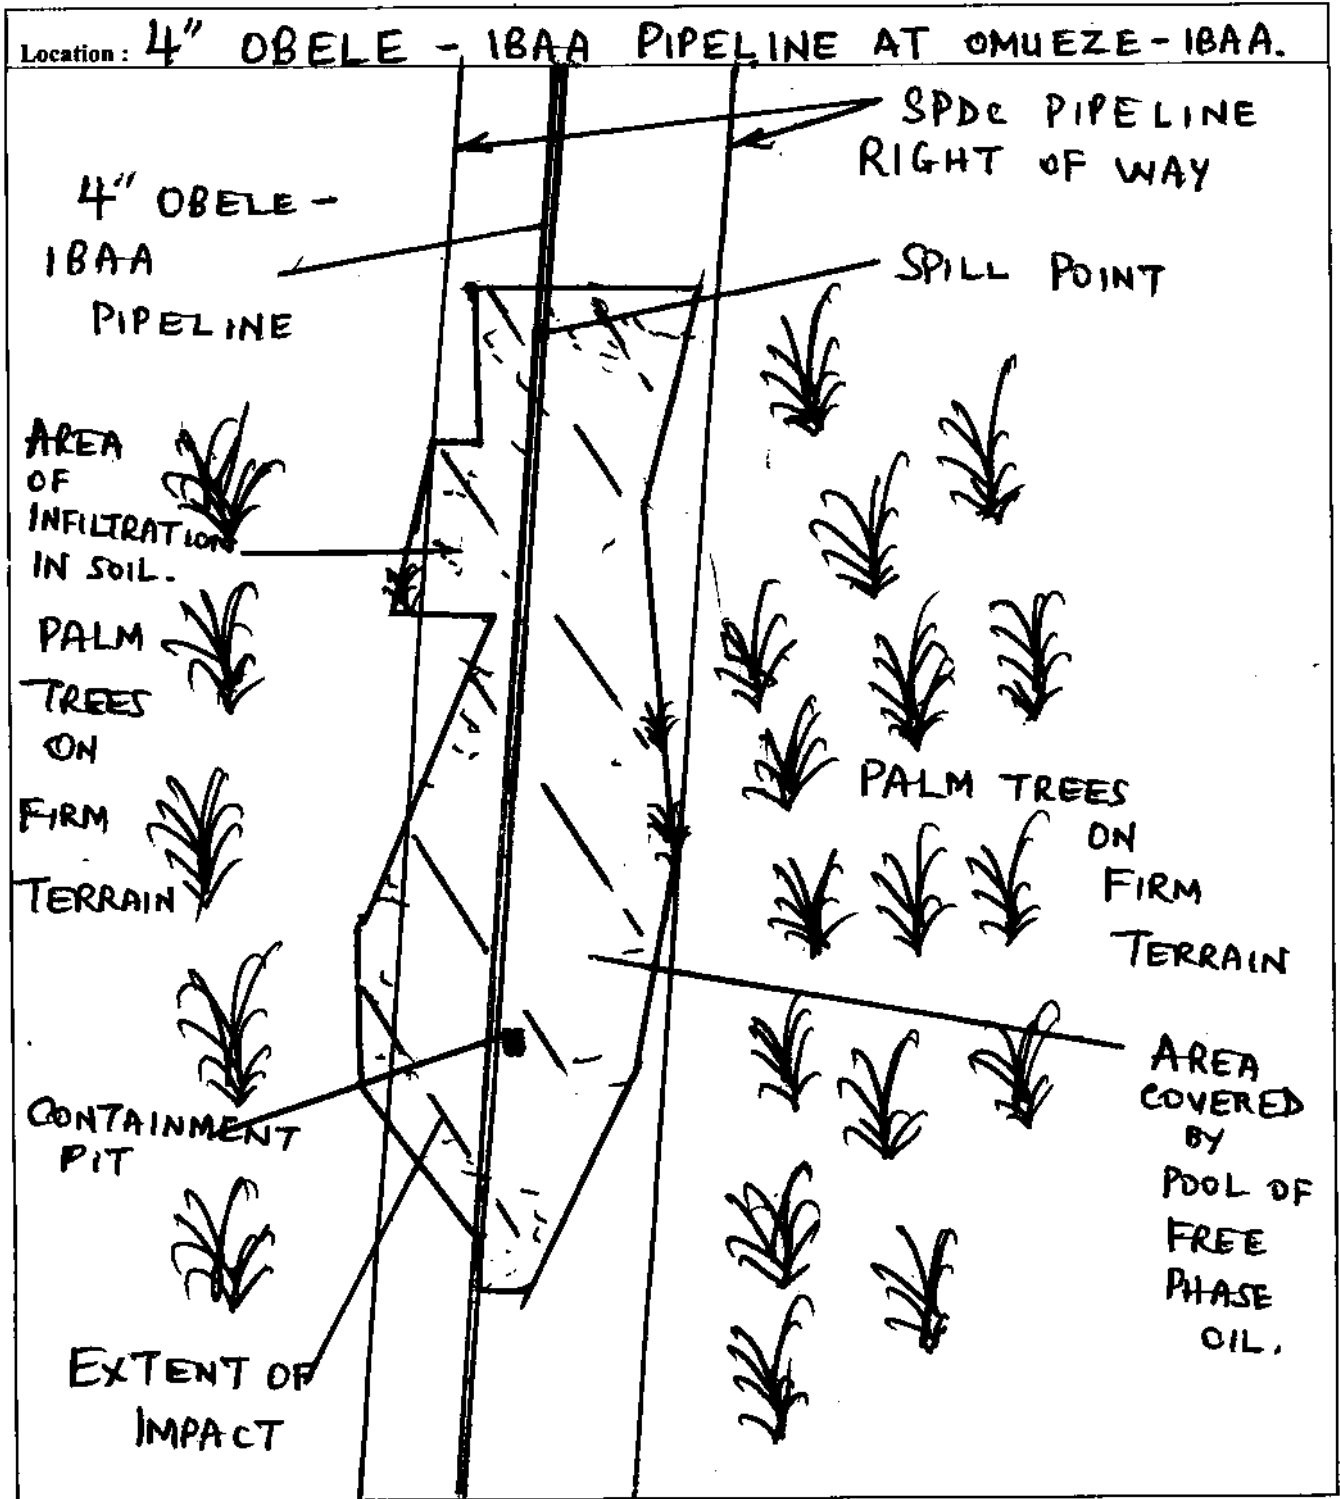
25. Appendix 1: Overview sketch of the site

Additional observations around the spill point:
THE SPILL WAS OBSERVED TO HAVE OCCURRED ON A CLEARED RIGHT OF WAY SURROUNDED BY NUMEROUS ROWS OF PALM TREES.
