THE SHELL PETROLEUM DEVELOPMENT COMPANY OF NIGERIA LIMITED.

JOINT INVESTIGATION REPORT FOR INCIDENT NO: 1155478 JIV report S/N: 0501

1. Spill incident Number: 1155478 2. Type of incident* OIL SPILL
 3. Name of Location 16" NUN RIVER - KOLOCREEK PIPELINE
 4. Name of nearest community ANGLAMA 5. State: BAYELSA 6. LGA SOUTHERN IJAW
 7. Type of Production facility/Installation OIL PIPELINE 8. Asset owner/District PIPELINE

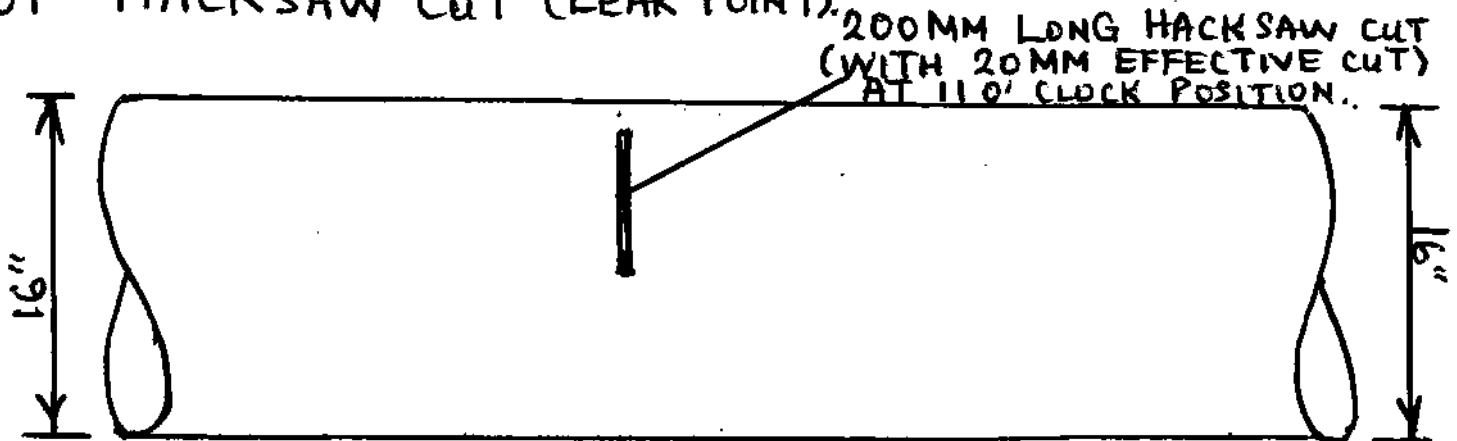
E. GRAPHIC DESCRIPTION OF LEAK POINT (while detail report of the leak point should be contained in the leak report, overview sketch of the site should be added as an appendix 1)

IMPACTED SOIL AROUND SPILL POINT IS LIGHT BROWN SILT WITH LOOSE PARTICLES. FREE PHASE OIL POOL WAS OBSERVED IN A DITCH AROUND SPILL POINT.

| <input type="checkbox"/> Drilled hole | <input checked="" type="checkbox"/> Hack saw cut | <input type="checkbox"/> Tear (_____), |

SECTION OF 16" NUN-RIVER — KOLOCREEK PIPELINE AT ANGIAMA SHOWING POSITION OF HACKSAW CUT (LEAK POINT).

RECOVERY OF FREE PHASE OIL HAD COMMENCED PRIOR TO JIV COMMENCEMENT WHILE REPAIRS WERE CARRIED OUT ON AFFECTED SECTION OF PIPELINE UPON EXPOSURE OF LEAK POINT.
