THE SHELL PETROLEUM DEVELOPMENT COMPANY OF NIGERIA LIMITED.

JOINT INVESTIGATION REPORT FOR INCIDENT NO: 1164424 JIV report S/N: 0515

1. Spill incident Number: 1164424 2. Type of incident* OIL SPILL
 3. Name of Location 4" Nun River Well 10T Flowline
 4. Name of nearest community OPOROKA 5. State: BAYELSA 6. LGA SOUTHERN ISAW
 7. Type of Production facility/Installation OIL FLOWLINE 8. Asset owner/District SWAMP 2

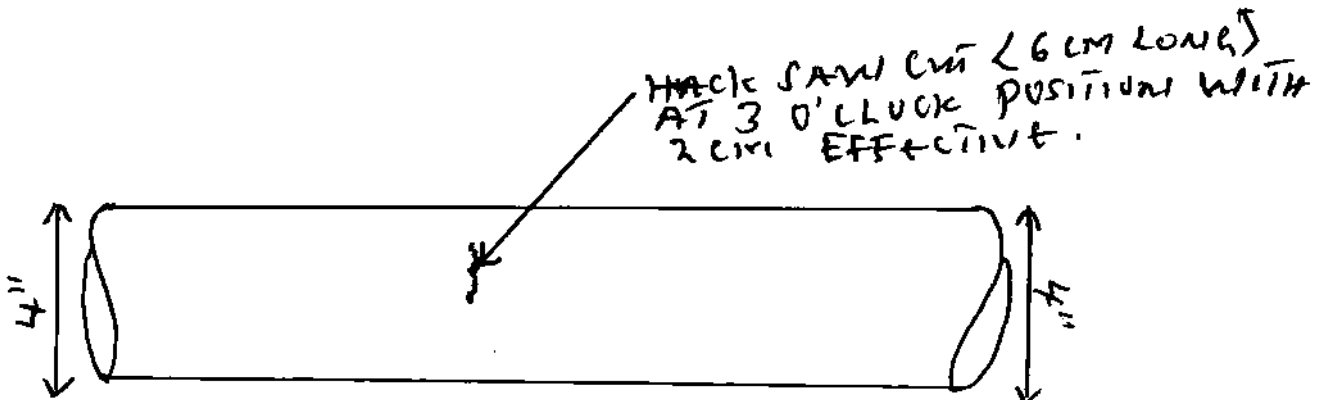
Additional observations around the spill point: PIECES OF BRICK WAS FOUND AROUND SPILL POINT. THE AFFECTED PART OF FLOWLINE WAS RAPPED WITH PIECES OF SACK BAG.

SECTION OF 4" NUN RIVER WELL 101 FLOWLINE AT OPOROMA
SHOWING POSITION OF HACK SAW CUT AT 3 O'CLOCK POSITION

FROM WELL 101 TO FLOW STATIONS.
