THE SHELL PETROLEUM DEVELOPMENT COMPANY OF NIGERIA LIMITED.

JOINT INVESTIGATION REPORT FOR INCIDENT NO: 1167046 JIV report S/N: 0525

1. Spill incident Number: 1167046 2. Type of incident* OIL SPILL/FIRE
 3. Name of Location 28" NKPOKY - BOMU PIPELINE
 4. Name of nearest community B-DERE 5. State: RIVERS 6. LGA GOKHANA
 7. Type of Production facility/Installation OIL PIPELINE 8. Asset owner/District PIPELINE

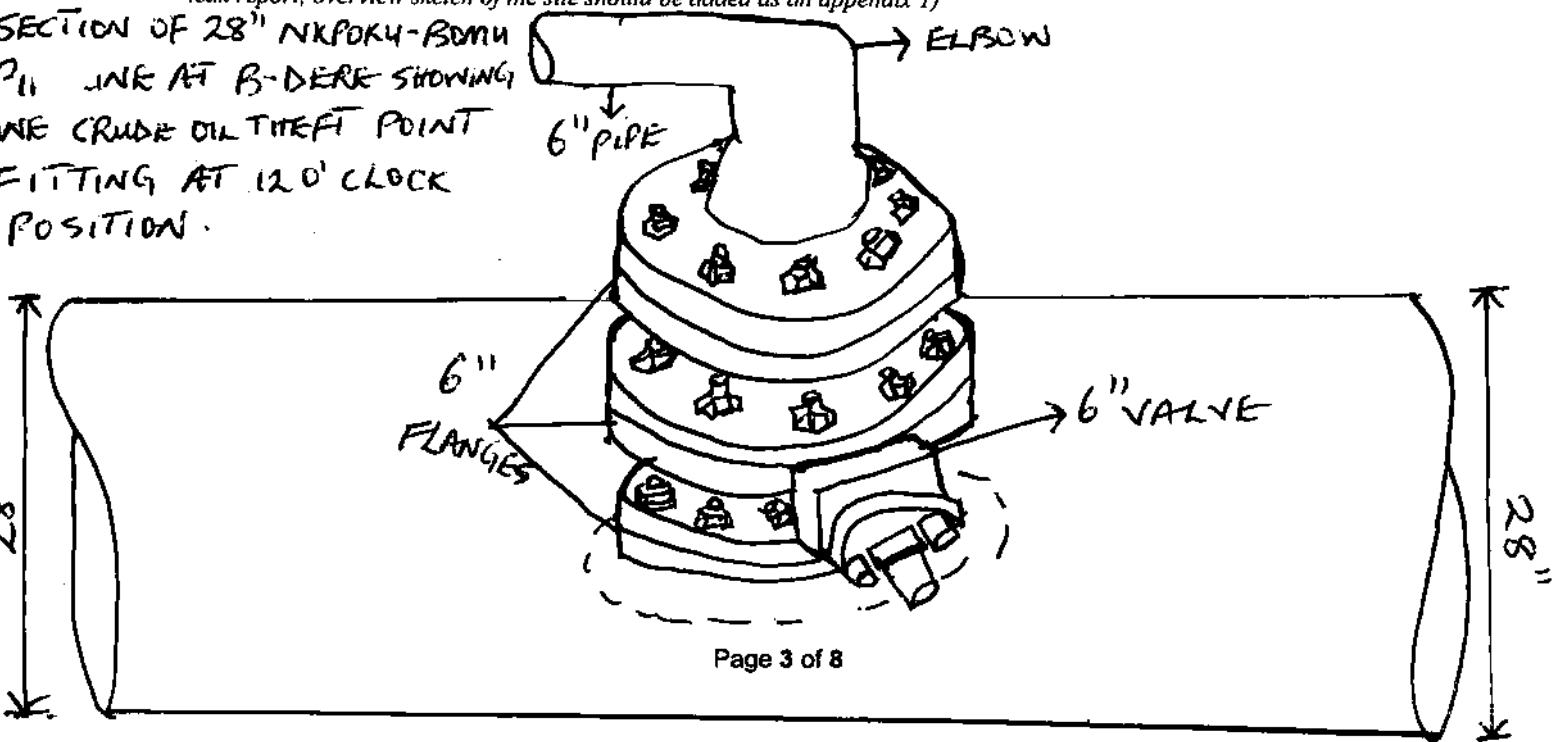
SECTION OF 28" NKPOKU-BOMU
LINE AT B-DERE SHOWING
ONE CRUDE OIL THEFT POINT
FITTING AT 12 O' CLOCK
POSITION.

← FROM NKPOKU - BOMU

CRUDE OIL RECOVERY / CLAMPING OF AFFECTED PIPE SECTION WAS INITIATED
