THE SHELL PETROLEUM DEVELOPMENT COMPANY OF NIGERIA LIMITED.

JOINT INVESTIGATION REPORT FOR INCIDENT NO: 1229361 JIV report S/N: 00692

1. Spill incident Number: 1229361 2. Type of incident* OIL SPILL
3. Name of Location 12" IMORIVER - OGALE PIPELINE
4. Name of nearest community KOMKOM 5. State: RIVERS 6. LGA OBIGBO
7. Type of Production facility/Installation PIPELINE 8. Asset owner/District PIPELINE/LAND

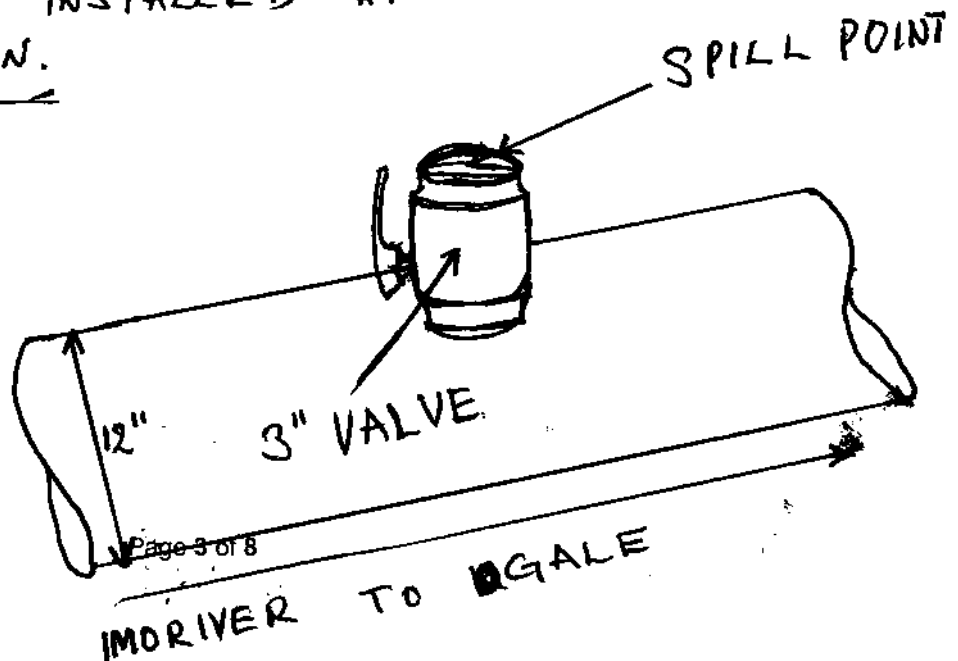
| <input checked="" type="checkbox"/> Crude oil theft (illegal bunkering) point, | | <input type="checkbox"/> Third party tampering with Clamp | |

- Third party interference (Sabotage ; crude theft ; Line theft ; Accidental 3rd party damage
 Operational Others (including Mystery spills) _____

SECTION OF 12" IMR RIVER - OGALE PIPELINE AT KOMKOM
SHOWING 3" VALVE INSTALLED AT
12 O'CLOCK POSITION.

THE LEAK POINT WAS CLAMPED DURING JOINT INVESTIGATION VISIT.
