THE SHELL PETROLEUM DEVELOPMENT COMPANY OF NIGERIA LIMITED.

JOINT INVESTIGATION REPORT FOR INCIDENT NO: 1121547 JIV report S/N: 0441

1. Spill incident Number: 1121547 2. Type of incident: OIL SPILL  
 3. Name of Location: 20" OTUMARA-ESCRAVOS PIPELINE  
 4. Name of nearest community: ADJUDAIBO 5. State: DELTA 6. LGA: WARRI SOUTH-WEST  
 7. Type of Production facility/Installation: OIL PIPELINE 8. Asset owner/District: PIPELINE

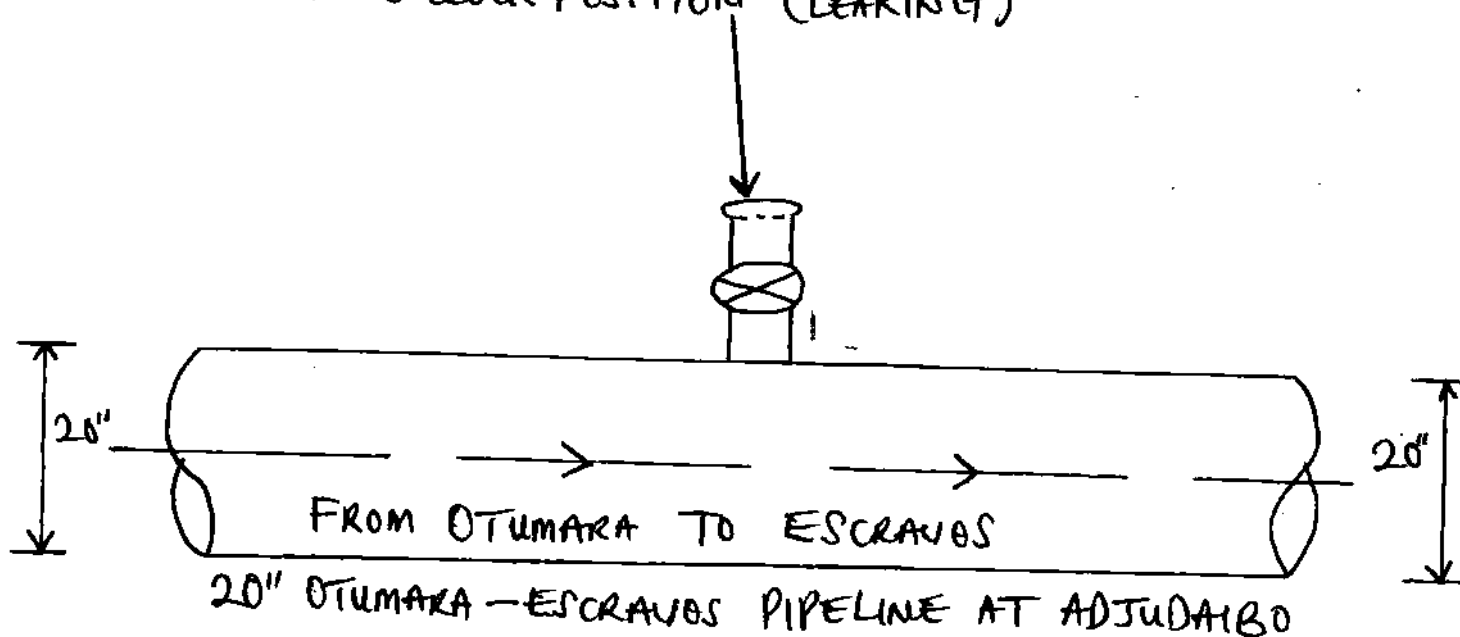
E. GRAPHIC DESCRIPTION OF LEAK POINT (while detail report of the leak point should be contained in the leak report, overview sketch of the site should be added as an appendix 1)

e. Description of leak point (tick as applicable):  
☐ Drilled hole ☐ Hack saw cut ☐ Tear (\_\_\_\_\_)  
☐ Complete Rupture ☐ Inward dent, ☐ Well head tampering  
☒ Failed Weld-on illegal hot tap valve, ☐ Failed Clamp ☐ Missing Pipeline/Flowline  
☒ Crude oil theft (illegal bunkering) point, ☐ Third party tampering with Clamp  
☐ Third party tampering with valve setting, ☐ Third party tampering with flange.  
☐ Corrosion ☐ Saver-pit over flow, ☐ Surge vessel overflow,  
☐ Bulging Outward ☐ Flare System/Bund wall failure ☐ Accidental 3<sup>rd</sup> party  
 equipment impact ☐ Valve Failure ☐ com unit failure ☐ Cold vent  
☐ Relief valve failure ☐ Others (specify) \_\_\_\_\_

- ☒ Third party interference (Sabotage ☐; crude theft ☒; Line theft ☐; Accidental 3<sup>rd</sup> party damage ☐  
☐ Operational ☐ Others (including Mystery spills) \_\_\_\_\_

3" FAILED WELD-ON ILLEGAL HOT TAP VALVE  
AT 12 O'CLOCK POSITION (LEAKING)

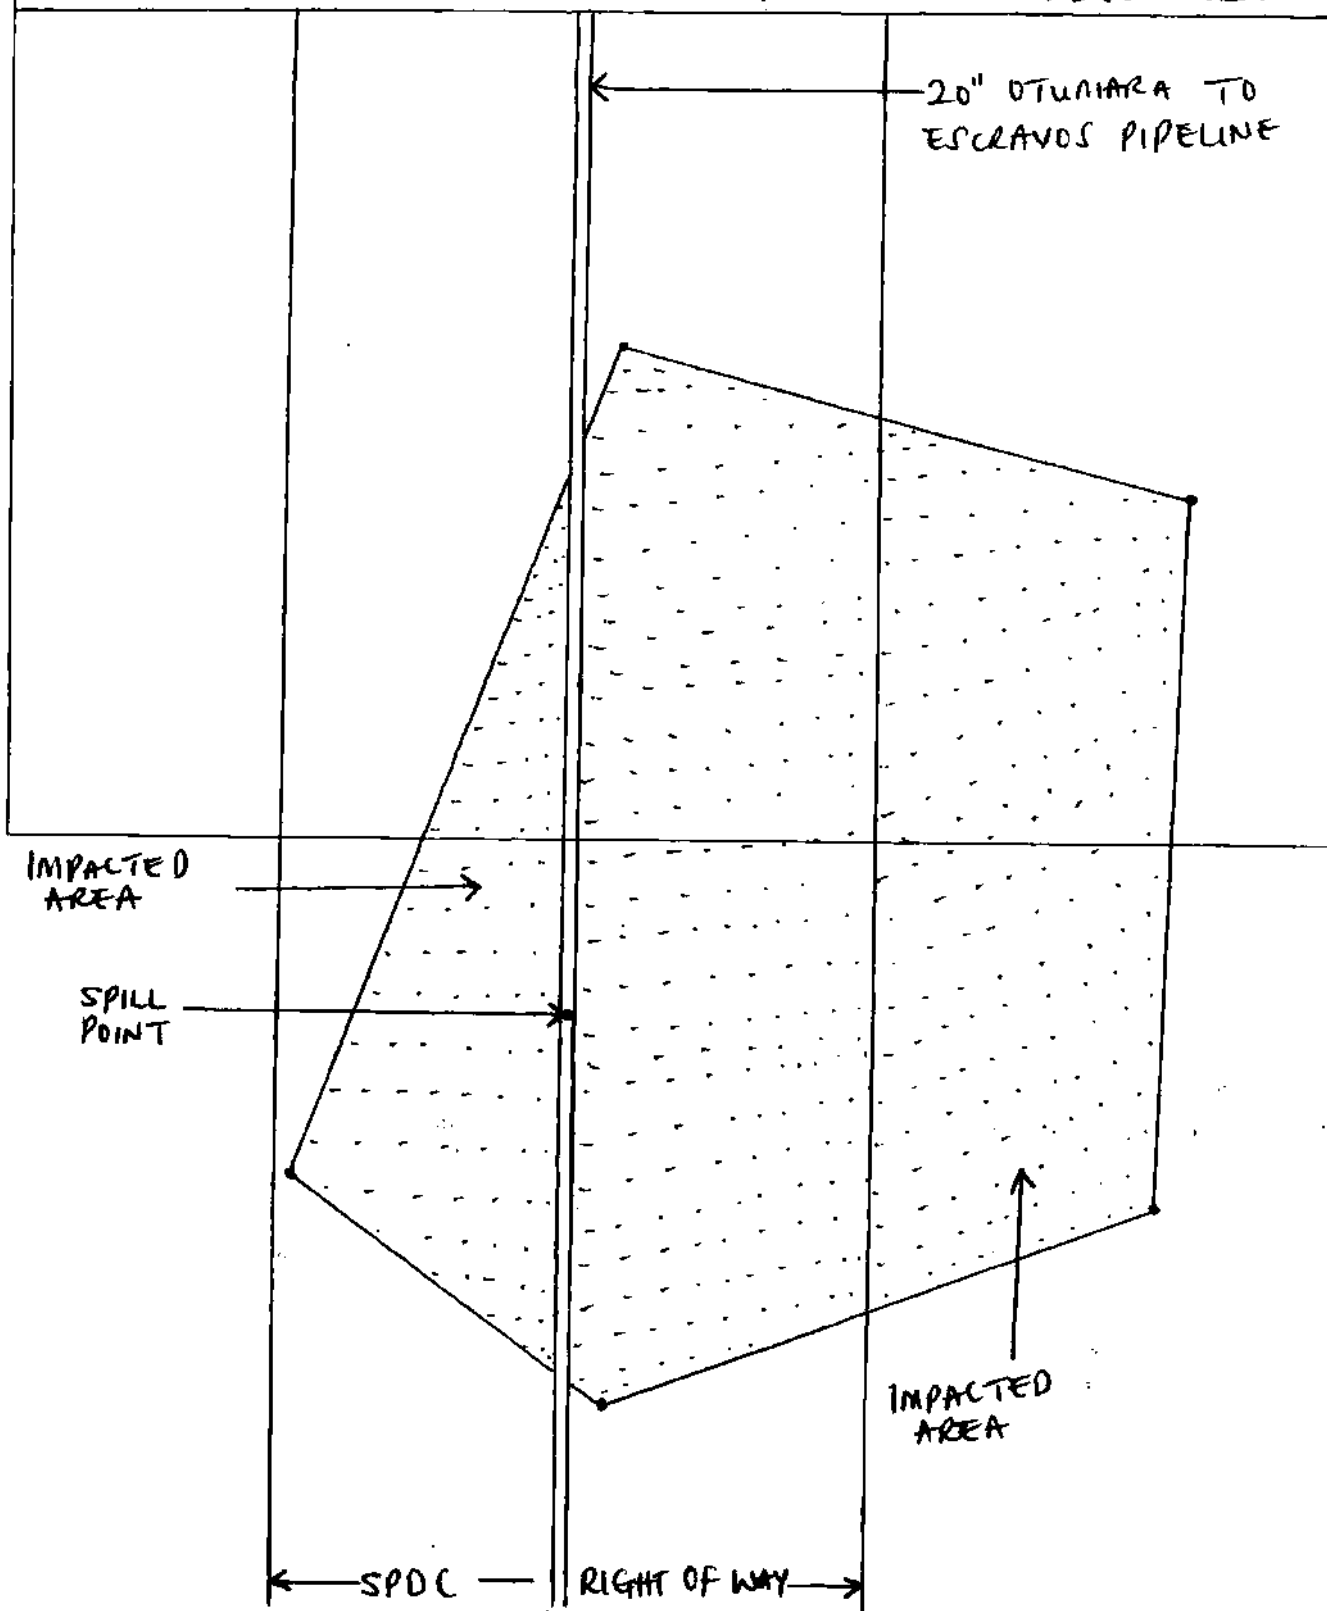
28. Appendix 1: Overview sketch of the site

LOCATION: 20" OTUMARA - ESCRAVOS PIPELINE AT ADJUDABO
