THE SHELL PETROLEUM DEVELOPMENT COMPANY OF NIGERIA LIMITED.

JOINT INVESTIGATION REPORT FOR INCIDENT NO: 1117596 JIV report S/N: 0230

1. Spill incident Number: 1117596 2. Type of incident*: OIL SPILL
 3. Name of Location: 20" OTUMARA - ESCRAVOS PIPELINE
 4. Name of nearest community: ADJUDABO 5. State: DELTA 6. LGA: WARRI SOUTH-WEST
 7. Type of Production facility/Installation: OIL PIPELINE 8. Asset owner/District: PIPELINE

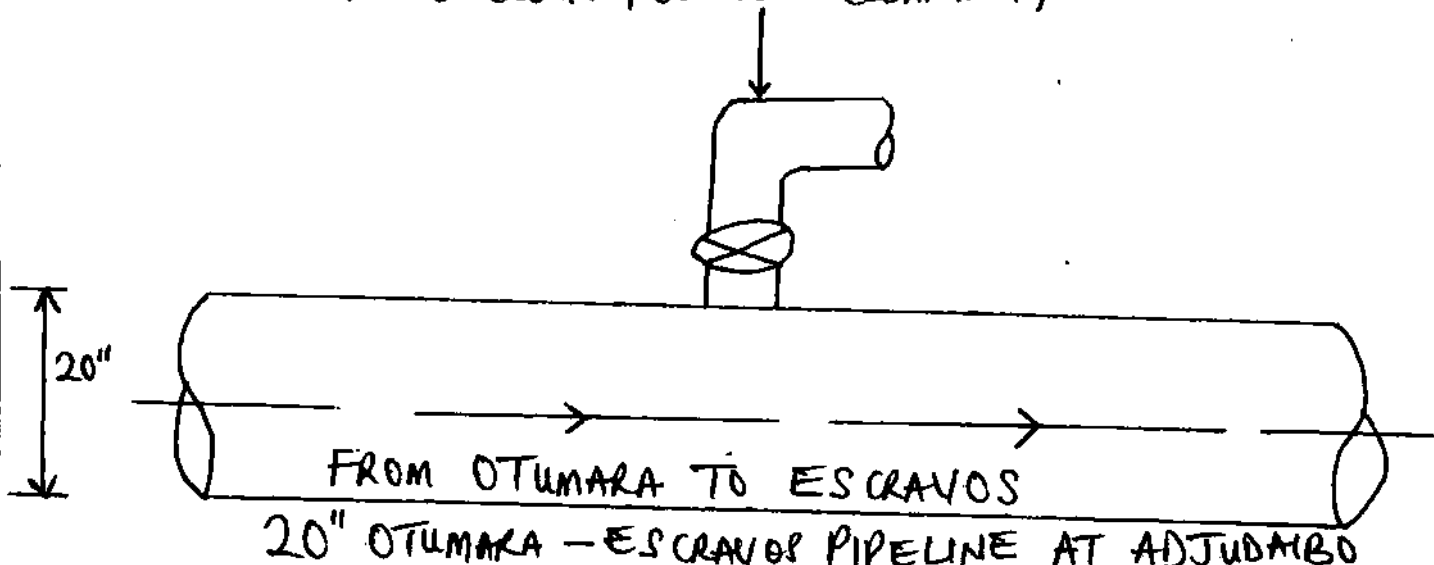
E. GRAPHIC DESCRIPTION OF LEAK POINT (while detail report of the leak point should be contained in the leak report, overview sketch of the site should be added as an appendix 1)

4" FAILED WELD - ON ILLEGAL HOT TAP VALVE
AT 12 O' CLOCK POSITION (LEAKING)
