THE SHELL PETROLEUM DEVELOPMENT COMPANY OF NIGERIA LIMITED.

JOINT INVESTIGATION REPORT FOR INCIDENT NO: 1118848 JIV report S/N: 0228

1. Spill incident Number: 1118848 2. Type of incident* OIL SPILL
 3. Name of Location 20" OTUMARA-ESCRAVOS PIPELINE
 4. Name of nearest community ULBOEGUNGUN 5. State: DELTA 6. LGA WARRI SOUTH-WEST
 7. Type of Production facility/Installation OIL PIPELINE 8. Asset owner/District PIPELINE

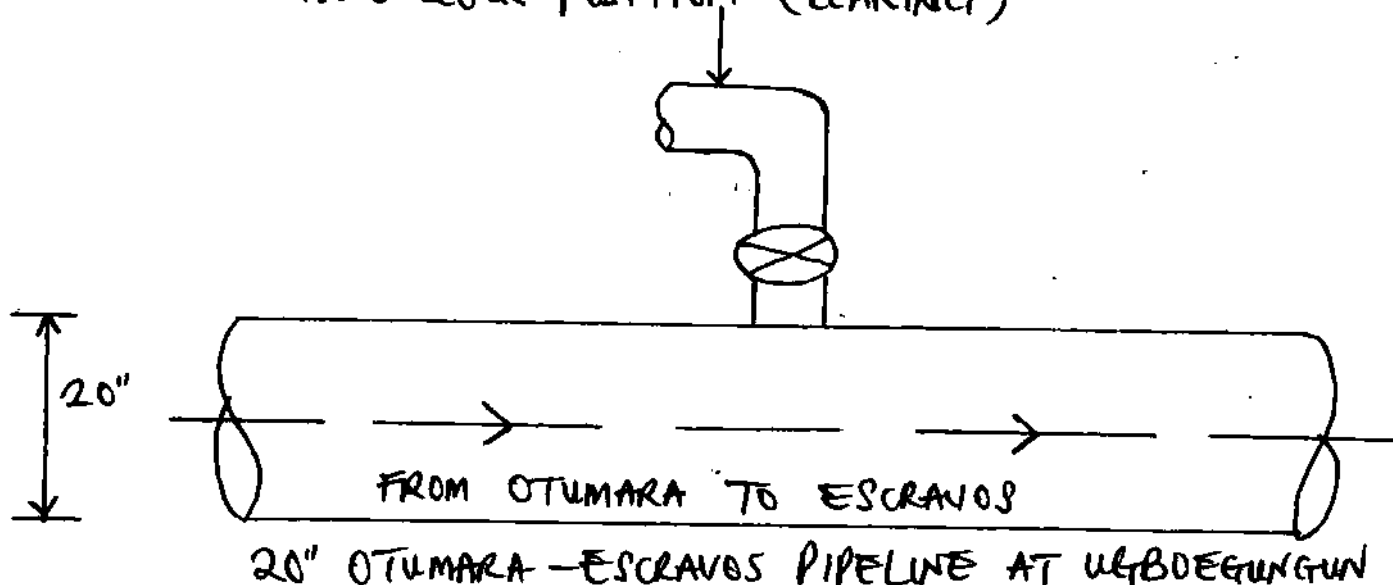
E. GRAPHIC DESCRIPTION OF LEAK POINT (while detail report of the leak point should be contained in the leak report, overview sketch of the site should be added as an appendix 1)

e. Description of leak point (tick as applicable):
☐ Drilled hole ☐ Hack saw cut ☐ Tear (____).
☐ Complete Rupture ☐ Inward dent. ☐ Well head tampering
☒ Failed Weld-on illegal hot tap valve, ☐ Failed Clamp ☐ Missing Pipeline/Flowline
☒ Crude oil theft (illegal bunkering) point. ☐ Third party tampering with Clamp
☐ Third party tampering with valve setting. ☐ Third party tampering with flange.
☐ Corrosion ☐ Saver-pit over flow. ☐ Surge vessel overflow.
☐ Bulging Outward ☐ Flare System/Bund wall failure ☐ Accidental 3rd party equipment impact ☐ Valve Failure ☐ com unit failure ☐ Cold vent
☐ Relief valve failure ☐ Others (specify) _____

f. Incident caused by:
☒ Third party interference (Sabotage ☐; crude theft ☒; Line theft ☐; Accidental 3rd party damage ☐
☐ Operational ☐ Others (including Mystery spills) _____

4" FAILED WELD-ON ILLEGAL HOT TAP VALVE
AT 12 O' CLOCK POSITION (LEAKING)

| B. Investigation of the incident site showed that there is residual impact on site requiring further works <input checked="" type="checkbox"/> |

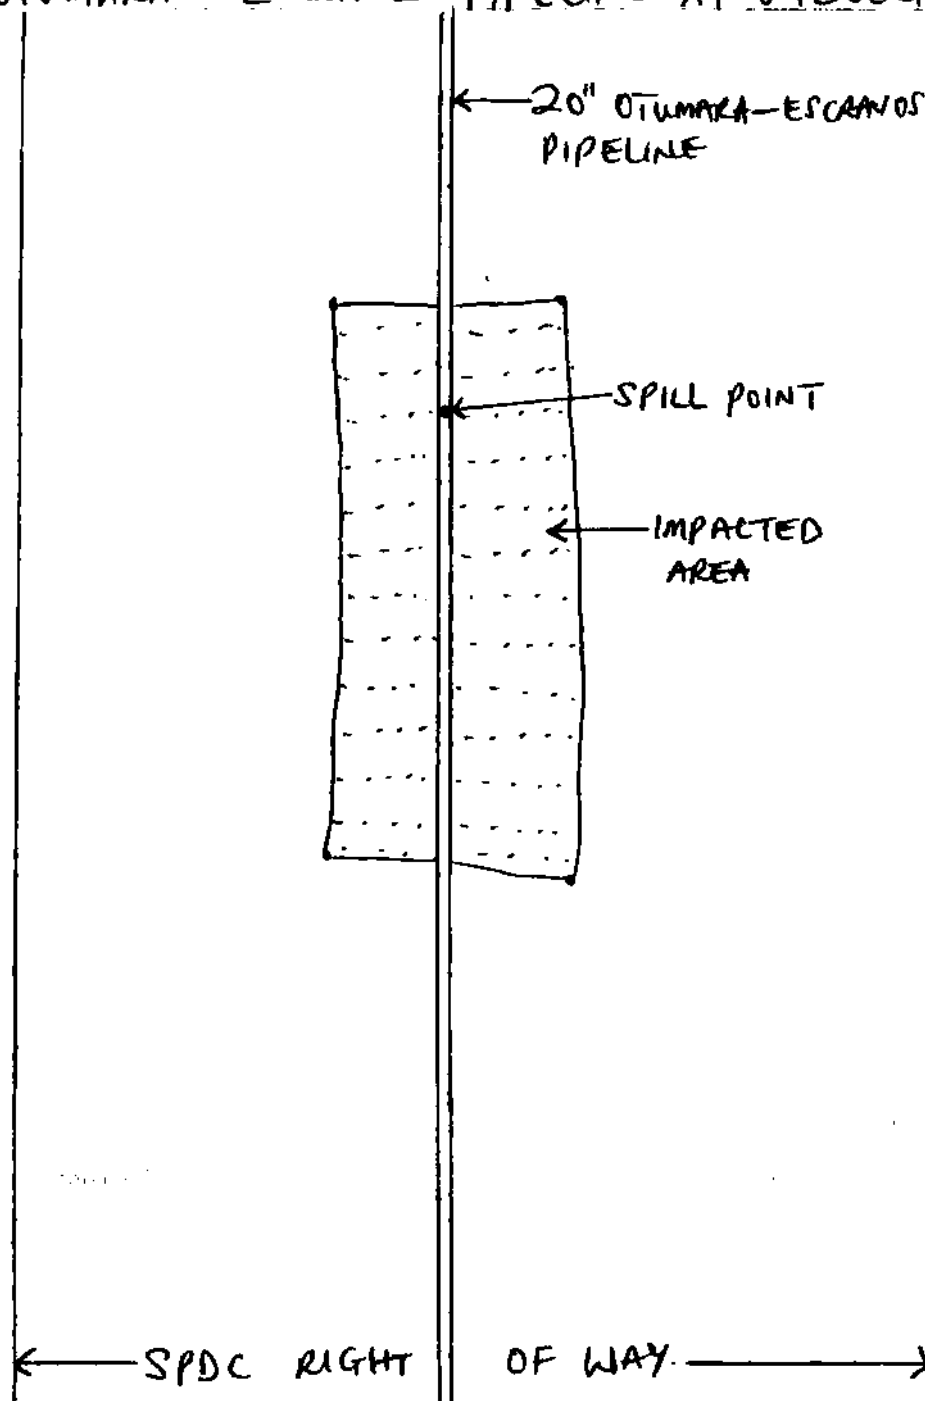
28 Appendix 1: Overview sketch of the site

Location: 20" OTUMARA — ESCRAVOS PIPELINE AT UGBOEGUNGUN
