THE SHELL PETROLEUM DEVELOPMENT COMPANY OF NIGERIA LIMITED.

JOINT INVESTIGATION REPORT FOR INCIDENT NO: 1124602 JIV report S/N: 0415

1. Spill incident Number: 1124602 2. Type of incident* OIL SPILL
 3. Name of Location 12th IMO RIVER 11 - ~~OGRALE~~ PIPELINE
(UMUEDEOKWARA)
 4. Name of nearest community ODAGWA 5. State: RIVERS 6. LGA ETCHE
 7. Type of Production facility/Installation OIL PIPELINE 8. Asset owner/District PIPELINE

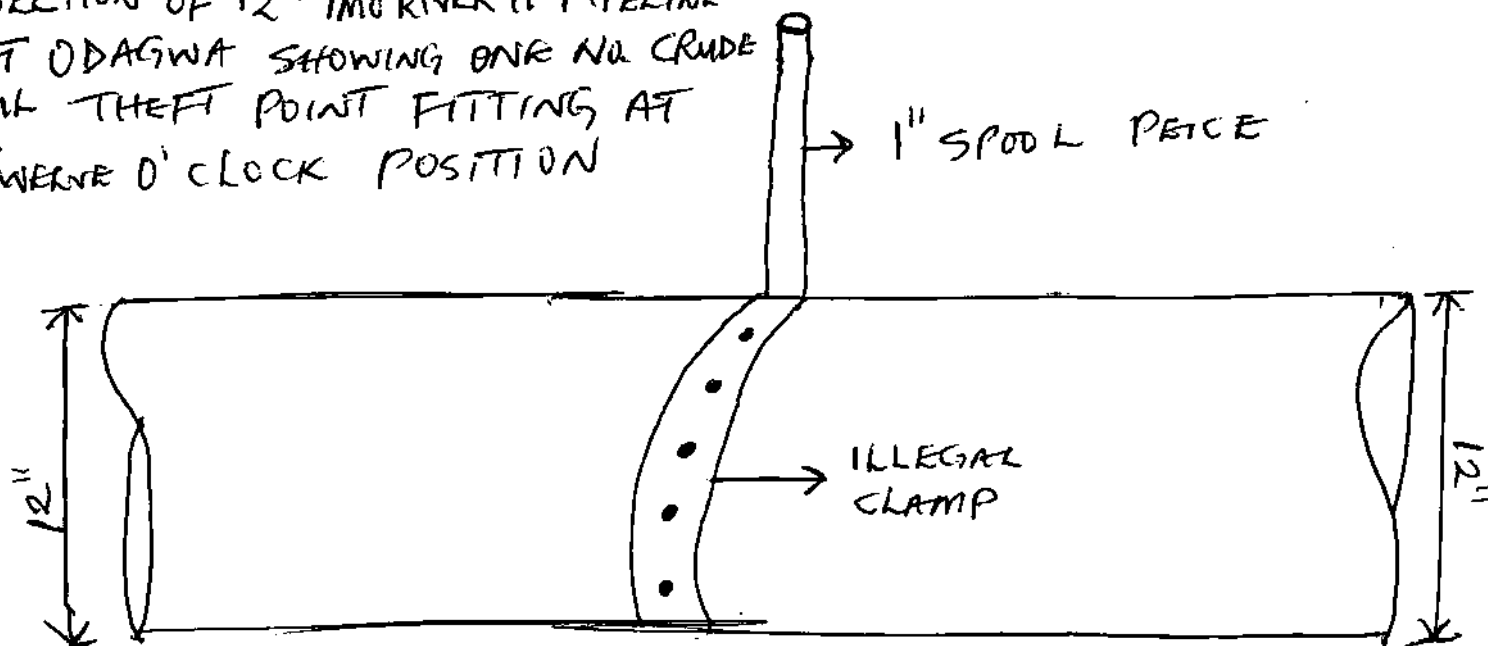
E. GRAPHIC DESCRIPTION OF LEAK POINT (while detail report of the leak point should be contained in the leak report, overview sketch of the site should be added as an appendix 1)

- ☐ Firmed soil ☒ Loose soil ☒ Recently excavated area
☐ Under water ☐ Swampy ☐ Exposed pipe surface
☐ Well Platform (on Water) ☐ Drill Rig
 e. Description of leak point (tick as applicable);
☐ Drilled hole ☐ Hack saw cut ☐ Tear (_____),
☐ Complete Rupture ☐ Inward dent, ☐ Well head tampering
☐ Failed Weld-on illegal hot tap valve, ☐ Failed Clamp ☐ Missing Pipeline/Flowline
☒ Crude oil theft (illegal bunkering) point, ☐ Third party tampering with Clamp
☐ Third party tampering with valve setting, ☐ Third party tampering with flange,
☐ Corrosion ☐ Saver-pit over flow, ☐ Surge vessel overflow,
☐ Bulging Outward ☐ Flare System/Bund wall failure ☐ Accidental 3rd party
 equipment impact ☐ Valve Failure ☐ com unit failure ☐ Cold vent
☐ Relief valve failure ☐ Others (specify) _____

- ☒ Third party interference (Sabotage ☐; crude theft ☒; Line theft ☐; Accidental 3rd party damage ☐
☐ Operational ☐ Others (including Mystery spills) _____

SECTION OF 12" IMO RIVER II PIPELINE
AT ODAGWA SHOWING ONE NO CRUDE
OIL THEFT POINT FITTING AT
TWELVE O'CLOCK POSITION

NOTE:
REPAIR WAS DONE
BY CLAMPING

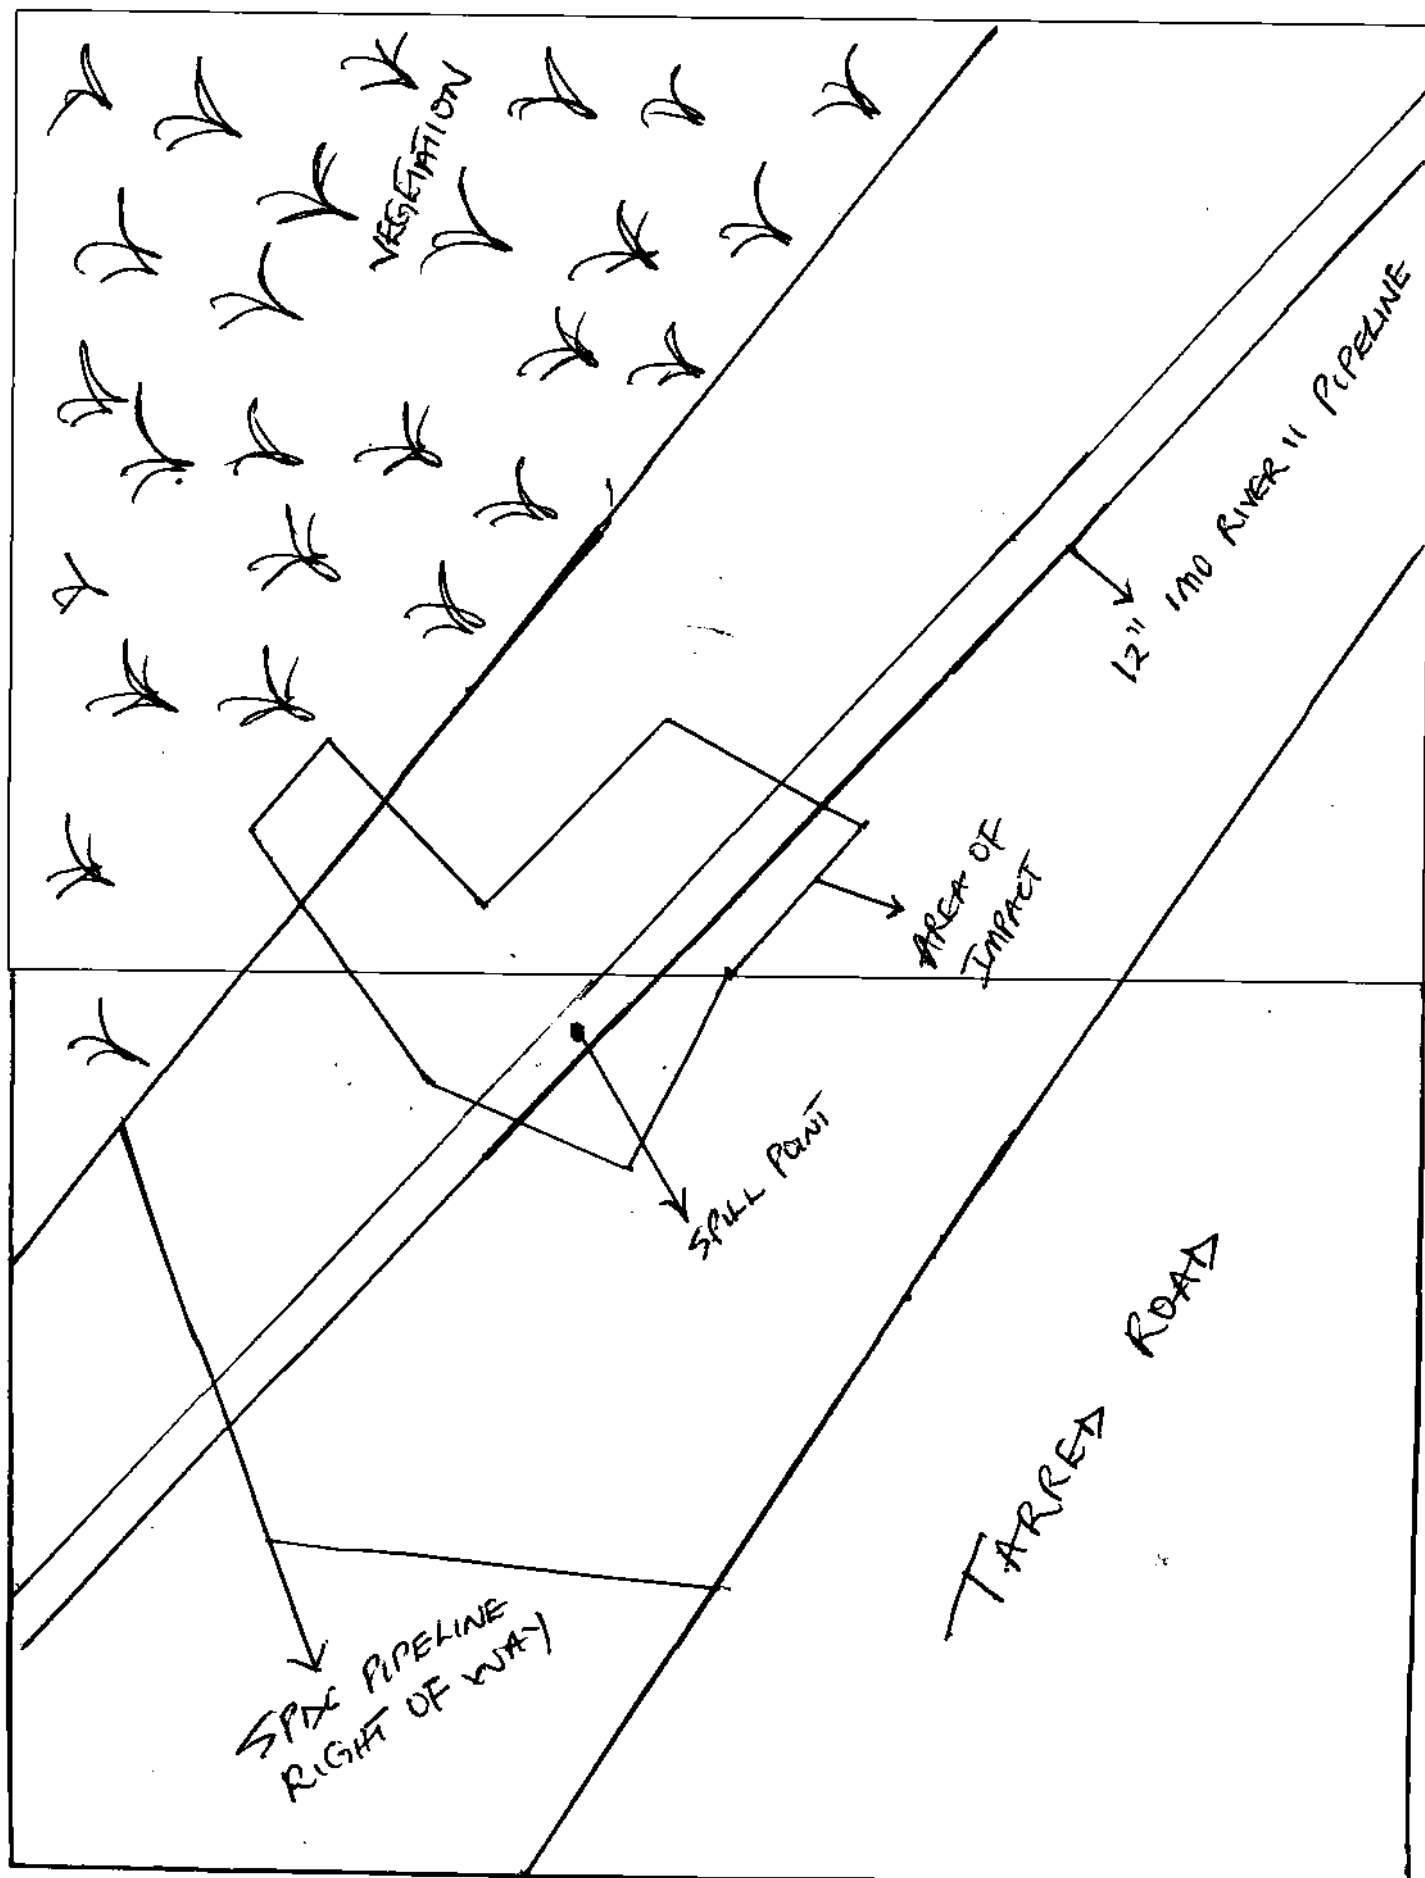
28. Appendix 1: Overview sketch of the site

Location: 12" IMO RIVER 11 PIPELINE AT ODAGWA
