THE SHELL PETROLEUM DEVELOPMENT COMPANY OF NIGERIA LIMITED.

JOINT INVESTIGATION REPORT FOR INCIDENT NO: 1129395 JIV report S/N: 0406

1. Spill incident Number: 1129395 2. Type of incident* OIL SPILL
 3. Name of Location 28" NKPOKU - BOMU PIPELINE
 4. Name of nearest community B-DERE 5. State: RIVERS 6. LGA GOKANA
 7. Type of Production facility/Installation OIL PIPELINE 8. Asset owner/District PIPELINE

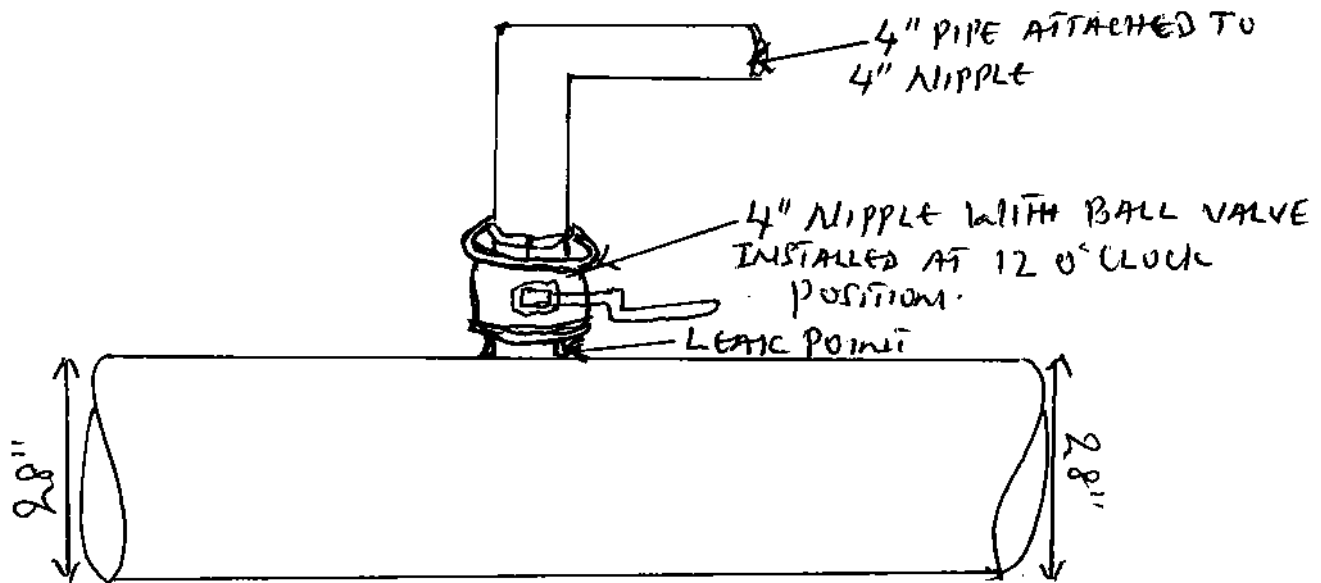
| <input checked="" type="checkbox"/> Failed Weld-on illegal hot tap valve, | <input type="checkbox"/> Failed Clamp | <input type="checkbox"/> Missing Pipeline/Flowline |
| <input checked="" type="checkbox"/> Crude oil theft (illegal bunkering) point, | | <input type="checkbox"/> Third party tampering with Clamp |

SECTION OF 28" Nkpoku - Boreu PIPELINE AT B-DERE SHOWING POSITION OF CRUDE OIL THEFT POINT AT 12 O'CLOCK POSITION.

FROM NKPOKU TO BOREU

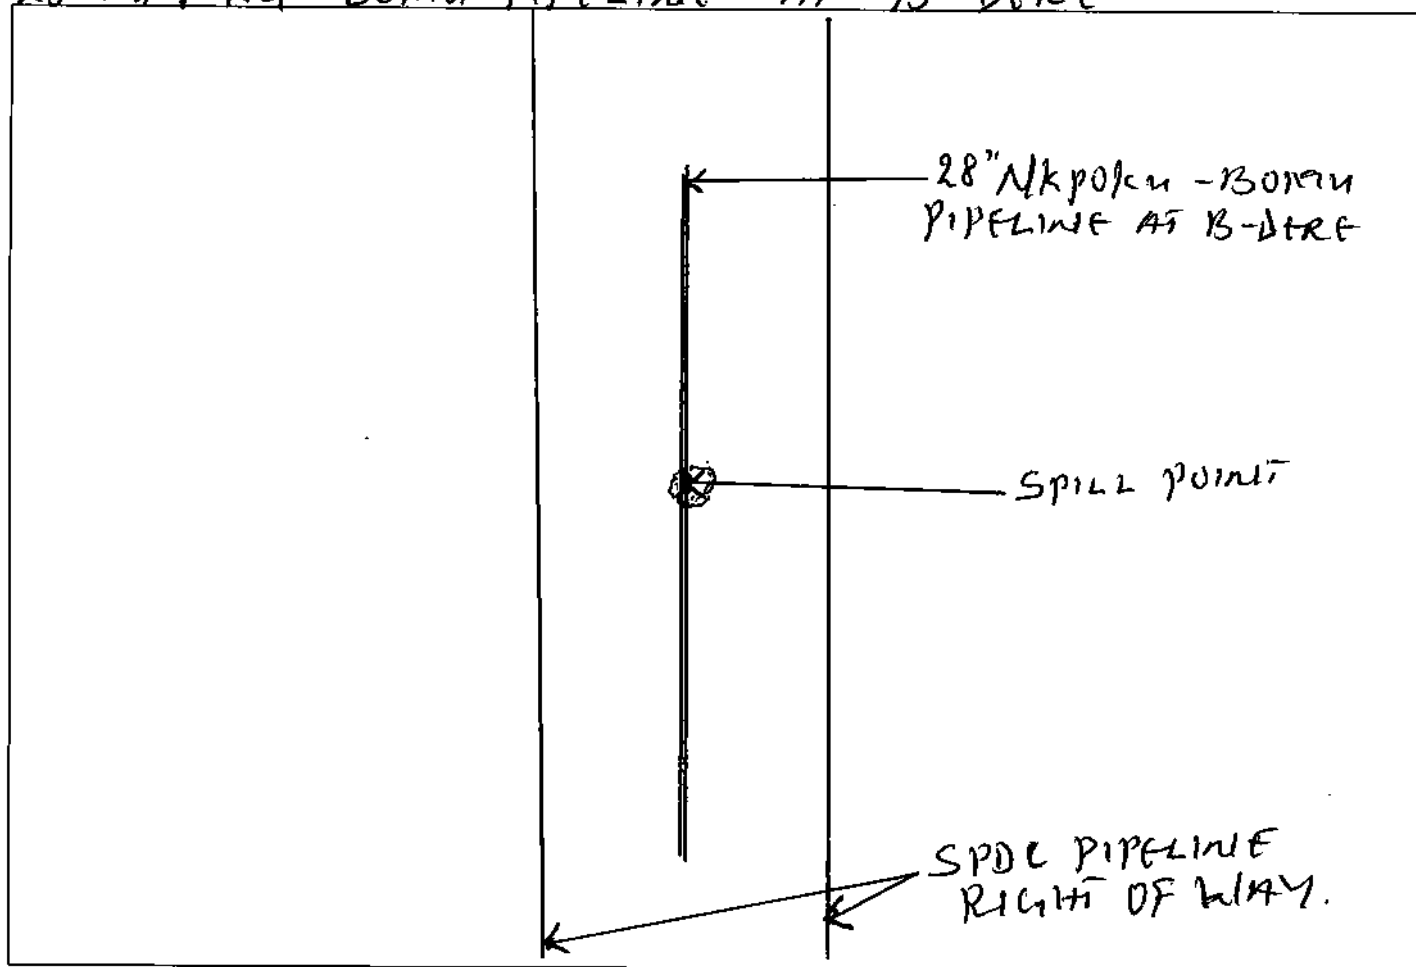
28. Appendix 1: Overview sketch of the site

Location: 28" Nkpoku - Boma Pipeline at B-DRE

JOINT INVESTIGATION REPORT FOR INCIDENT NO: 1129395 JIV report S/N: 0406
28" Nkpoku - BOMU PIPELINE AT B-DTRE
