THE SHELL PETROLEUM DEVELOPMENT COMPANY OF NIGERIA LIMITED.

JOINT INVESTIGATION REPORT FOR INCIDENT NO: 1103858 JIV report S/N: 0226

1. Spill incident Number: 1103858 2. Type of incident\*: OIL SPILL  
 3. Name of Location 20" OPUKUSHI - BRASS CREEK PIPELINE  
 4. Name of nearest community TAMOGBENE 5. State: BAYELSA 6. LGA EKEREMOR  
 7. Type of Production facility/Installation OIL PIPELINE 8. Asset owner/District PIPELINE

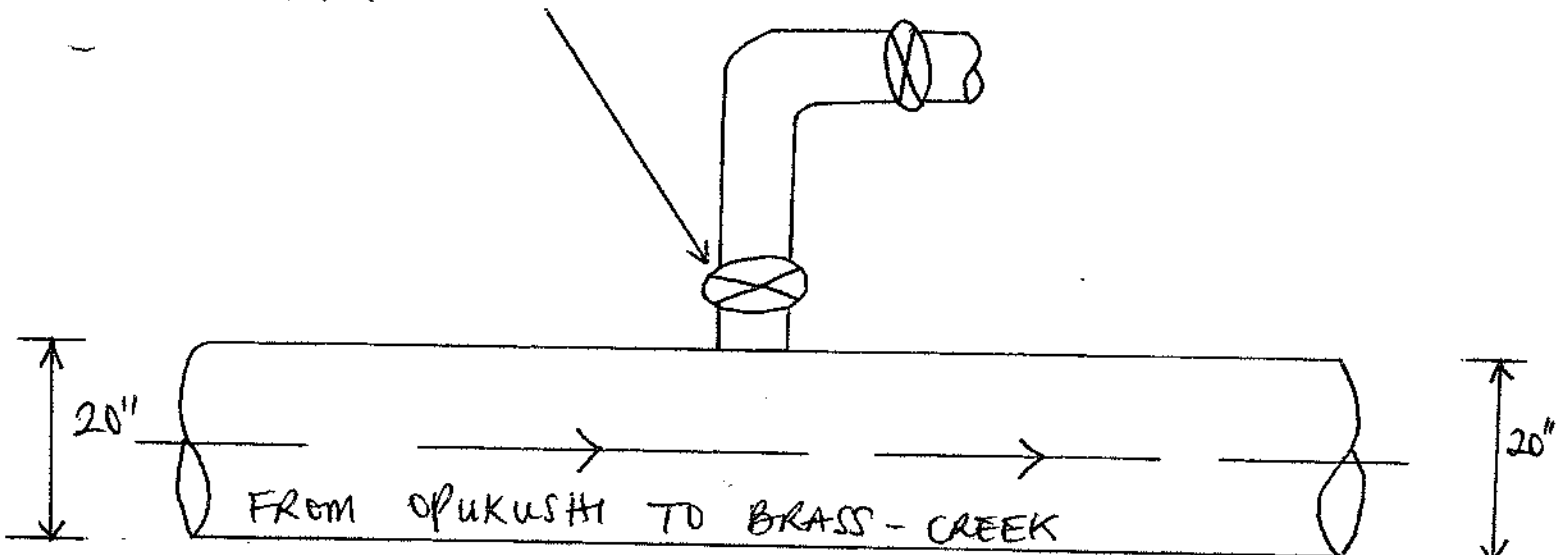
20" OPUKUSHI-BRASS CREEK PIPELINE AT TAMOGBENE

4" WELD-ON ILLEGAL HOT-TAP VALVE  
AT 12 O'CLOCK POSITION
