**THE SHELL PETROLEUM DEVELOPMENT COMPANY OF NIGERIA LIMITED.**

JOINT INVESTIGATION REPORT FOR INCIDENT NO: 1104854 JIV report S/N: 0383

1. Spill incident Number: 1104854 2. Type of incident\* OIL SPILL  
 3. Name of Location 28" Nkpoku - BOMU PIPELINE  
 4. Name of nearest community EKPORO 5. State: RIVERS 6. LGA ELEME-  
 7. Type of Production facility/Installation PIPELINE 8. Asset owner/District PIPELINE

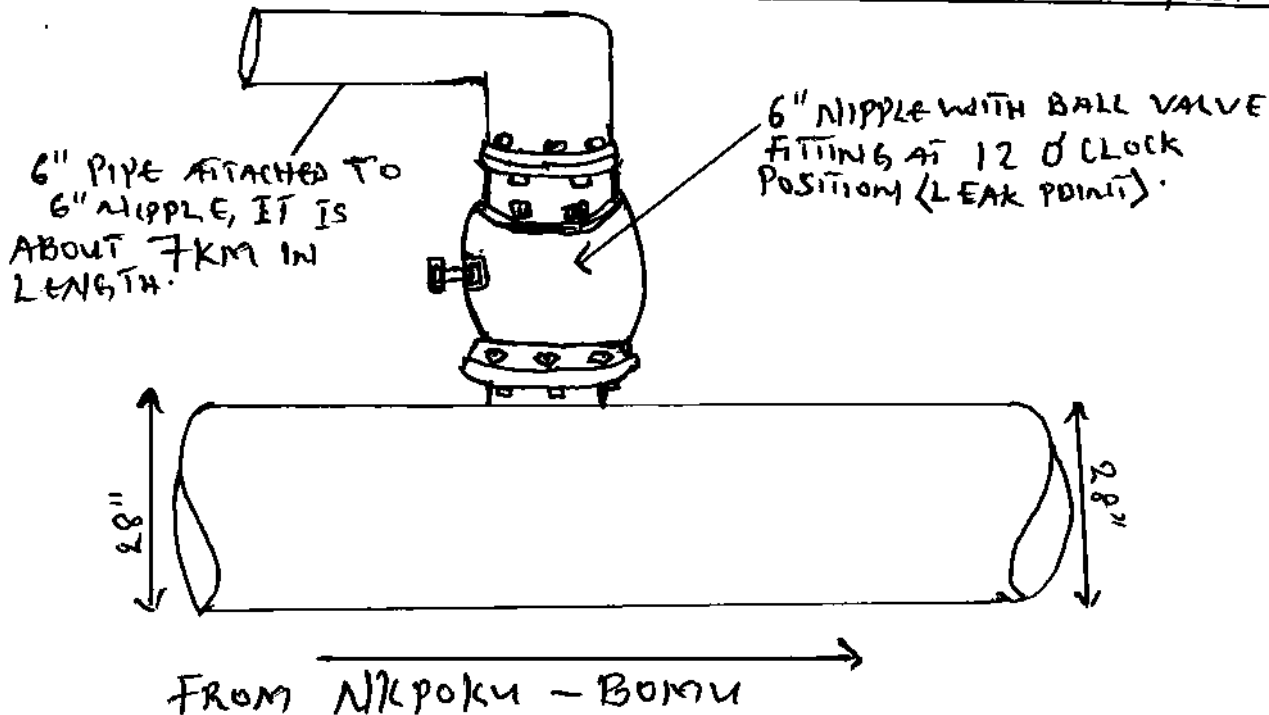
| <input checked="" type="checkbox"/> Failed Weld-on illegal hot tap valve, | <input type="checkbox"/> Failed Clamp | <input type="checkbox"/> Missing Pipeline/Flowline |
| <input checked="" type="checkbox"/> Crude oil theft (illegal bunkering) point, | | <input type="checkbox"/> Third party tampering with Clamp |

SECTION OF 28" NIKPOKU - BOMU PIPELINE AT EKPOBU SHOWING POSITION OF CRUDE OIL LEAK POINT AT 12 O'CLOCK POSITION.

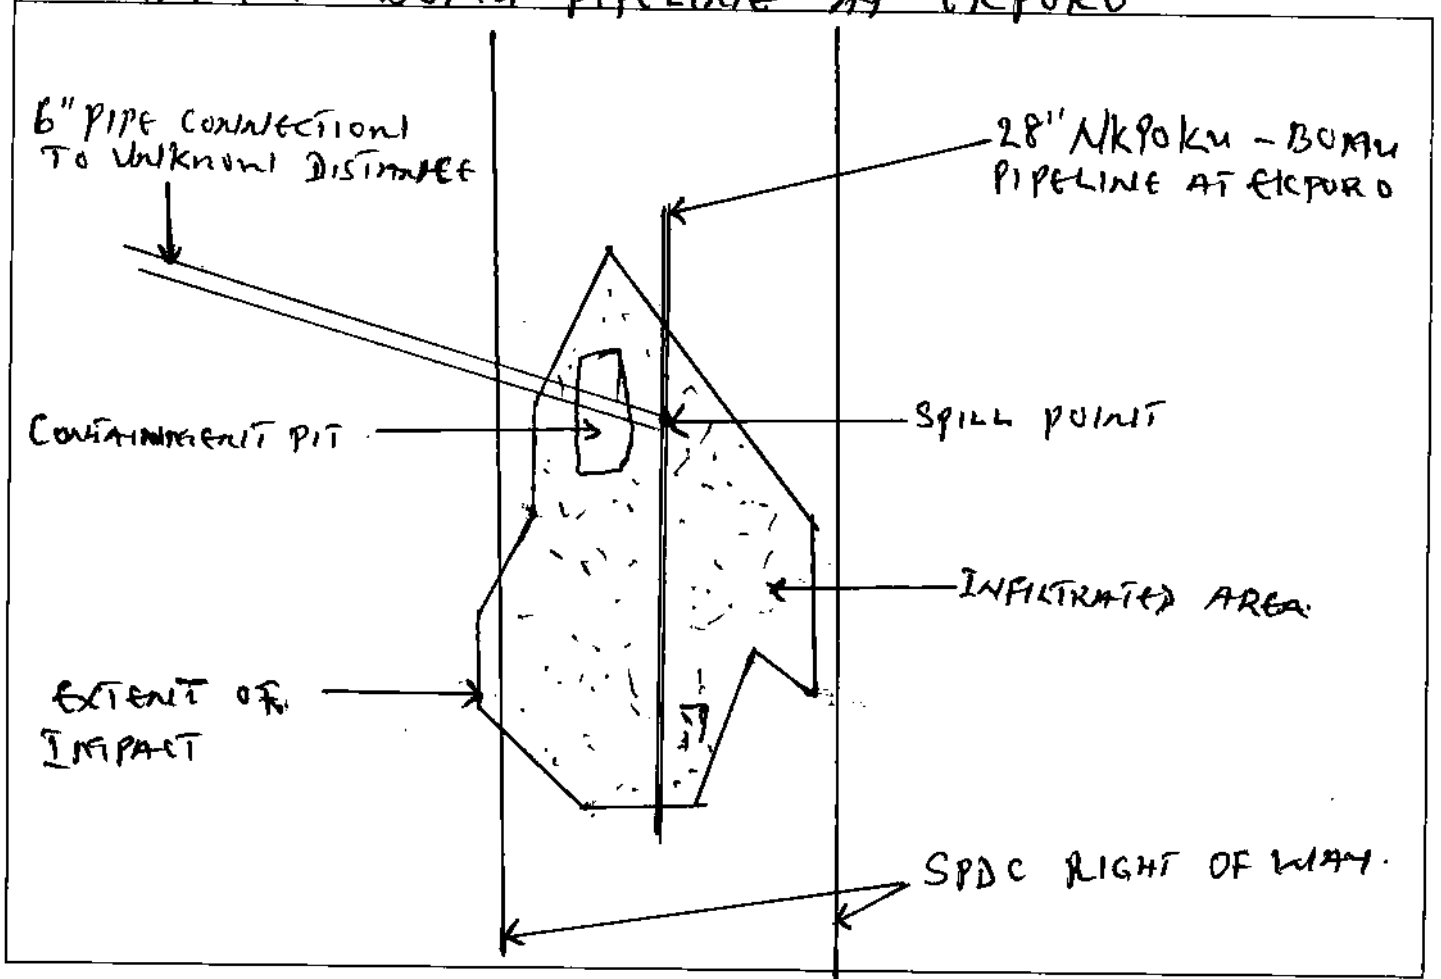
28. Appendix 1: Overview sketch of the site

Location: 28" Nkporu - Boma Pipeline at Ekporo

JOINT INVESTIGATION REPORT FOR INCIDENT NO: 1104854 JIV report S/N: 0383  
28" Nkpoku - BOMU PIPELINE AT EKPORO
