**THE SHELL PETROLEUM DEVELOPMENT COMPANY OF NIGERIA LIMITED.**

JOINT INVESTIGATION REPORT FOR INCIDENT NO: 1109543 JIV report S/N: 0391

1. Spill incident Number: 1109543 2. Type of incident\* OIL SPILL  
 3. Name of Location OKORDIA MANIFOLD  
 4. Name of nearest community IKARAMA - OKORDIA 5. State: BAYELSA 6. LGA TENAGUA  
 7. Type of Production facility/Installation MANIFOLD 8. Asset owner/District PIPELINE

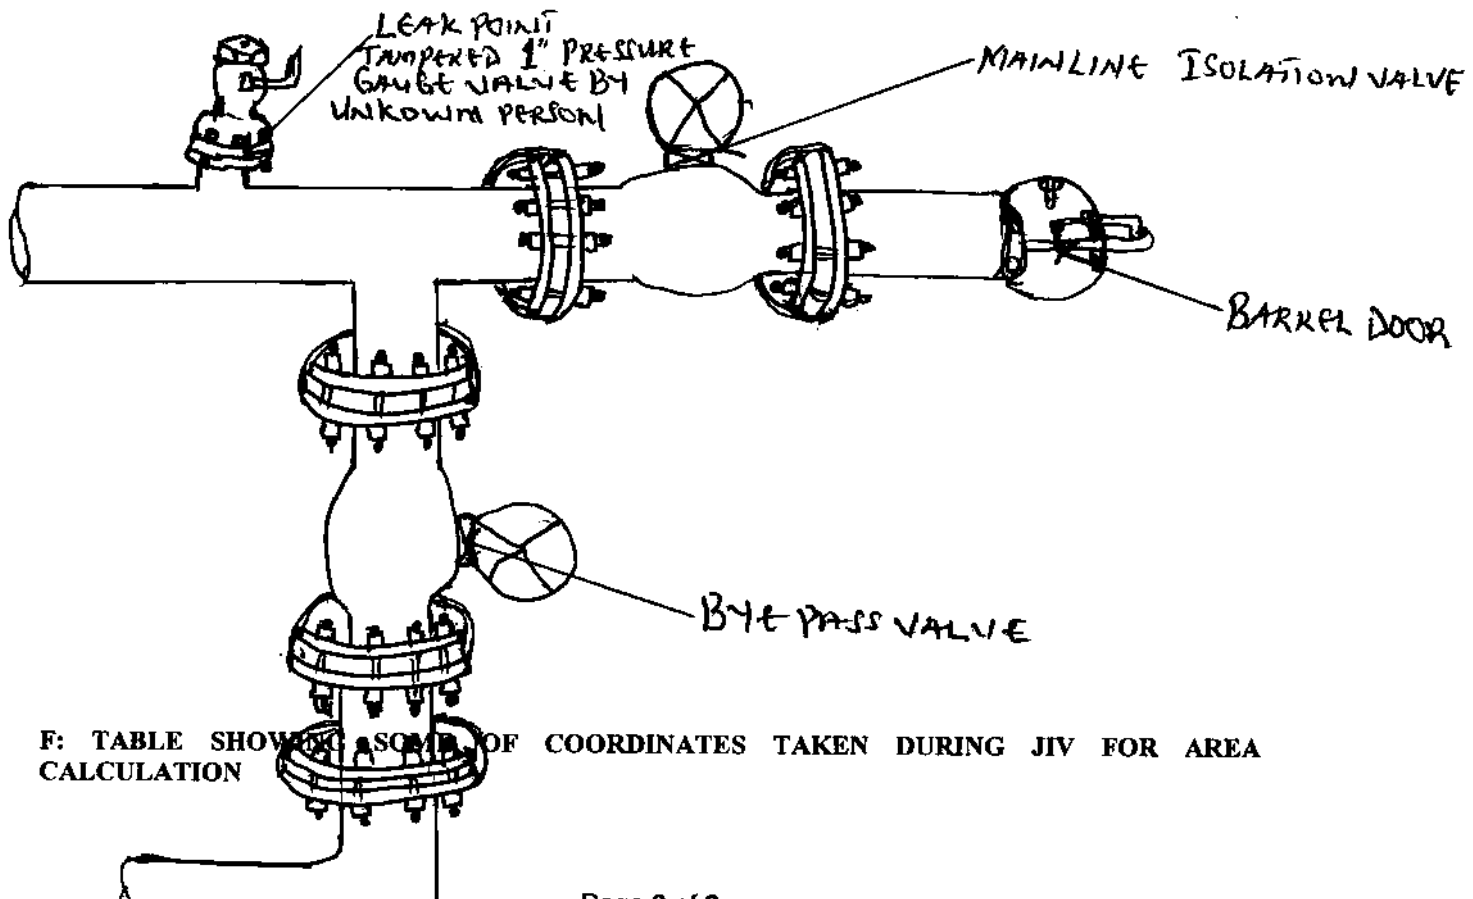
Relief valve failure  Others (specify) TAMPERS 1" PRESSURE GAUGE VALVE.

SECTION OF OKORDIA MANIFOLD AT IKARAMA - OKORDIA  
SHOWING POSITION OF LEAK POINT AT 1" PRESSURE GAUGE VALVE.

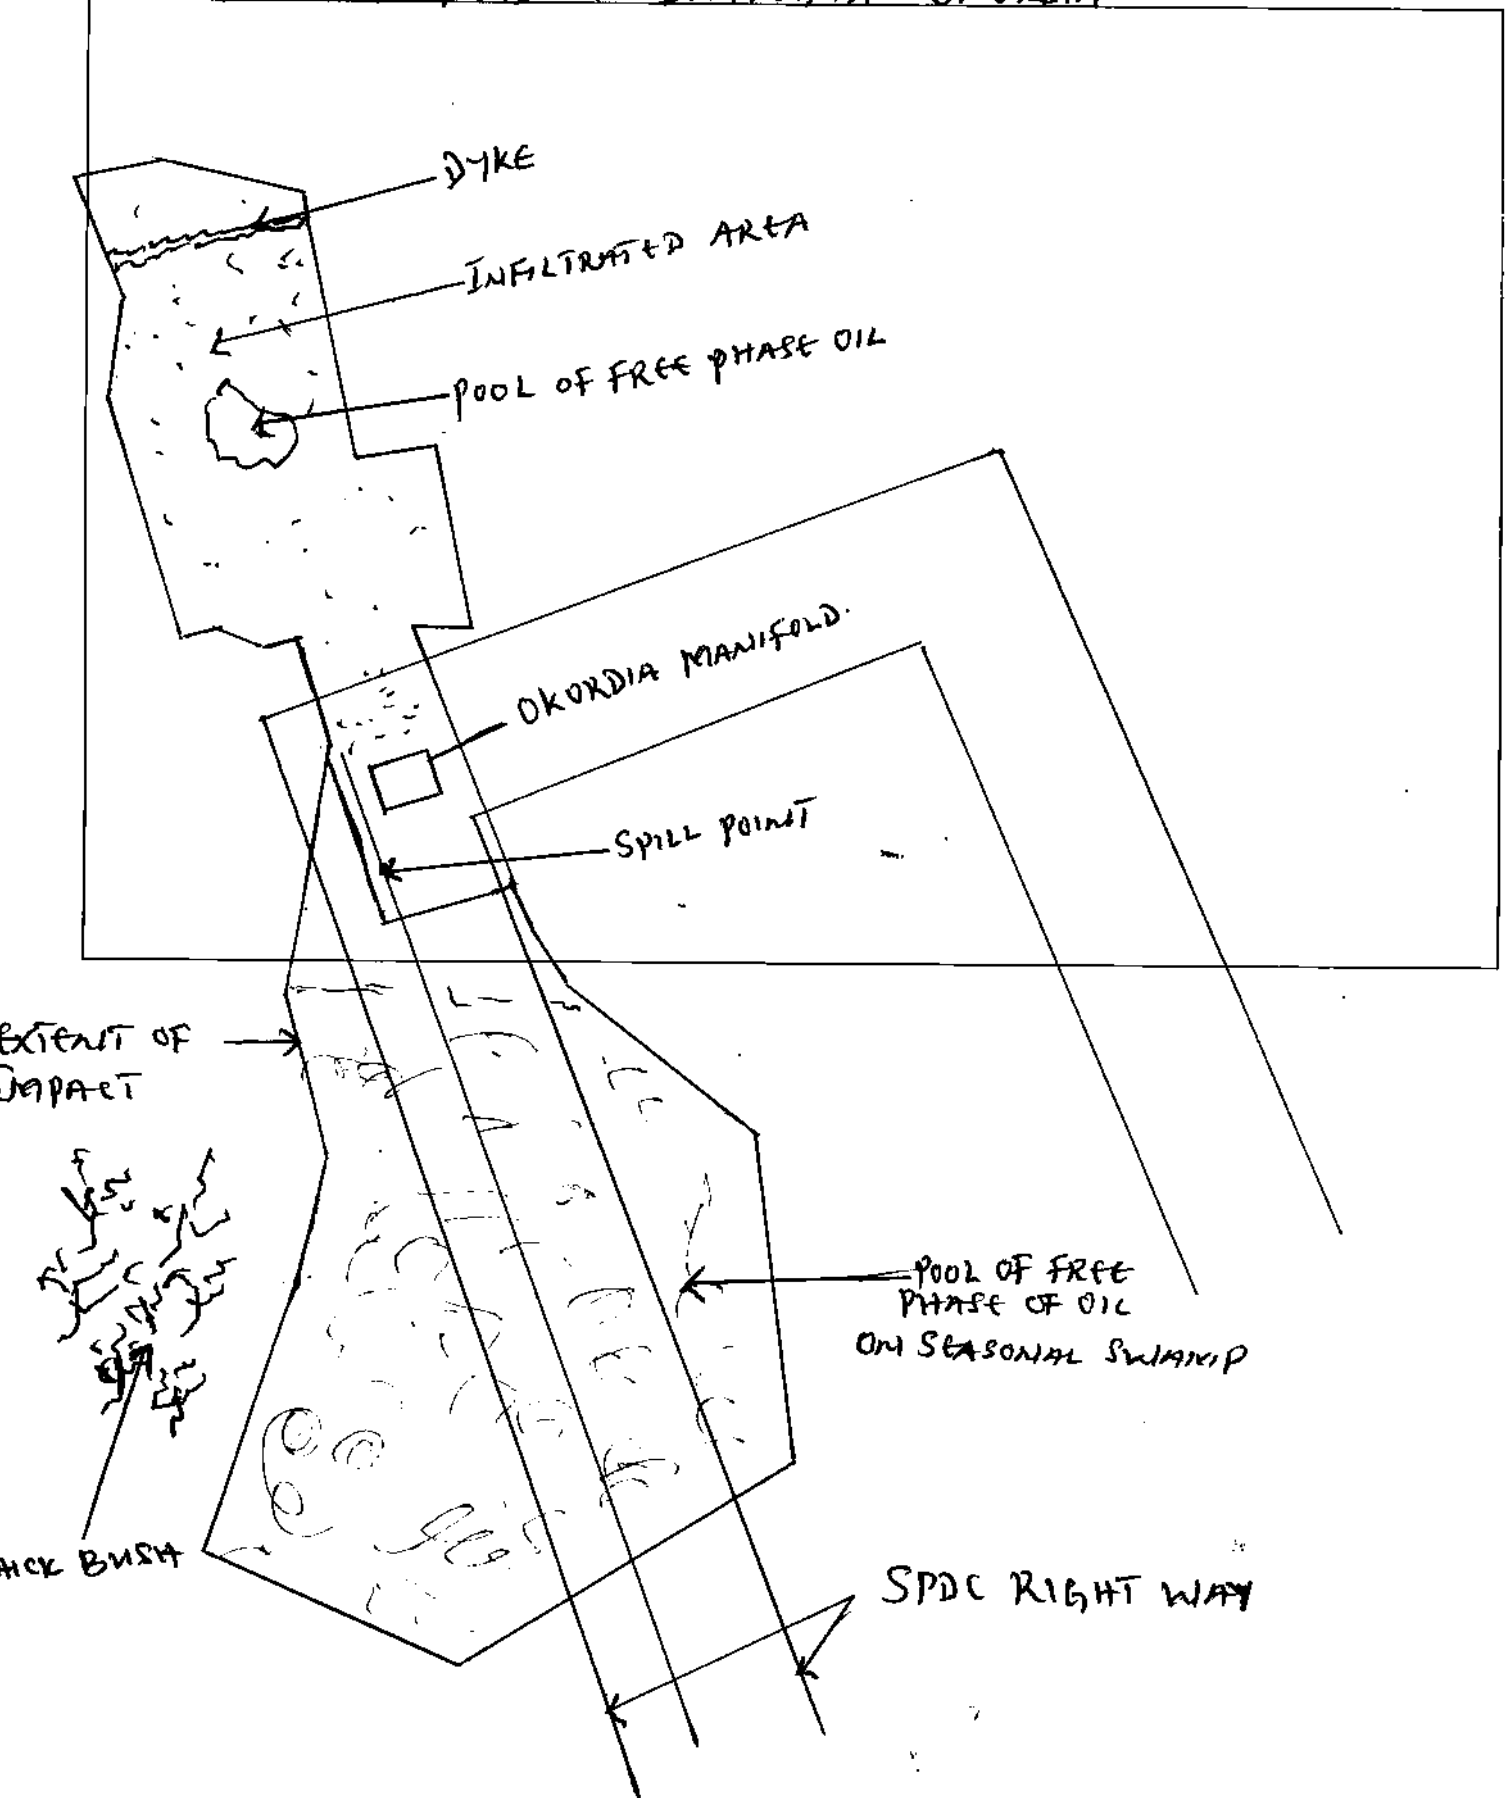
28. Appendix 1: Overview sketch of the site

Location: OKORDIA MANIFOLD AT IKARRAMA - OKORDIA.
