THE SHELL PETROLEUM DEVELOPMENT COMPANY OF NIGERIA LIMITED.

JOINT INVESTIGATION REPORT FOR INCIDENT NO: 111600 JIV report S/N: 0227

1. Spill incident Number: 111600 2. Type of incident* OIL SPILL
 3. Name of Location 20" OTUMARA - ESCRAVOS PIPELINE
 4. Name of nearest community UGBOEGUNGUN State: DELTA 6. LGA WARRI SOUTH - WEST
 7. Type of Production facility/Installation OIL PIPELINE 8. Asset owner/District PIPELINE

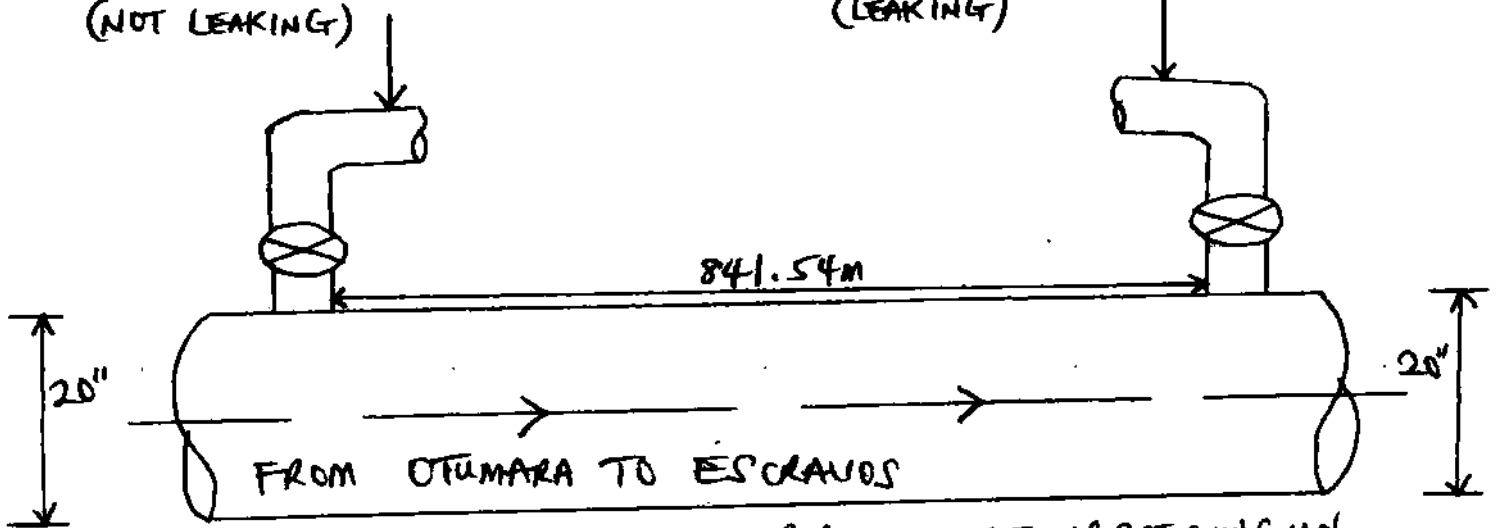
20" OTUMARA - ESCRAVOS PIPELINE AT URBOROGUNGUN

3" WELD-ON ILLEGAL HOT TAP VALVE AT 12 O'CLOCK POSITION (NOT LEAKING)

3" FAILED WELD-ON ILLEGAL HOT TAP VALVE AT 12 O'CLOCK POSITION (LEAKING)

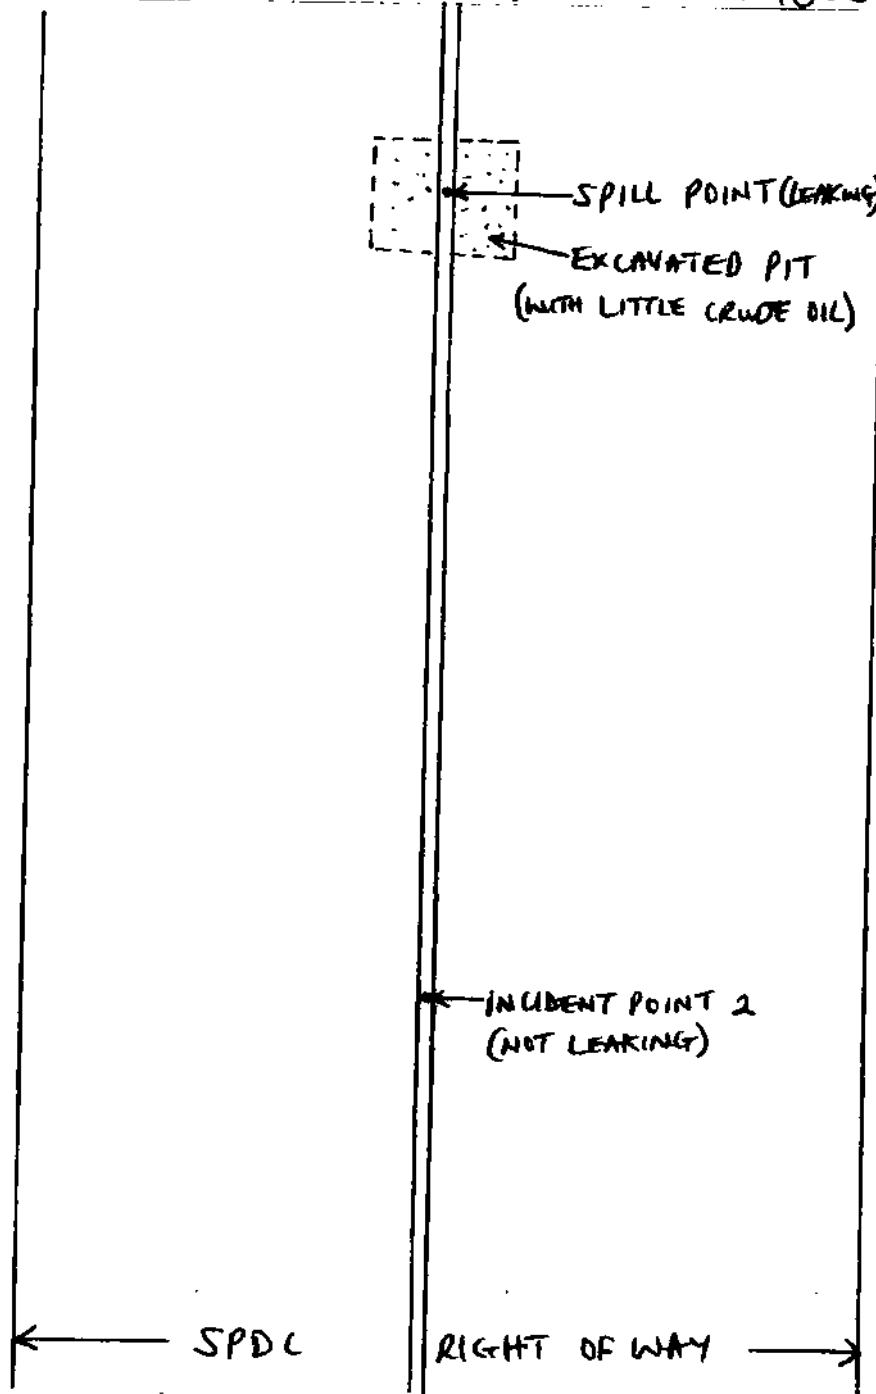
28 Appendix 1: Overview sketch of the site

Location: 20" OTUMARA-ESCRAVOS PIPELINE AT UGBOEGWUN
