THE SHELL PETROLEUM DEVELOPMENT COMPANY OF NIGERIA LIMITED.

JOINT INVESTIGATION REPORT FOR INCIDENT NO: 1208043 JIV report S/N: 0575

1. Spill incident Number: 1208043 2. Type of incident* OIL SPILL
 3. Name of Location 24" TRANS - RAMOS PIPELINE
 4. Name of nearest community AGHORO 5. State: BAYELSA 6. LGA EKEREMOR
 7. Type of Production facility/Installation OIL PIPELINE 8. Asset owner/District PIPELINE

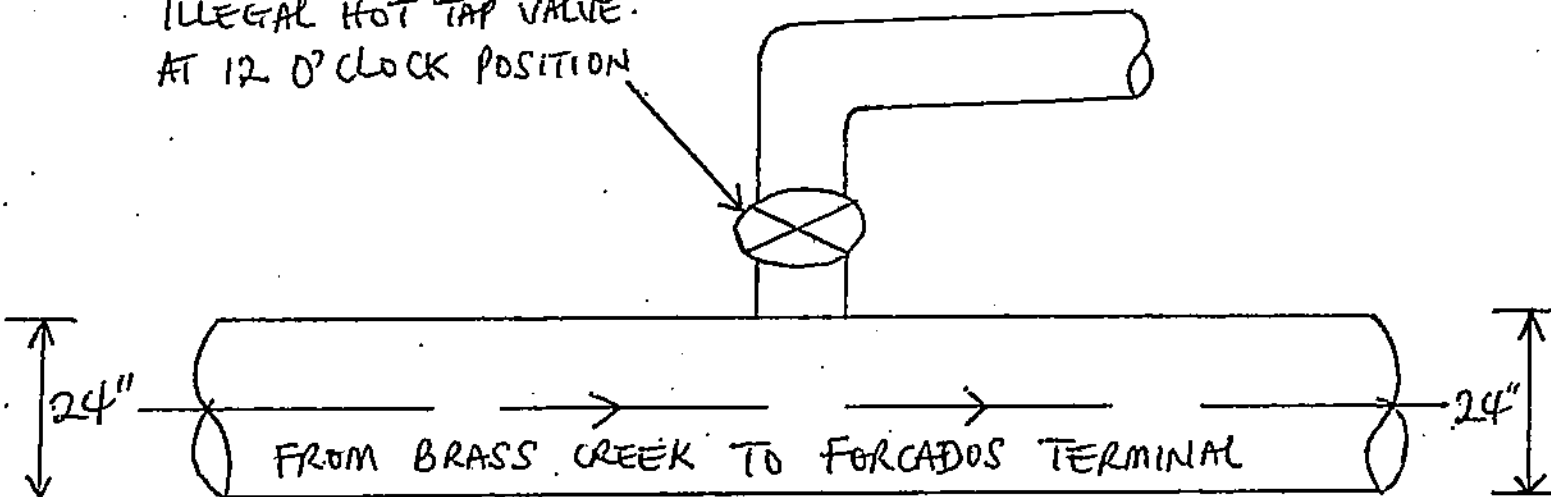
24" TRANS - RAMOS PIPELINE AT AGHORO

Additional observations around the spill point: UPON EXCAVATION, A 4" ILLEGAL HOT TAP VALVE WAS OBSERVED WELDED ON THE 24" CRUDE OIL PIPELINE AT 12 O'CLOCK POSITION.

| <input checked="" type="checkbox"/> Failed Weld-on illegal hot tap valve, | <input type="checkbox"/> Failed Clamp | <input type="checkbox"/> Missing Pipeline/Flowline |

4" FAILED WELD-ON
 ILLEGAL HOT TAP VALVE.
 AT 12 O'CLOCK POSITION

If yes to item 14, give brief description: REPAIR IS BEING PLANNED BY THE PIPELINES ASSET TEAM.
