THE SHELL PETROLEUM DEVELOPMENT COMPANY OF NIGERIA LIMITED.

JOINT INVESTIGATION REPORT FOR INCIDENT NO: 1209516 JIV report S/N: 00599

1. Spill incident Number: 1209516 2. Type of incident* OIL SPILL
 3. Name of Location 28" BOMU - BONNAY PIPELINE
PATRICK WATERSIDE
 4. Name of nearest community (BODO WEST) 5. State: RIVERS 6. LGA GOKANA
 7. Type of Production facility/Installation OIL PIPELINE 8. Asset owner/District PIPELINE

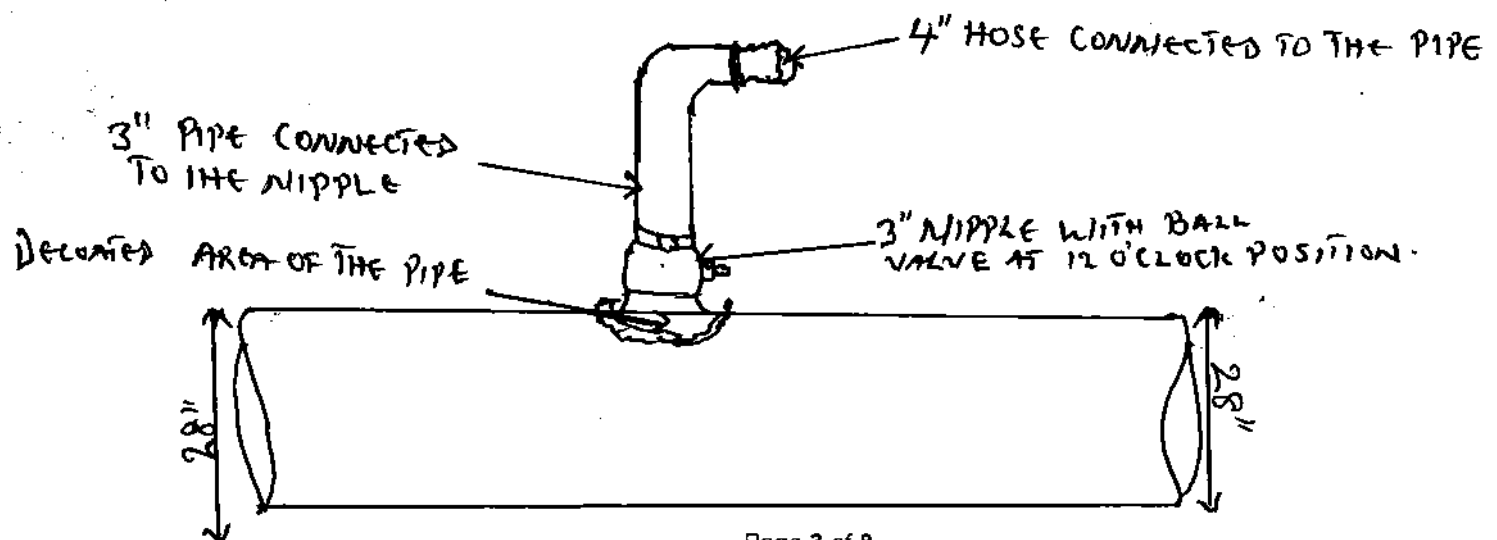
E. GRAPHIC DESCRIPTION OF LEAK POINT (while detail report of the leak point should be contained in the leak report, overview sketch of the site should be added as an appendix 1)

Additional observations around the spill point:
AT SPILL SOURCE (ILLEGAL HOSE CONNECTION) CLIP AND SPANNER WAS OBSERVED DURING THE JOINT INVESTIGATION VISIT.

| <input checked="" type="checkbox"/> Failed Weld-on illegal hot tap valve, | <input type="checkbox"/> Failed Clamp | <input type="checkbox"/> Missing Pipeline/Flowline |
| <input checked="" type="checkbox"/> Crude oil theft (illegal bunkering) point, | | <input type="checkbox"/> Third party tampering with Clamp |

SECTION OF 28" BOMU - BONNY PIPELINE AT PATRICK WATERSIDE (BODO WEST) SHOWING POSITION OF CRUDE OIL LEAK POINT AT 12 O'CLOCK POSITION.
