THE SHELL PETROLEUM DEVELOPMENT COMPANY OF NIGERIA LIMITED.

JOINT INVESTIGATION REPORT FOR INCIDENT NO: 1209916 JIV report S/N: 00581

1. Spill incident Number: 1209916 2. Type of incident* OIL SPILL
 3. Name of Location 6" OBIGBO NORTH - OGHELE PIPELINE
 4. Name of nearest community Amuokolobe 5. State: RIVERS 6. LGA OBIGBO
 7. Type of Production facility/Installation OIL PIPELINE 8. Asset owner/District PIPELINE

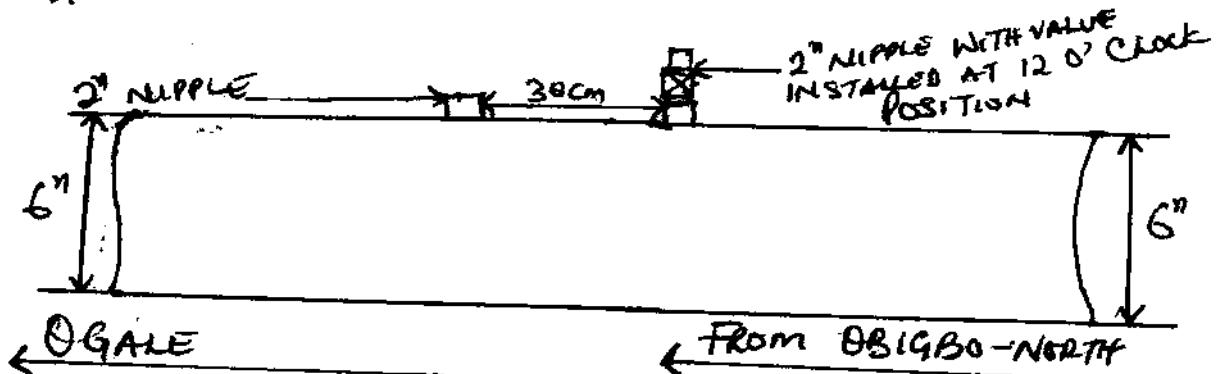
Additional observations around the spill point: SOME SAND BAGS WERE OBSERVED AT THE SPILL POINT BESIDE A SMALL POOL OF FREE-PHASE OIL. THE SPILL OCCURRED CLOSED TO A BUILT-UP RESIDENTIAL AREA. IMPACTED SOIL AROUND SPILL POINT IS DARK BROWN SLT

| <input checked="" type="checkbox"/> Failed Weld-on illegal hot tap valve, | <input type="checkbox"/> Failed Clamp | <input type="checkbox"/> Missing Pipeline/Flowline |
| <input checked="" type="checkbox"/> Crude oil theft (illegal bunkering) point, | | <input type="checkbox"/> Third party tampering with Clamp |

A SECTION OF 6" OBIQBO - NORTH TO OGALE PIPELINE AT UMBI OKOLOBE SHOWING TWO NPS BUNKERING POINTS.

MOPPING OF OIL IMPACT WAS DONE WITH ABSORBENT PADS WHILE REPAIRS WERE EFFECTED ON AFFECTED PIPELINE SECTION
