THE SHELL PETROLEUM DEVELOPMENT COMPANY OF NIGERIA LIMITED.

JOINT INVESTIGATION REPORT FOR INCIDENT NO: 1207520 JIV report S/N: 00601

1. Spill incident Number: 1207520 2. Type of incident* OIL SPILL
 3. Name of Location 12" IMD RIVER - OGALE PIPELINE
 4. Name of nearest community KOM-KOM 5. State: RIVERS 6. LGA OYIGBO
 7. Type of Production facility/Installation OIL PIPELINE 8. Asset owner/District PIPELINE

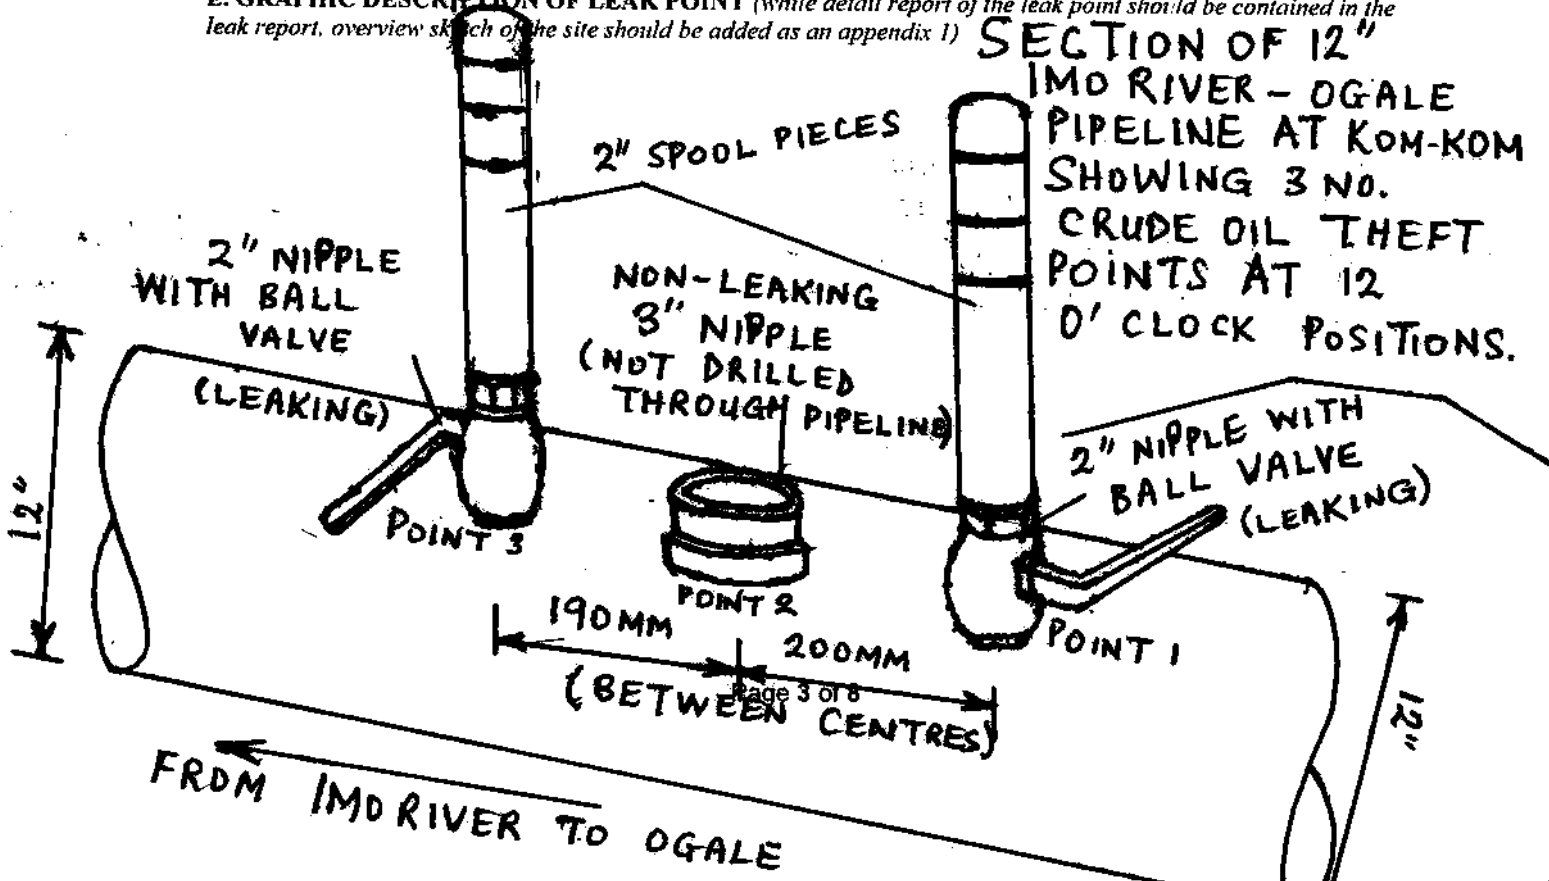
E. GRAPHIC DESCRIPTION OF LEAK POINT (while detail report of the leak point should be contained in the leak report, overview sketch of the site should be added as an appendix 1)

Additional observations around the spill point: **SPILL WAS OBSERVED TO HAVE OCCURRED IN A BUILT-UP AREA. 22 SANDBAGS WERE NOTICED TO BE CONCEALED IN A DITCH AROUND THE SPILL POINT WITH DEBRIS. HEAPS OF SAND WERE ALSO OBSERVED CLOSE TO SPILL POINT. IMPACTED SOIL IS LIGHT BROWN SILT**

| <input checked="" type="checkbox"/> Failed Weld-on illegal hot tap valve, | <input type="checkbox"/> Failed Clamp | <input type="checkbox"/> Missing Pipeline/Flowline |
| <input checked="" type="checkbox"/> Crude oil theft (illegal bunkering) point, | | <input type="checkbox"/> Third party tampering with Clamp |

MAPPING OF IMPACT WITHIN THE SPILL POINT WAS DONE SIMULTANEOUSLY AS REPAIRS WERE CARRIED OUT ON THE AFFECTED SECTION OF PIPELINE.
