THE SHELL PETROLEUM DEVELOPMENT COMPANY OF NIGERIA LIMITED.

JOINT INVESTIGATION REPORT FOR INCIDENT NO: 1210255 JIV report S/N: 00600

1. Spill incident Number: 1210255 2. Type of incident* OIL SPILL
 3. Name of Location 28" BOMU - BOMAY PIPELINE
 4. Name of nearest community OHIOKIRI ^(Bodo West) 5. State: RIVERS 6. LGA GOKANA
 7. Type of Production facility/Installation OIL PIPELINES 8. Asset owner/District PIPELINE

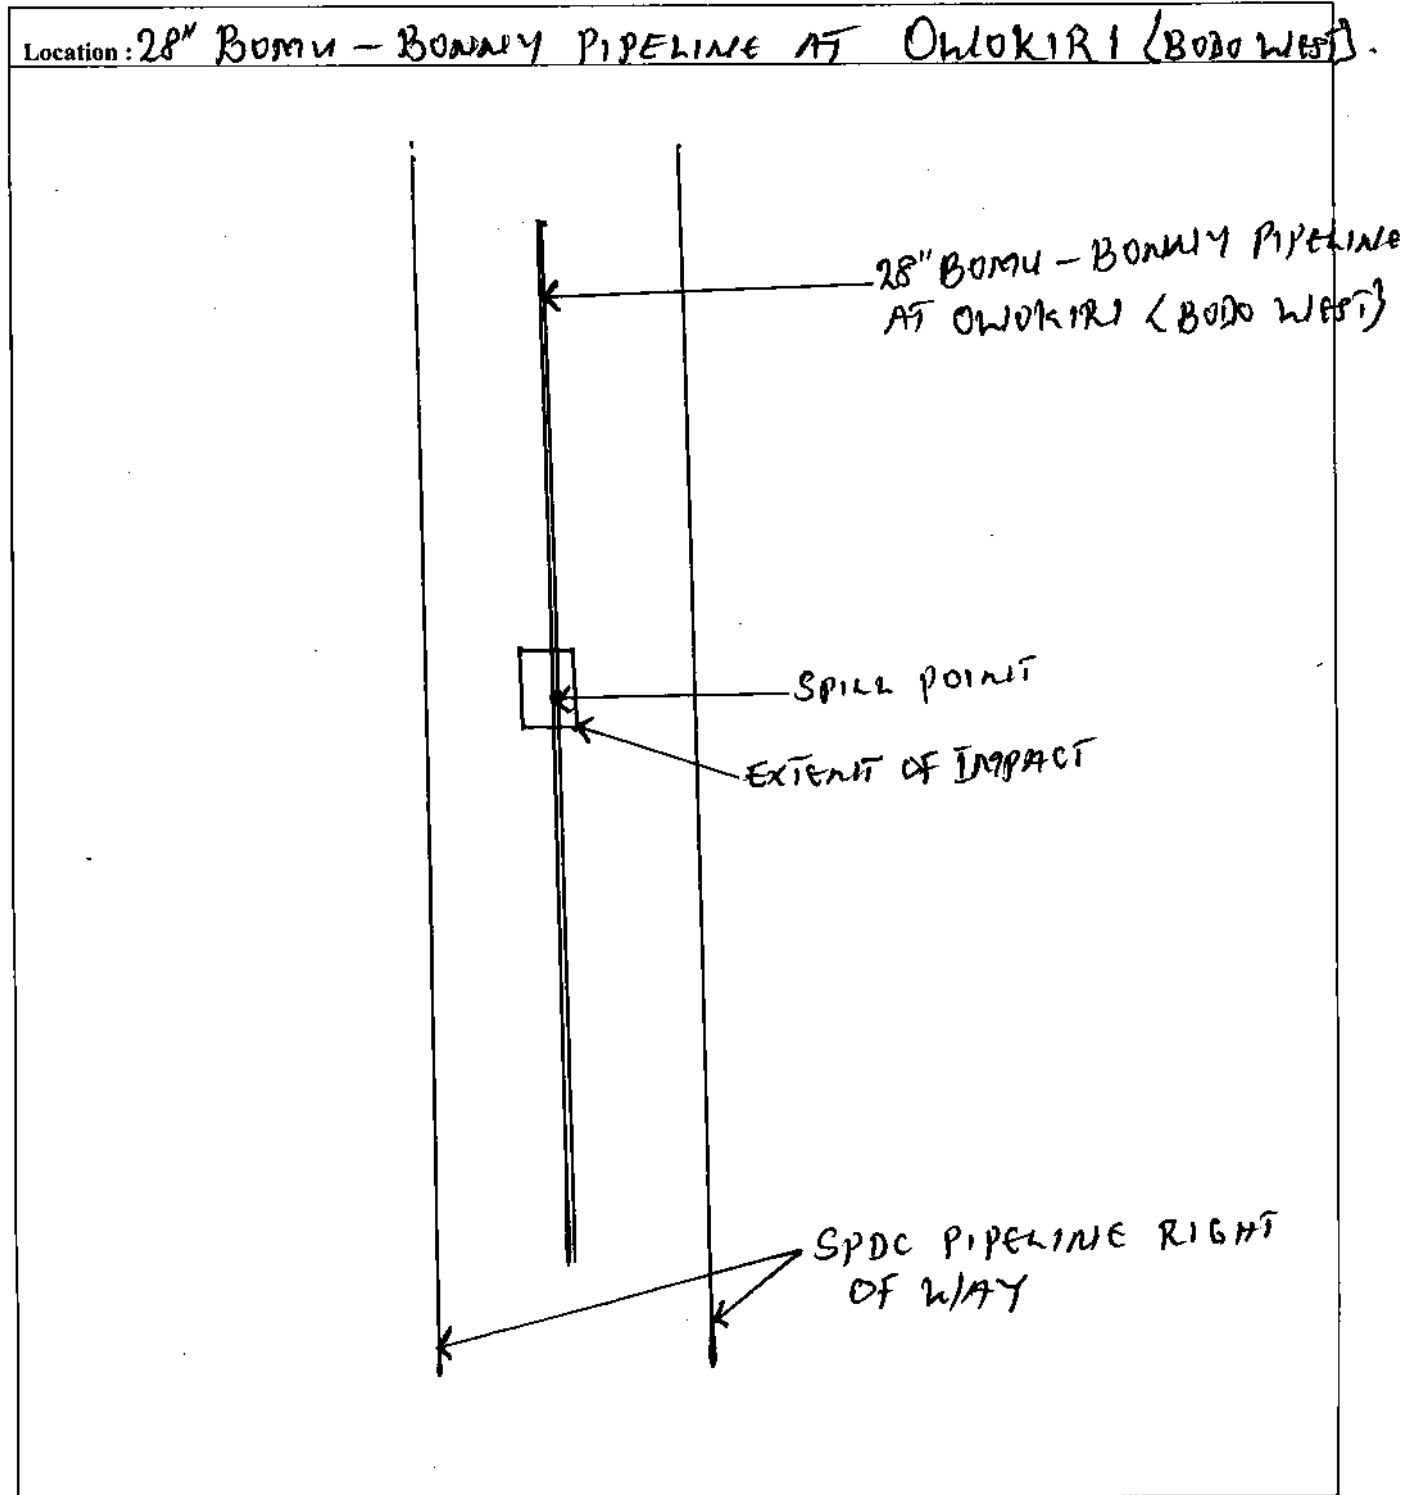
25. Appendix 1: Overview sketch of the site

Additional observations around the spill point:
 A COFFERDAM HAS BEEN BUILT WITHIN THE BOUNDARIES OF BUND WALLS SERVING AS CONTAINMENT. PIECES OF PLANK WAS OBSERVED AT SPILL POINT.

- Booms
 Trench
 Dyke
 Natural depression
 Pit
 None
 Others: COFFERDAM BUILT AROUND SPILL POINT
