THE SHELL PETROLEUM DEVELOPMENT COMPANY OF NIGERIA LIMITED.

JOINT INVESTIGATION REPORT FOR INCIDENT NO: 1211061 JIV report S/N: 00609

1. Spill incident Number: 1211061 2. Type of incident\* OIL SPILL  
3. Name of Location 1/4" DKORDIA - RUMUEKPE PIPELINE  
4. Name of nearest community IKARAMA 5. State: BAYELSA 6. LGA TENAGOPA  
7. Type of Production facility/Installation OIL PIPELINE 8. Asset owner/District PIPELINE

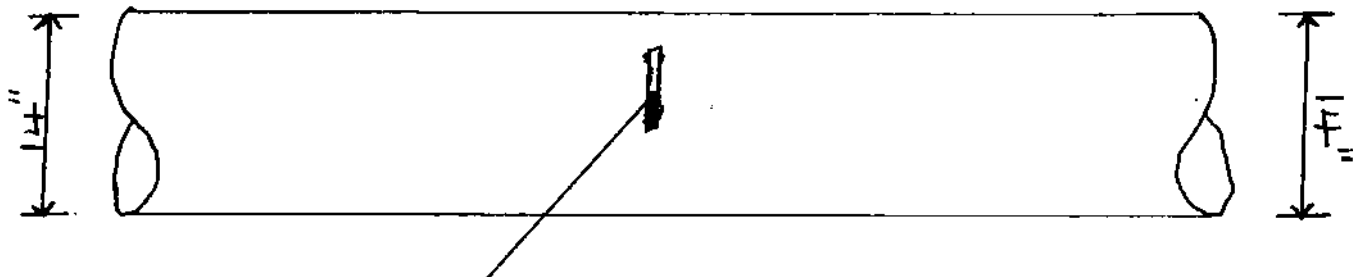
SECTION OF 14" OKORDIA - RUMUEKPE PIPELINE AT IKARAMA SHOWING POSITION OF HACKSAW CUT AT 2° CLOCK POSITION.

80mm LONG HACKSAW CUT FROM 2-3° CLOCK POSITION (WITH 40mm EFFECTIVE CUT AT 2° CLOCK POSITION).

← FROM OKORDIA TO RUMUEKPE.

REPAIRS WERE EFFECTED ON AFFECTED PIPELINE SECTION USING CLAMP.
