THE SHELL PETROLEUM DEVELOPMENT COMPANY OF NIGERIA LIMITED.

JOINT INVESTIGATION REPORT FOR INCIDENT NO: 1212856 JIV report S/N: 00589

1. Spill incident Number: 1212856 2. Type of incident* OIL SPILL
 3. Name of Location ADIBAWA Well-23L 4" FLOWLINE
 4. Name of nearest community EDAKBIRI 5. State: RIVERS 6. LGA AHODA WEST
 7. Type of Production facility/Installation FLOWLINE 8. Asset owner/District LAND II | ADIBAWA

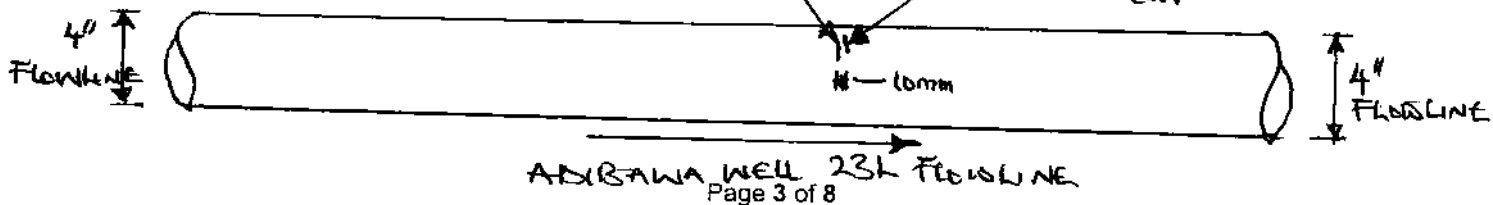
SECTIONAL VIEW OF ANBAWA WELL 23L 4" FLOWLINE AT EDAGE
SHOWING (HACKSAW CUT) SABOTAGE SPILL

LEAK IS DUE TO

60mm LENGTH OF HACKSAW
CUT WITH EFFECTIVE CUT.
OF 10mm AT 11 O'CLOCK
POSITION.

40mm of ATTEMPTED CUT
WITHOUT EFFECTIVE CUT AND
IT IS 10mm AWAY FROM THE
LEAK CUT.

REPAIR COMPLETED BY CLAMPING.
