THE SHELL PETROLEUM DEVELOPMENT COMPANY OF NIGERIA LIMITED.

JOINT INVESTIGATION REPORT FOR INCIDENT NO: 1212857 JIV report S/N: 00590

1. Spill incident Number: 1212857 2. Type of incident* OIL SPILL
 3. Name of Location ADIBAWA WELL-2BS FLOWLINE (4")
 4. Name of nearest community EDAGBIRI 5. State: RIVERS 6. LGA ATHODA WEST
 7. Type of Production facility/Installation FLOWLINE 8. Asset owner/District LAND II / ADIBAWA

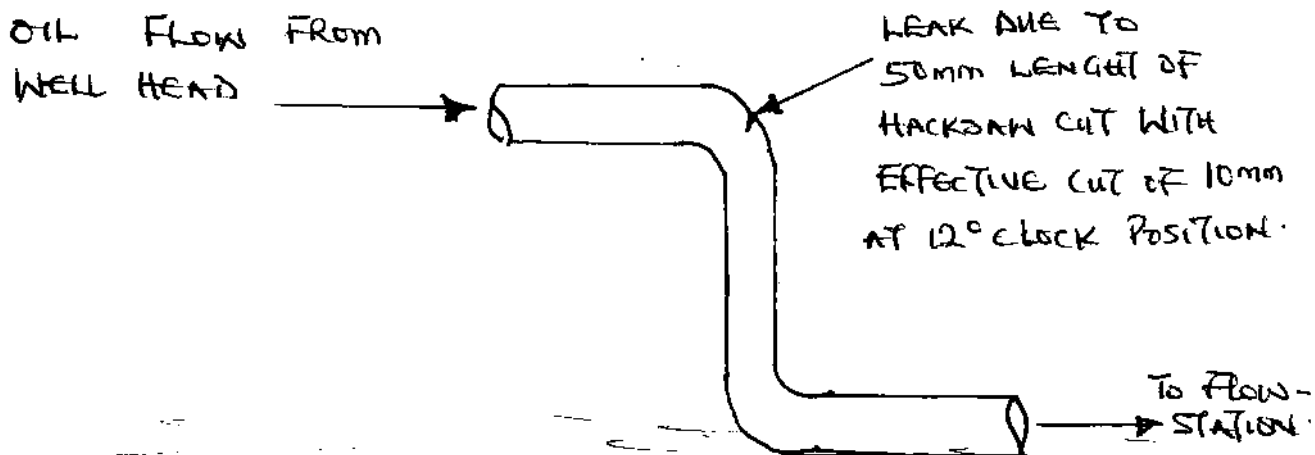
| <input type="checkbox"/> Drilled hole | <input checked="" type="checkbox"/> Hack saw cut | <input type="checkbox"/> Tear (_____). |

SECTIONAL VIEW OF ADIBAWA WELL 23S 4" FLOWLINE AT EDAGBIRI SHOWING HACKSAW CUT (SABOTAGE)

REPAIR WORK PLANNED FOR SECTIONAL REPLACEMENT.
