THE SHELL PETROLEUM DEVELOPMENT COMPANY OF NIGERIA LIMITED.

JOINT INVESTIGATION REPORT FOR INCIDENT NO: 1214505 JIV report S/N: 0578

1. Spill incident Number: 1214505 2. Type of incident\* OIL SPILL  
 3. Name of Location 20" OPUKUSHI - BRASS CREEK PIPELINE  
 4. Name of nearest community EGBEMO-ANGALABIRI State: BAYELSA G. LGA EKEREMOR  
 7. Type of Production facility/Installation OIL PIPELINE, Asset owner/District PIPELINE

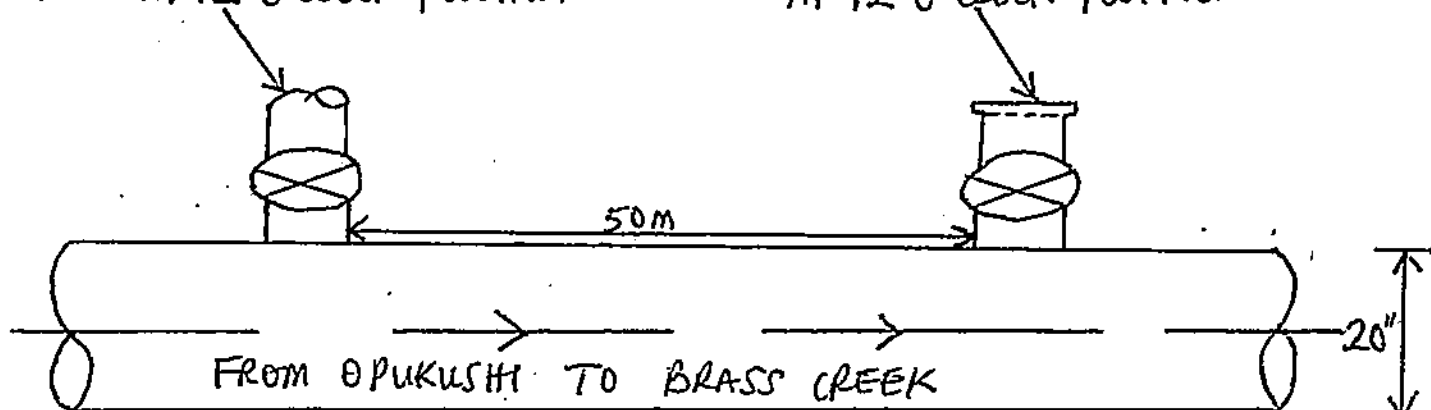
Additional observations around the spill point: UPON EXCAVATION, 2 NOS OF 6" ILLEGAL HOT TAP VALVES WERE OBSERVED WELDED ON THE 20" CRUDE OIL PIPELINE AT 12 O' CLOCK POSITIONS.

| <input checked="" type="checkbox"/> Failed Weld-on illegal hot tap valve, | <input type="checkbox"/> Failed Clamp | <input type="checkbox"/> Missing Pipeline/Flowline |
| <input checked="" type="checkbox"/> Crude oil theft (illegal bunkering) point, | | <input type="checkbox"/> Third party tampering with Clamp |

SECTION OF 20" OPUKUSHI - BRASS CREEK PIPELINE AT EGBEMO-ANGALABIRI  
SHOWING: WELD-ON ILLEGAL HOT-TAP VALVES

6" FAILED WELD-ON ILLEGAL HOT-TAP VALVE AT 12 O'CLOCK POSITION

6" WELD-ON ILLEGAL HOT TAP VALVE AT 12 O'CLOCK POSITION

20" OPUKUSHI - BRASS CREEK PIPELINE AT EGBEMO - ANGALABIRI

If yes to item 14, give brief description: REPAIR IS BEING PLANNED BY THE PIPELINES ASSET TEAM.
