THE SHELL PETROLEUM DEVELOPMENT COMPANY OF NIGERIA LIMITED.

JOINT INVESTIGATION REPORT FOR INCIDENT NO: 1218318 JIV report S/N: 0580

1. Spill incident Number: 1218318 2. Type of incident* OIL SPILL
 3. Name of Location 24" TRANS - RAMOS PIPELINE
 4. Name of nearest community AGHORO 5. State: BATELSA 6. LGA EKEREMOR
 7. Type of Production facility/Installation OIL PIPELINE 8. Asset owner/District PIPELINE

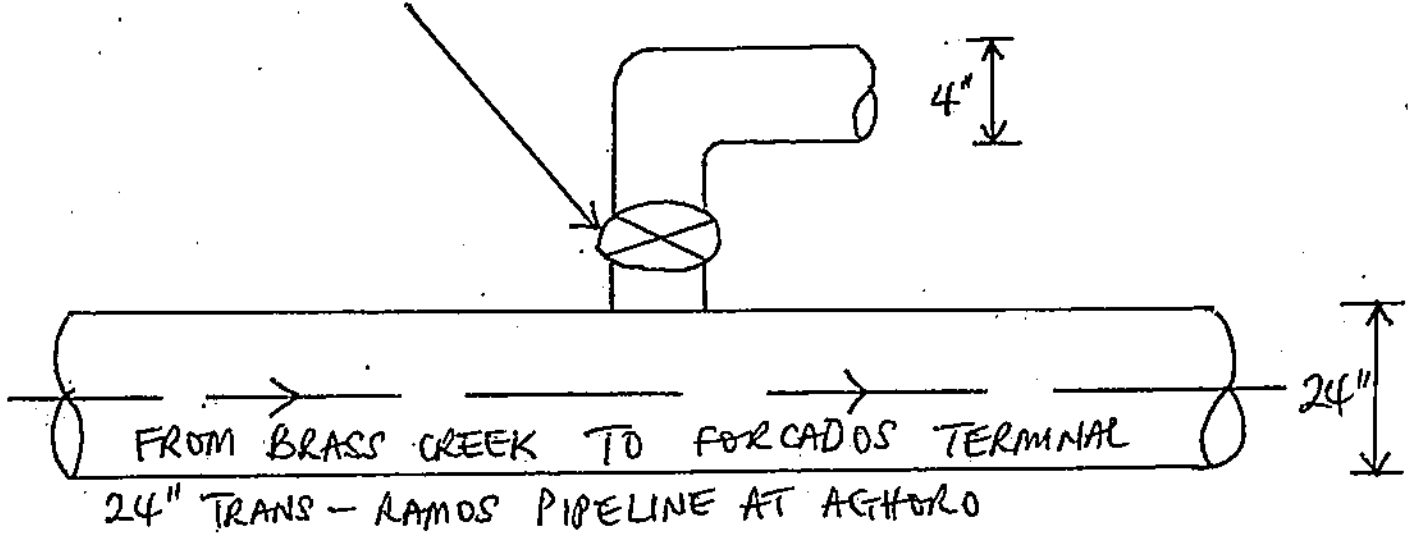
E. GRAPHIC DESCRIPTION OF LEAK POINT (while detail report of the leak point should be contained in the leak report, overview sketch of the site should be added as an appendix 1)

Additional observations around the spill point: UPON EXCAVATION, A 4" FAILED WEGAL HOT TAP VALVE WAS OBSERVED WELDED ON THE 24" CRUDE OIL PIPELINE AT 12 O'CLOCK POSITION.

4" FAILED WELD - ON ILLEGAL HOT TAP VALVE
AT 12 O'CLOCK POSITION

If yes to item 14, give brief description: REPAIR IS BEING PLANNED BY THE PIPELINES ASSET TEAM
