THE SHELL PETROLEUM DEVELOPMENT COMPANY OF NIGERIA LIMITED.

JOINT INVESTIGATION REPORT FOR INCIDENT NO: 1217823 JIV report S/N: 00611

1. Spill incident Number: 1217823 2. Type of incident* CRACK FLUSHED WATER (EFFLUENT)
 3. Name of Location 24" NKPOKU - BOMU PIPELINE
 4. Name of nearest community BERA 5. State: RIVERS 6. LGA GOKANA
 7. Type of Production facility/Installation OIL PIPELINE 8. Asset owner/District PIPELINE

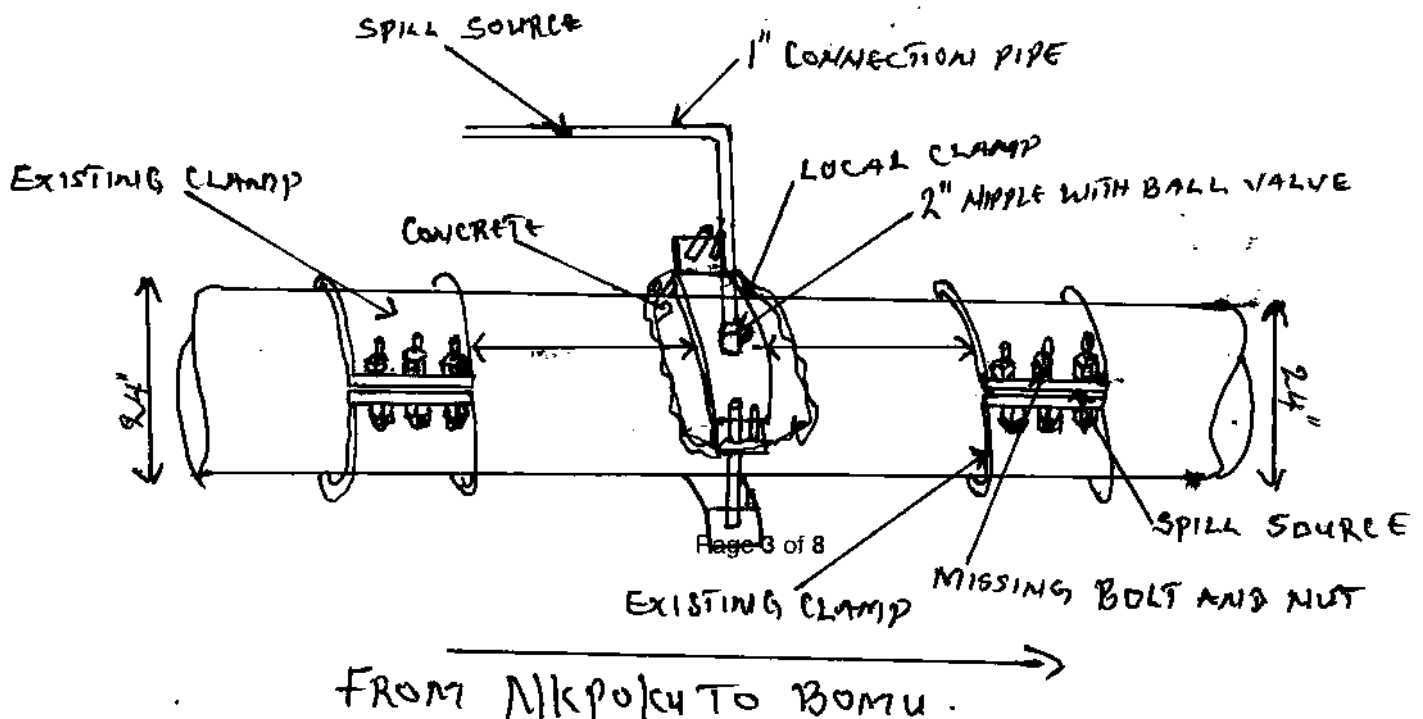
E. GRAPHIC DESCRIPTION OF LEAK POINT (while detail report of the leak point should be contained in the leak report, overview sketch of the site should be added as an appendix 1)

SECTION OF 24" NIKPOKU - BOMU PIPELINE AT BERA SHOWING POSITION OF CRUDE OIL THEFT POINT AND TAMPERED CLAMP.

REPAIR WORK WAS DONE BY CLAMPING.
