THE SHELL PETROLEUM DEVELOPMENT COMPANY OF NIGERIA LIMITED.

JOINT INVESTIGATION REPORT FOR INCIDENT NO: 1220208 JIV report S/N: 00617

1. Spill incident Number: 1220208 2. Type of incident: OIL SPILL AND FIRE
 3. Name of Location: 28" NKPOKU - BOMU PIPELINE
 4. Name of nearest community: B-DERE 5. State: RIVERS 6. LGA: GOKANJA
 7. Type of Production facility/Installation: OIL PIPELINE 8. Asset owner/District: PIPELINE

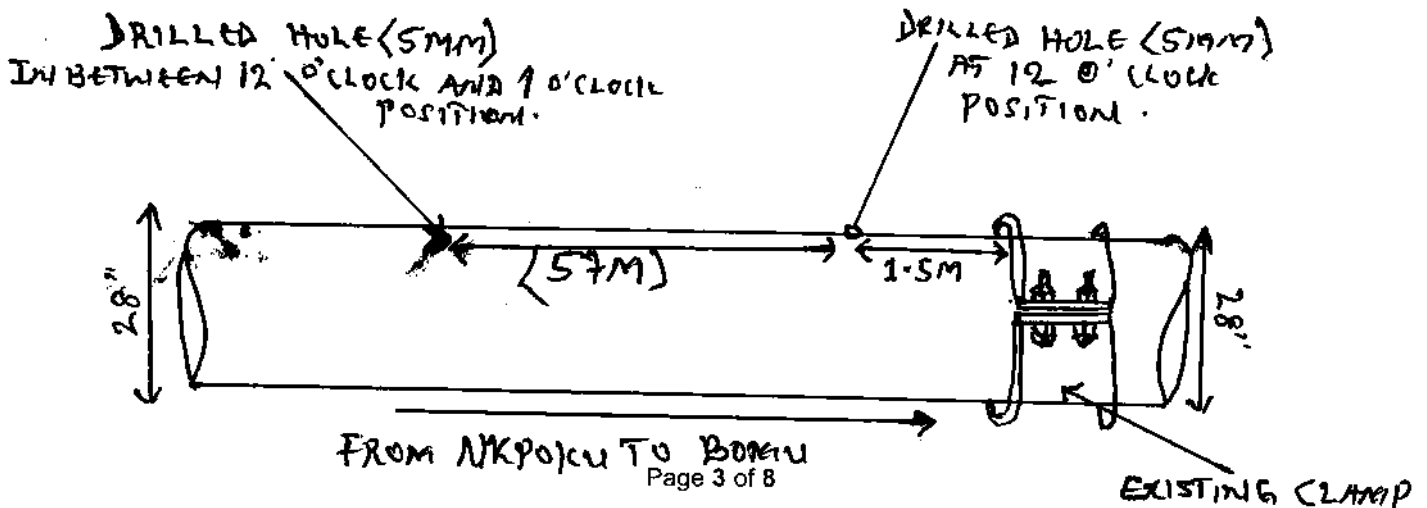
| <input checked="" type="checkbox"/> Drilled hole | <input type="checkbox"/> Hack saw cut | <input type="checkbox"/> Tear (_____), |

SECTION OF 28" NIKPOKU - BOMU PIPELINE AT B-DERE SHOWING POSITION OF DRILLED HOLES, TWO (2) POINTS.

REPAIR WORK WAS DONE BY CLAMPING.
