THE SHELL PETROLEUM DEVELOPMENT COMPANY OF NIGERIA LIMITED.

JOINT INVESTIGATION REPORT FOR INCIDENT NO: 1222879 JIV report S/N: 00686

1. Spill incident Number: 1222879 2. Type of incident* OIL SPILL
 3. Name of Location 20" RUMUEKPE - NKPOKY PIPELINE
 4. Name of nearest community OMUSUNU-IBAA. State: RIVERS 6. LGA EMOHUA
 7. Type of Production facility/Installation OIL PIPELINE 8. Asset owner/District PIPELINE

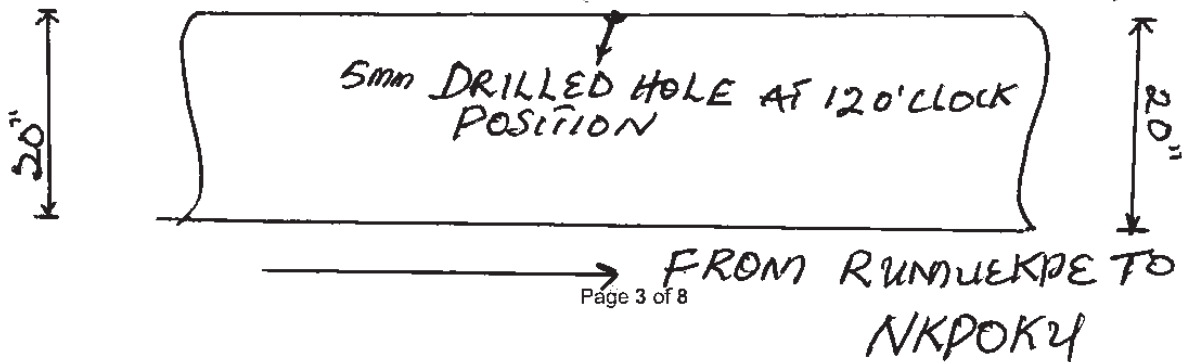
Additional observations around the spill point: ON ARRIVAL AT SITE, WE OBSERVED A DITCH WITH FREE PHASE OIL AT THE LEAK POINT; ON EXPOSURE OF THE AFFECTED PIPELINE SECTION, ILLEGAL DRILL HOLE AT 12 O'CLOCK POSITION WAS OBSERVED.

A SECTION OF 20" RUMUEKPE - NKPOKY PIPELINE AT OMUSUNU-IBAA SHOWING DRILLED HOLE AT 12 O'CLOCK POSITION

RECOVERY OF FREE PHASE OIL ONGOING. REPAIR ACTIVITY ONGOING.
