**THE SHELL PETROLEUM DEVELOPMENT COMPANY OF NIGERIA LIMITED.**

JOINT INVESTIGATION REPORT FOR INCIDENT NO: 1221598 JIV report S/N: 00619

1. Spill incident Number: 1221598 2. Type of incident\* OIL SPILL  
 3. Name of Location 28" NKPOKU - BONNU PIPELINE  
 4. Name of nearest community MOGHO 5. State: RIVERS 6. LGA GOKANA  
 7. Type of Production facility/Installation OIL PIPELINE 8. Asset owner/District PIPELINE

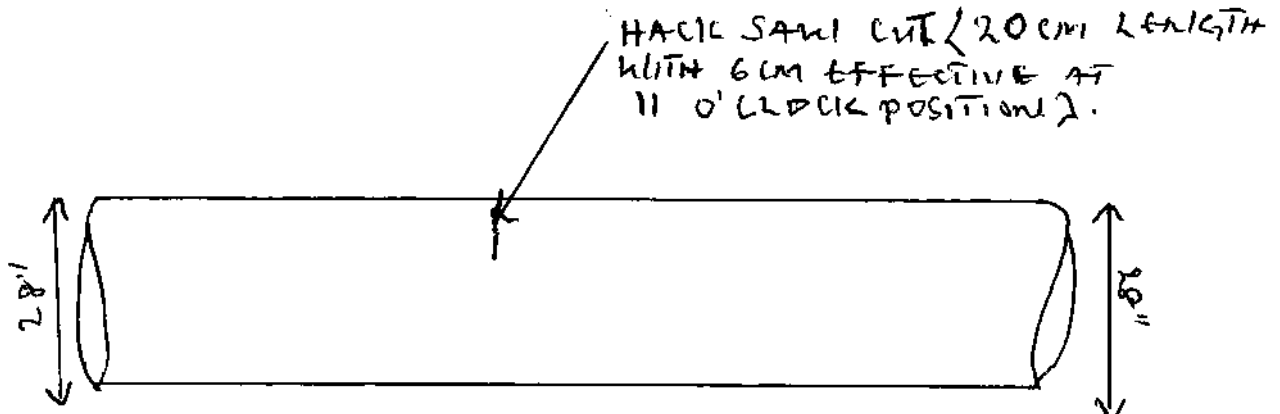
| <input type="checkbox"/> Drilled hole | <input checked="" type="checkbox"/> Hack saw cut | <input type="checkbox"/> Tear (_____). |

- f. Incident caused by:
- Third party interference (Sabotage , crude theft ; Line theft ; Accidental 3<sup>rd</sup> party damage )  
 Operational  Others (including Mystery spills) \_\_\_\_\_

SECTION OF 28" NKPOKU - BOMU PIPELINE AT MUGHO SHOWING POSITION OF HACK SAW CUT AT 11 O'CLOCK POSITION.

RECOVERY ACTIVITIES ONGOING. REPAIR WORK WAS DONE BY CLAMPING.
