THE SHELL PETROLEUM DEVELOPMENT COMPANY OF NIGERIA LIMITED.

JOINT INVESTIGATION REPORT FOR INCIDENT NO: 1193540 JIV report S/N: 0571

1. Spill incident Number: 1193540 2. Type of incident\* OIL SPILL  
 3. Name of Location 20" OPUKUSHI - BRASS CREEK PIPELINE  
 4. Name of nearest community TAMOGBENE 5. State: BAYELSA 6. LGA EKEREMOR  
 7. Type of Production facility/Installation OIL PIPELINE 8. Asset owner/District PIPELINE

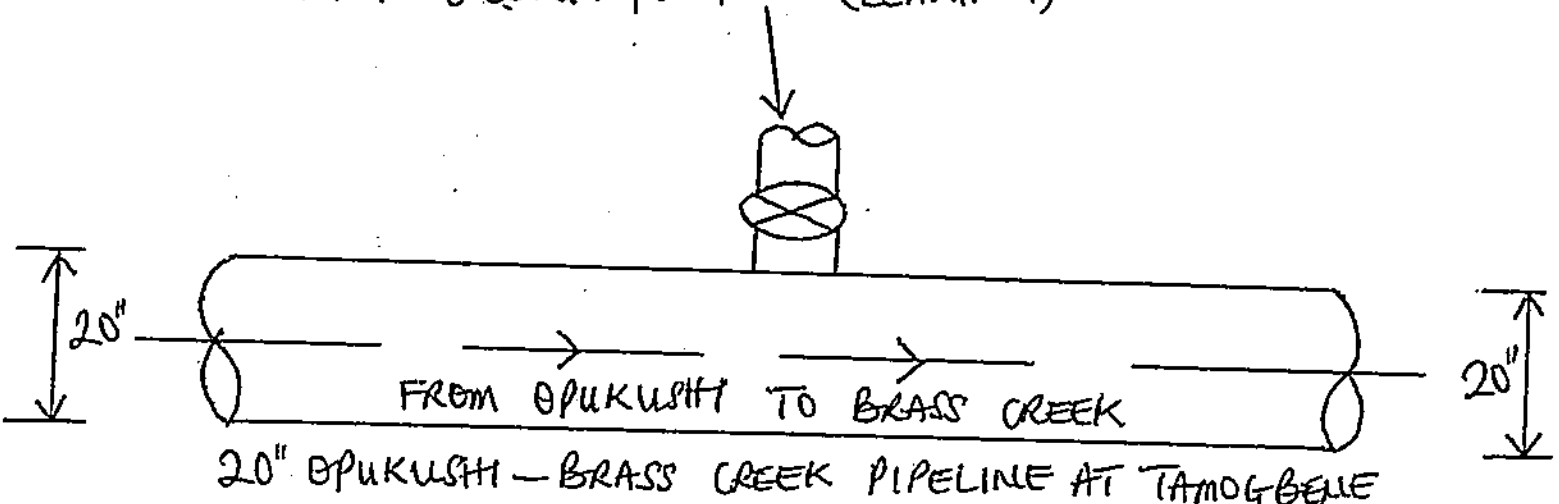
E. GRAPHIC DESCRIPTION OF LEAK POINT (while detail report of the leak point should be contained in the leak report, overview sketch of the site should be added as an appendix 1)

Additional observations around the spill point: UPON EXCAVATION, A 3" ILLEGAL HOT-TAP VALVE WAS OBSERVED WELDED ON THE 20" CRUDE OIL PIPELINE AT 12 O'CLOCK POSITION AND IT WAS LEAKING AT THE TIME OF JIV.

| <input checked="" type="checkbox"/> Failed Weld-on illegal hot tap valve, | <input type="checkbox"/> Failed Clamp | <input type="checkbox"/> Missing Pipeline/Flowline |

3" FAILED WELD - ON ILLEGAL HOT TAP VALVE  
AT 12 O'CLOCK POSITION (LEAKING)

If yes to item 14, give brief description: REPAIR IS BEING PLANNED BY PIPELINE ASSET TEAM.
