THE SHELL PETROLEUM DEVELOPMENT COMPANY OF NIGERIA LIMTED. JOINT INVESTIGATION REPORT FOR INCIDENT NO: 1191083 JIV report S/N: (Note: As practicable as possible the JIT report is to be signed in the field by all the participating parties) A. GENERAL INFORMATION: 191083 2. Type of incident* OIL STILL 1. Spill incident Number: 3. Name of Location 36" NKYOKY - BOMU PIPELINE 4. Name of nearest community ATALI 5. State: RIVERS 6. LGA OB10 AKPO 7. Type of Production facility/Installation OIL PIPELINES., Asset owner/District PIPELINE **B. INCIDENT INFORMATION:** 9. Details of incident a. Date of incident: ○3RD JUNE, 2014. b. Start date/time of investigation: OGTH JUNE, 2014 1 14 50 PM c. Investigation End date: 06 Tune 90 Actual investigation duration, days: ONE (1) DAY d. Description of spill point environment Loose soil ☐Firmed soil Recently excavated area ☐Under water □ Swampy Exposed pipe surface Well Platform (on Water) Drill Rig Additional observations around the spill point: ONGOING REMEDIATION ACTIVITIES WHENE OBSERVED AND THERE WAS DYKE WITH CAUTION TAY'E CONSTRUCTED AROUND THE SPILL POINT. e. Description of leak point (tick as applicable); Drilled hole ☐ Hack saw cut Tear (), ☐I

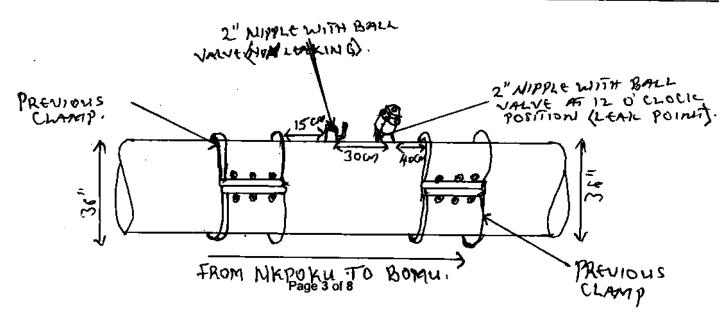
E. GRAPHIC DESCRIPTION OF LEAK POINT (while detail report of the leak point should be contained in the

OF 36" Mk 10 ku - Borgu PIPTLINE AT ATALL THIO MOS OF CRUBE OIR THEFT POINT AT 12 0' CLOUR POSITION.
