THE SHELL PETROLEUM DEVELOPMENT COMPANY OF NIGERIA LIMITED.

JOINT INVESTIGATION REPORT FOR INCIDENT NO: 1193469 JIV report S/N: 0570

1. Spill incident Number: 1193469 2. Type of incident\* OIL SPILL  
 3. Name of Location 20" OPUKUSHI - BRASS CREEK PIPELINE  
 4. Name of nearest community TAMOGBENE 5. State: BAYELSA 6. LGA EKEREMOR  
 7. Type of Production facility/Installation OIL PIPELINE 8. Asset owner/District PIPELINE

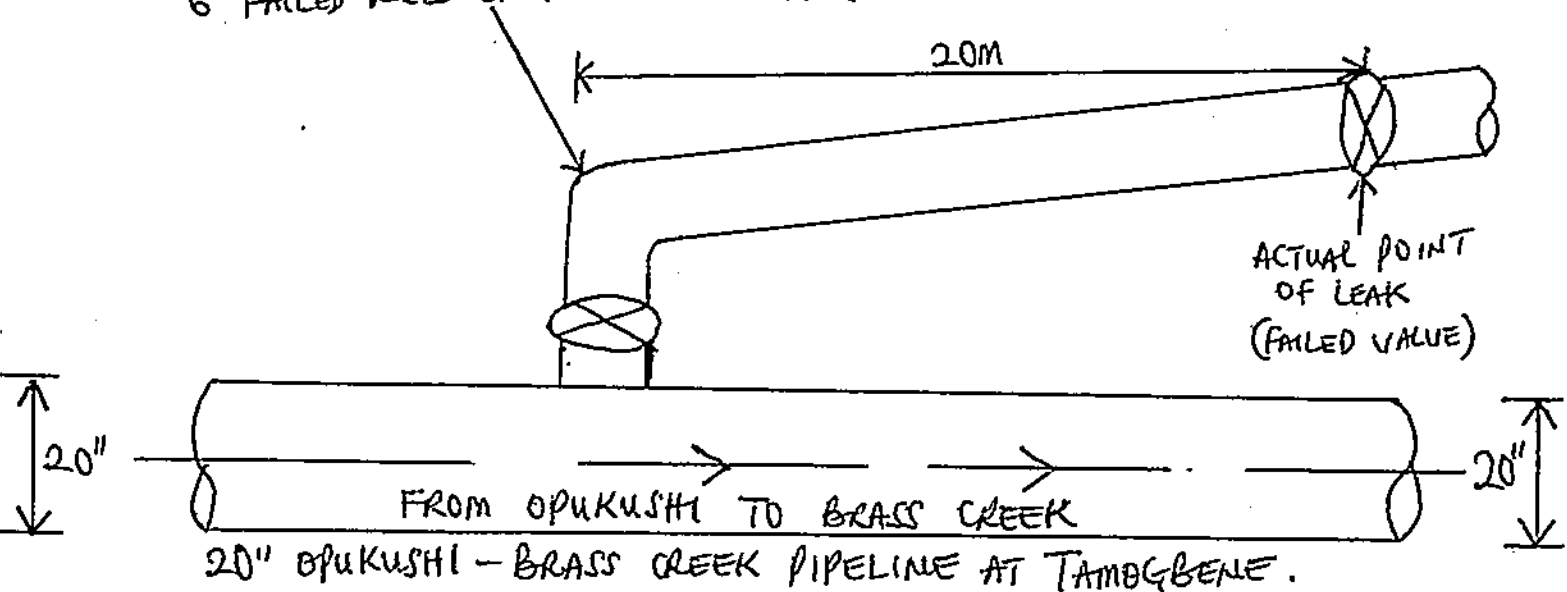
Additional observations around the spill point: UPON EXCAVATION, A 6" ILLEGAL HOT TAP VALVE WAS OBSERVED WELDED ON THE 20" CRUDE OIL PIPELINE AT 12 O'CLOCK POSITION. THE LEAK IS FROM THE CONNECTED PIPE FITTING ABOUT 20m FROM INCIDENT POINT.

6" FAILED WELD-ON ILLEGAL HOT TAP VALVE AT 12 O'CLOCK POSITION

20" OPUKUSHI - BRASS CREEK PIPELINE AT TAMOGBENE.

If yes to item 14, give brief description: REPAIR IS BEING PLANNED BY PIPELINE
