**THE SHELL PETROLEUM DEVELOPMENT COMPANY OF NIGERIA LIMITED.**

JOINT INVESTIGATION REPORT FOR INCIDENT NO: 1194724 JIV report S/N: 0553

1. Spill incident Number: 1194724 2. Type of incident\* OIL SPILL  
 3. Name of Location 12" ABIBAWA - OKORDIA (OKORDIA MANIFOLD)  
 4. Name of nearest community IKAKAMA/OKORDIA 5. State: BAYELSA 6. LGA YENA BORA  
 7. Type of Production facility/Installation OIL PIPELINE (MANIFOLD) 8. Asset owner/District PIPELINE

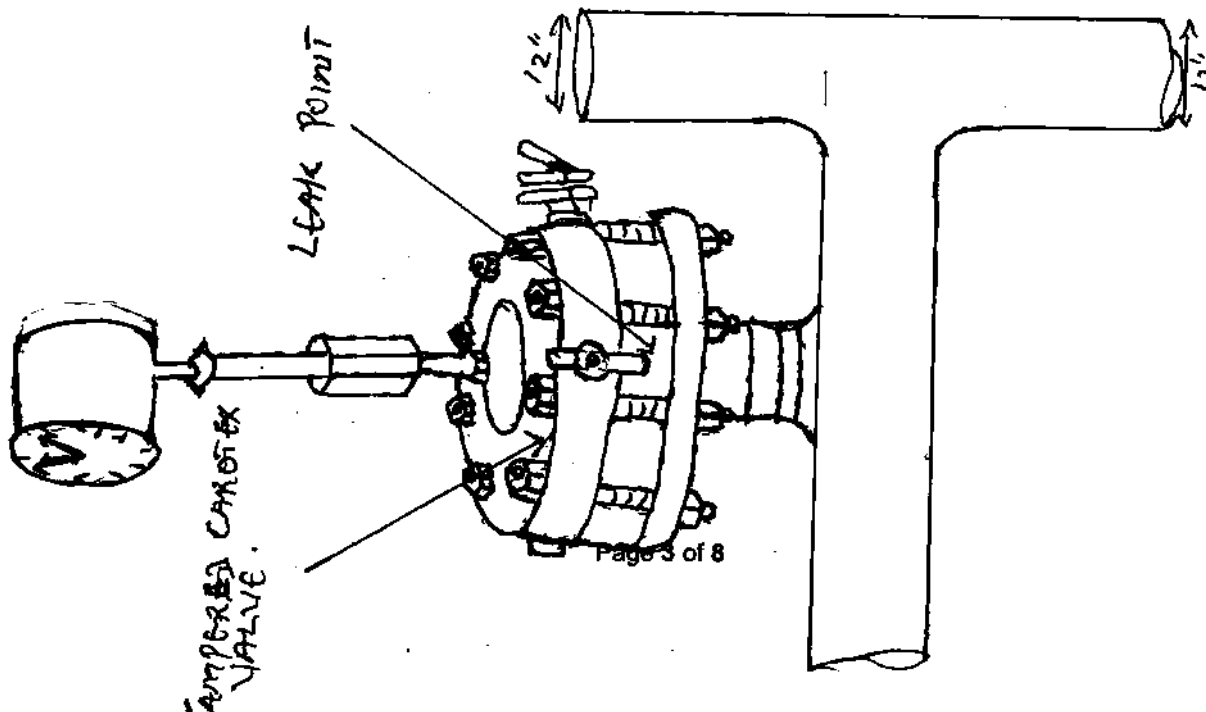
E. GRAPHIC DESCRIPTION OF LEAK POINT (while detail report of the leak point should be contained in the leak report, overview sketch of the site should be added as an appendix 1)

| <input checked="" type="checkbox"/> Third party tampering with valve setting, | | <input type="checkbox"/> Third party tampering with flange, |

SECTION OF 12" ADIBAWA - OKORDIA (OKORDIA MANIFOLD) AT IKARAMA OKORDIA  
SHOWING POSITION OF TAMPERED CAROTEX VALVE
