THE SHELL PETROLEUM DEVELOPMENT COMPANY OF NIGERIA LIMITED.

JOINT INVESTIGATION REPORT FOR INCIDENT NO: 1193004 JIV report S/N: 0555

1. Spill incident Number: 1193004 2. Type of incident* OIL SPILL
 3. Name of Location BELEMA WELL 9T WELL HEAD
 4. Name of nearest community BELEMA 5. State: RIVERS 6. LGA AKUKY-TORU
 7. Type of Production facility/Installation WELL HEAD 8. Asset owner/District SWAMP

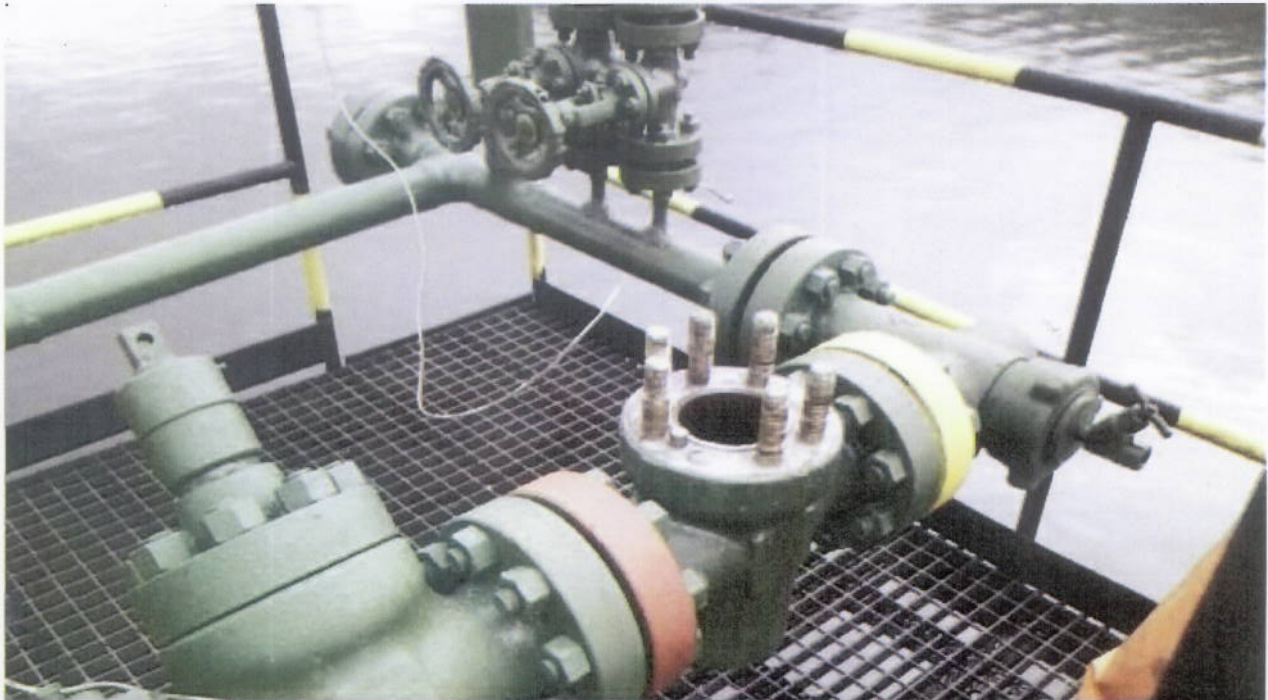
INCIDENT No. 1193004

Additional observations around the spill point: IT WAS OBSERVED THAT SOME OF THE NUTS OF THE CAMERON CONTROL UNIT WERE STILL ON THE WELL HEAD PLATFORM

- Others (specify) THE BELEMA WELL 9T CAMERON CONTROL UNIT (CCU) WAS REMOVED BY UNKNOWN PERSONS
- f. Incident caused by:
- Third party interference (Sabotage ; crude theft ; Line theft ; Accidental 3rd party damage
 Operational Others (including Mystery spills) _____

BELEMA WELL 9T WELL HEAD AT BELEMA SHOW MISSING CAMERON CONTROL UNIT.

A. Joint investigation of the incident site found that there is no residual impact after the initial response and JIT therefore recommend that the site be closed out <input type="checkbox"/>
B. Investigation of the incident site showed that there is residual impact on site requiring further works <input checked="" type="checkbox"/>
