**THE SHELL PETROLEUM DEVELOPMENT COMPANY OF NIGERIA LIMITED.**

JOINT INVESTIGATION REPORT FOR INCIDENT NO: 1193884 JIV report S/N: 0560

1. Spill incident Number: 1193884 2. Type of incident\* OIL SPILL  
 3. Name of Location BELEMA WELL 2 T WELL HEAD  
 4. Name of nearest community BELEMA 5. State: RIVERS 6. LGA AKUKU-TOMI  
 7. Type of Production facility/Installation WELL HEAD 8. Asset owner/District SWAMP

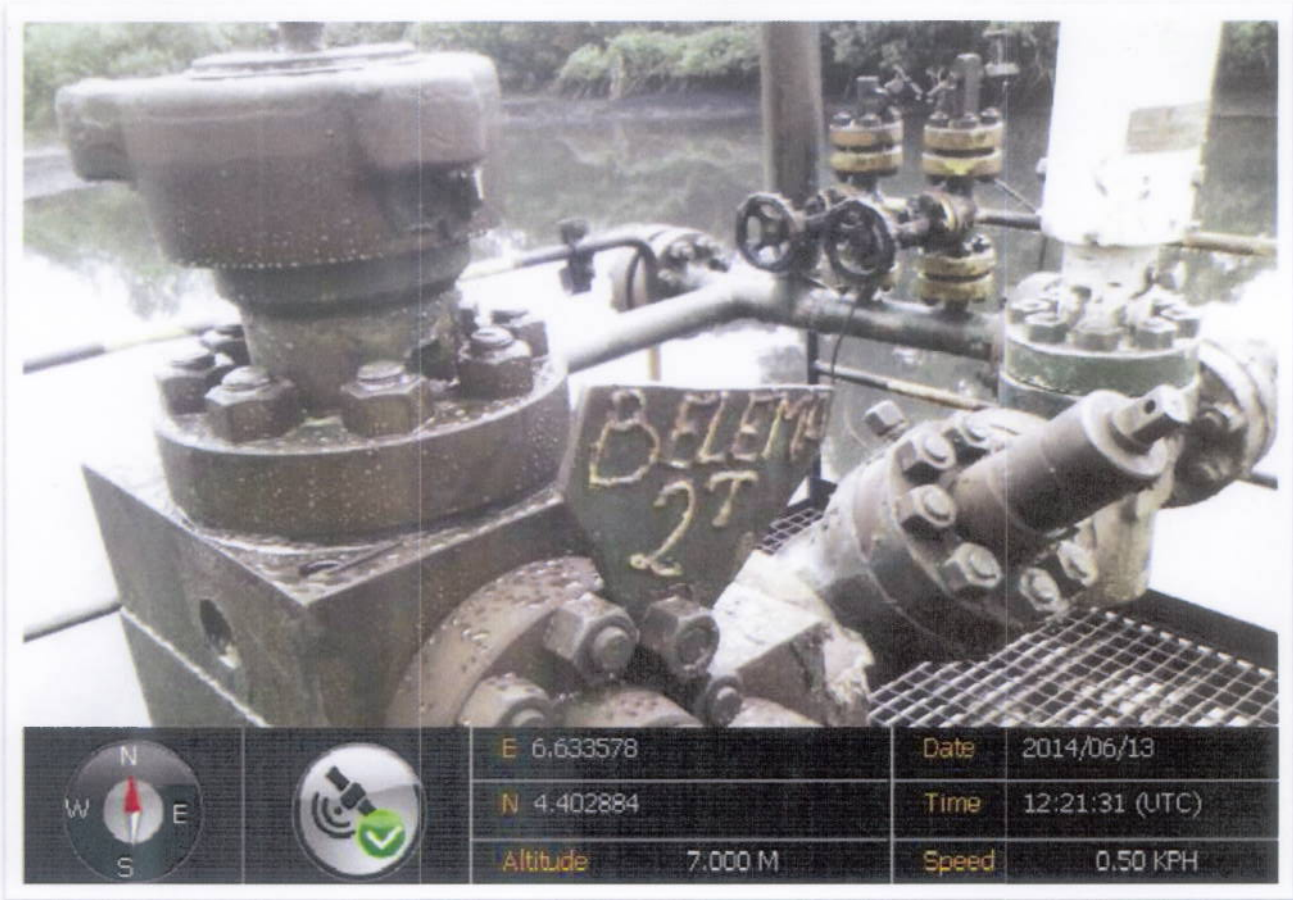
INCIDENT No. 1193884

| <input type="checkbox"/> Relief valve failure | <input checked="" type="checkbox"/> Others (specify) <u>THE WELL 2 T CAMERON CONTROL UNIT (CCU) WAS REMOVED BY UNKNOWN PERSONS.</u> | <input type="checkbox"/> Cold vent |

BELEMA WELL 2T WELL HEAD SHOWING MISSING CAMERON CONTROLL UNIT (CCU)
