**THE SHELL PETROLEUM DEVELOPMENT COMPANY OF NIGERIA LIMITED.**

JOINT INVESTIGATION REPORT FOR INCIDENT NO: 1202387 JIV report S/N: 00606

1. Spill incident Number: 1202387      2. Type of incident\* OIL SPILL  
 3. Name of Location 30" NEMBE CREEK PIPELINE  
 4. Name of nearest community BORO      5. State: RIVERS      6. LGA AKYKU-TORY  
 7. Type of Production facility/Installation OK PIPELINE      8. Asset owner/District PIPELINE

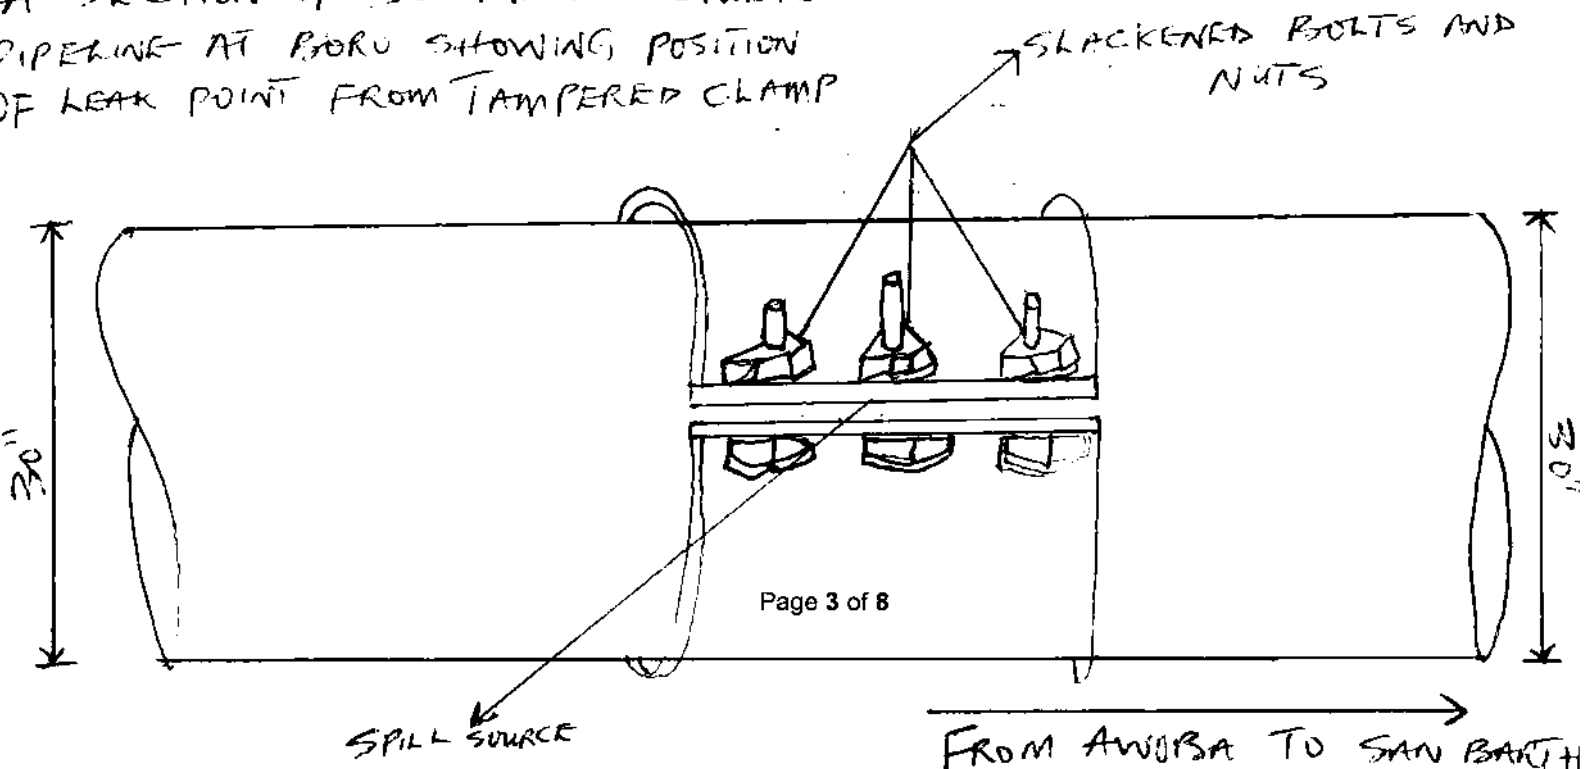
| <input type="checkbox"/> Crude oil theft (illegal bunkering) point, | | <input checked="" type="checkbox"/> Third party tampering with Clamp |

- Third party interference (Sabotage ; crude theft ; Line theft ; Accidental 3<sup>rd</sup> party damage   
 Operational       Others (including Mystery spills) \_\_\_\_\_

A SECTION OF 30" NEMBE CREEK  
PIPELINE AT BORU SHOWING POSITION  
OF LEAK POINT FROM TAMPERED CLAMP
