THE SHELL PETROLEUM DEVELOPMENT COMPANY OF NIGERIA LIMITED.

JOINT INVESTIGATION REPORT FOR INCIDENT NO: 1201770 JIV report S/N: 00598

1. Spill incident Number: 1201770 2. Type of incident* OIL SPILL
 3. Name of Location 10" DIEBU CREEK - MUN RIVER PIPELINE
 4. Name of nearest community ONYOMA / ENIWAAT 5. State: BAYELSA 6. LGA SOUTHERN IJAW
 7. Type of Production facility/Installation OIL PIPELINE 8. Asset owner/District PIPELINE

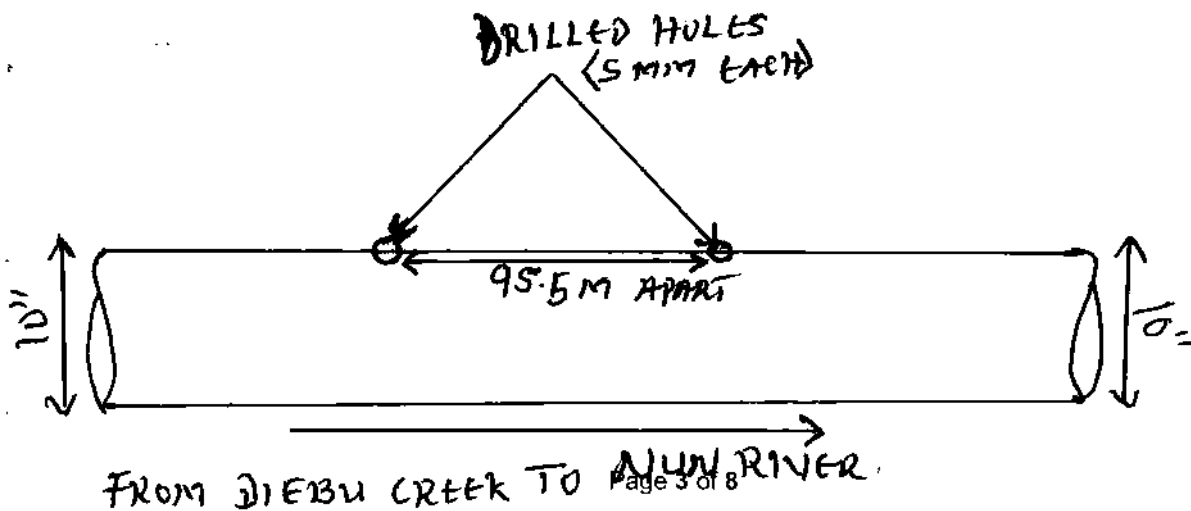
| <input checked="" type="checkbox"/> Drilled hole | <input type="checkbox"/> Hack saw cut | <input type="checkbox"/> Tear (_____). |

SECTION OF 10" DIEBU CREEK - NUN RIVER PIPELINE AT ONYOMA/ENIWARI SHOWING POSITIONS OF DRILLED HOLES AT 12 O'CLOCK POSITIONS.

REPAIR BY CLAMPING WAS DONE.
