THE SHELL PETROLEUM DEVELOPMENT COMPANY OF NIGERIA LIMITED.

JOINT INVESTIGATION REPORT FOR INCIDENT NO: 1198906 JIV report S/N: 0552

1. Spill incident Number: 1198906 2. Type of incident* OIL SPILL
 3. Name of Location 24" CANTHORNE CHANNEL - BONNY PIPELINE (LOOPLINE)
 4. Name of nearest community ADAMAKIRI 5. State: RIVERS 6. LGA BONNY
 7. Type of Production facility/Installation OIL PIPELINE 8. Asset owner/District PIPELINE

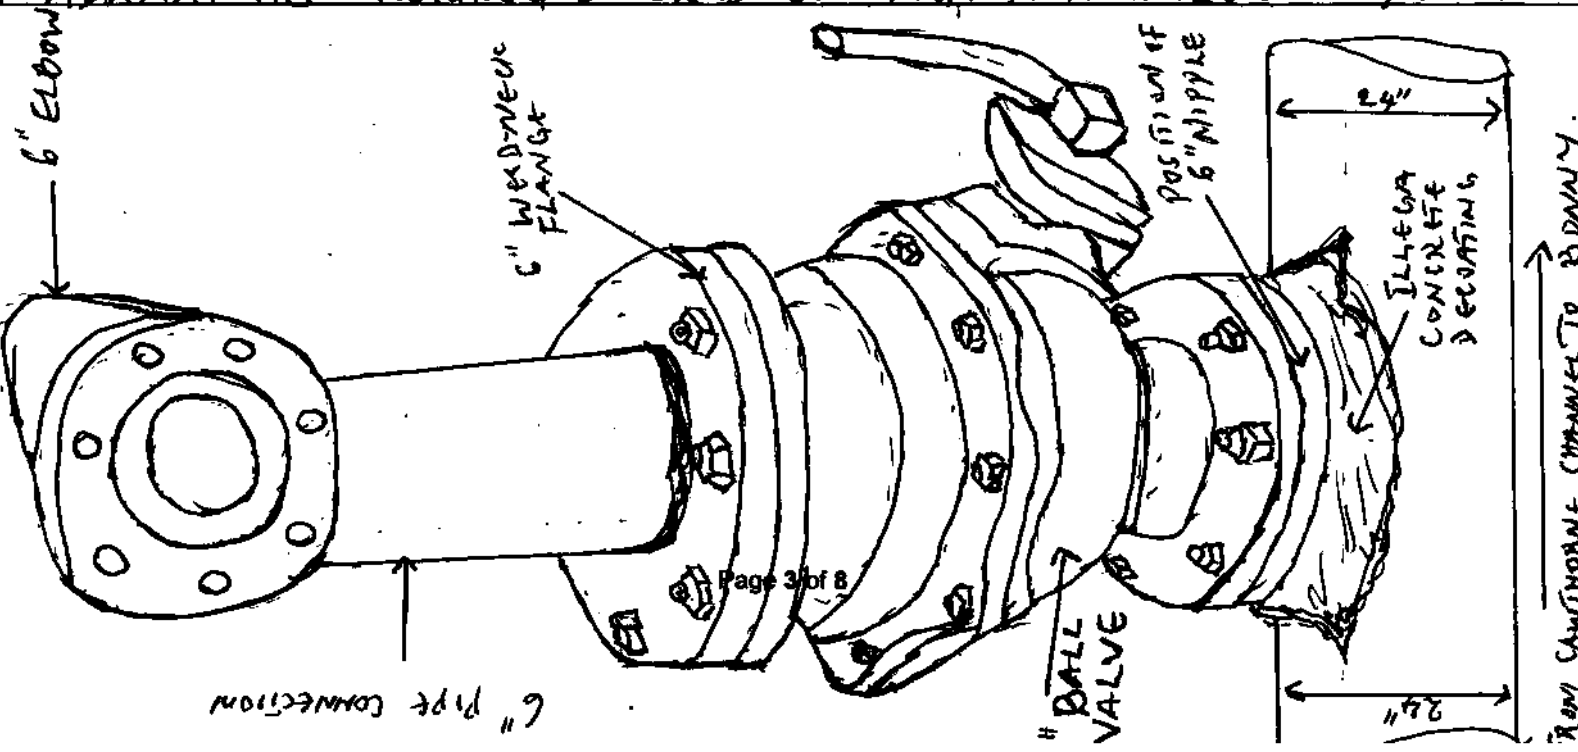
E. GRAPHIC DESCRIPTION OF LEAK POINT (while detail report of the leak point should be contained in the leak report, overview sketch of the site should be added as an appendix 1)

Additional observations around the spill point: PIECES OF PLANK WERE OBSERVED AT THE SPILL POINT. CONSTRUCTED COFFERDAM WHICH SERVED AS BUND WALL WAS ALSO OBSERVED. SOME IMPACTED AREA WAS SIGHTED TO BE OIL SHEEN ON SWAMPY TERRAIN.

| <input checked="" type="checkbox"/> Failed Weld-on illegal hot tap valve, | <input type="checkbox"/> Failed Clamp | <input type="checkbox"/> Missing Pipeline/Flowline |
| <input checked="" type="checkbox"/> Crude oil theft (illegal bunkering) point, | | <input type="checkbox"/> Third party tampering with Clamp |

SECTION OF 24" CAUSTHORNE CHANNEL - BONNY PIPELINE (LOOP LINE)
 AT ADAMACIBI SHOWING 6" CRUDE OIL LEAK POINT AT 12 O'CLOCK POSITION.

REPAIR WORKS AND RECOVERY
ACTIVITIES ON-GOING AS AT THE TIME OF JIV
