THE SHELL PETROLEUM DEVELOPMENT COMPANY OF NIGERIA LIMITED.

JOINT INVESTIGATION REPORT FOR INCIDENT NO: 1134131 JIV report S/N: 0404

1. Spill incident Number: 1134131 2. Type of incident* OIL SPILL
 3. Name of Location IMO RIVER 2 WELL 28L WELL HEAD
UMUEDEOKWARA
 4. Name of nearest community (ODDAGWA) 5. State: RIVERS 6. LGA ETCHE
 7. Type of Production facility/Installation WELL HEAD 8. Asset owner/District LAND 1

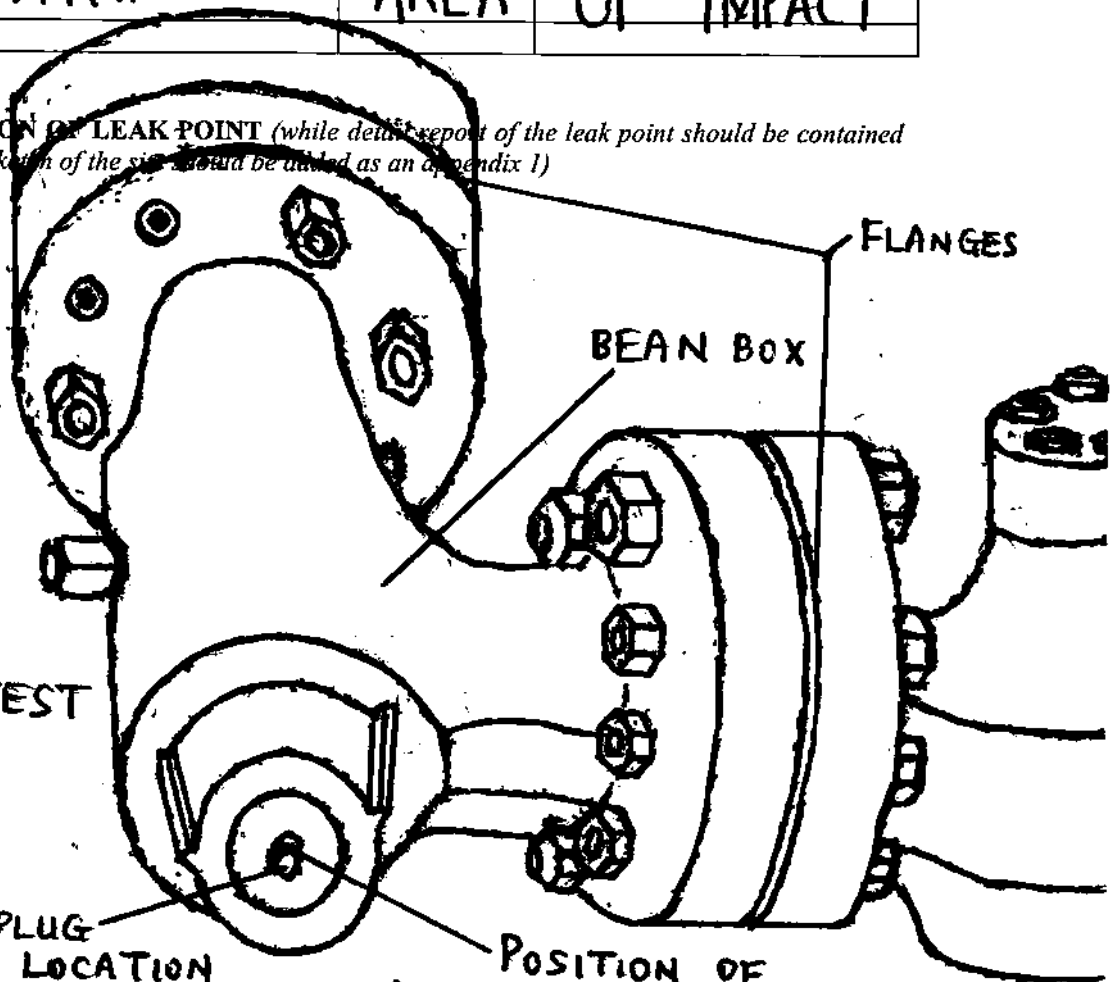
SECTION OF
IMU RIVER 2
WELL 28L
WELL HEAD AT
UMUEDEOKWARA
(ODAGWA)
SHOWING
POSITION OF
MISSING KEROTEST
VALVE.

TEMPORARY PLUG
INSTALLED AT LOCATION
OF MISSING KEROTEST
F: TABLE SHOWING SOME OF COORDINATES
CALCULATION VALVE.

POSITION OF
MISSING KEROTEST VALVE
TAKEN DURING JIV FOR AREA
(REMOVED BY UNKNOWN PERSON)
IDENTIFIED AS LEAK POINT.

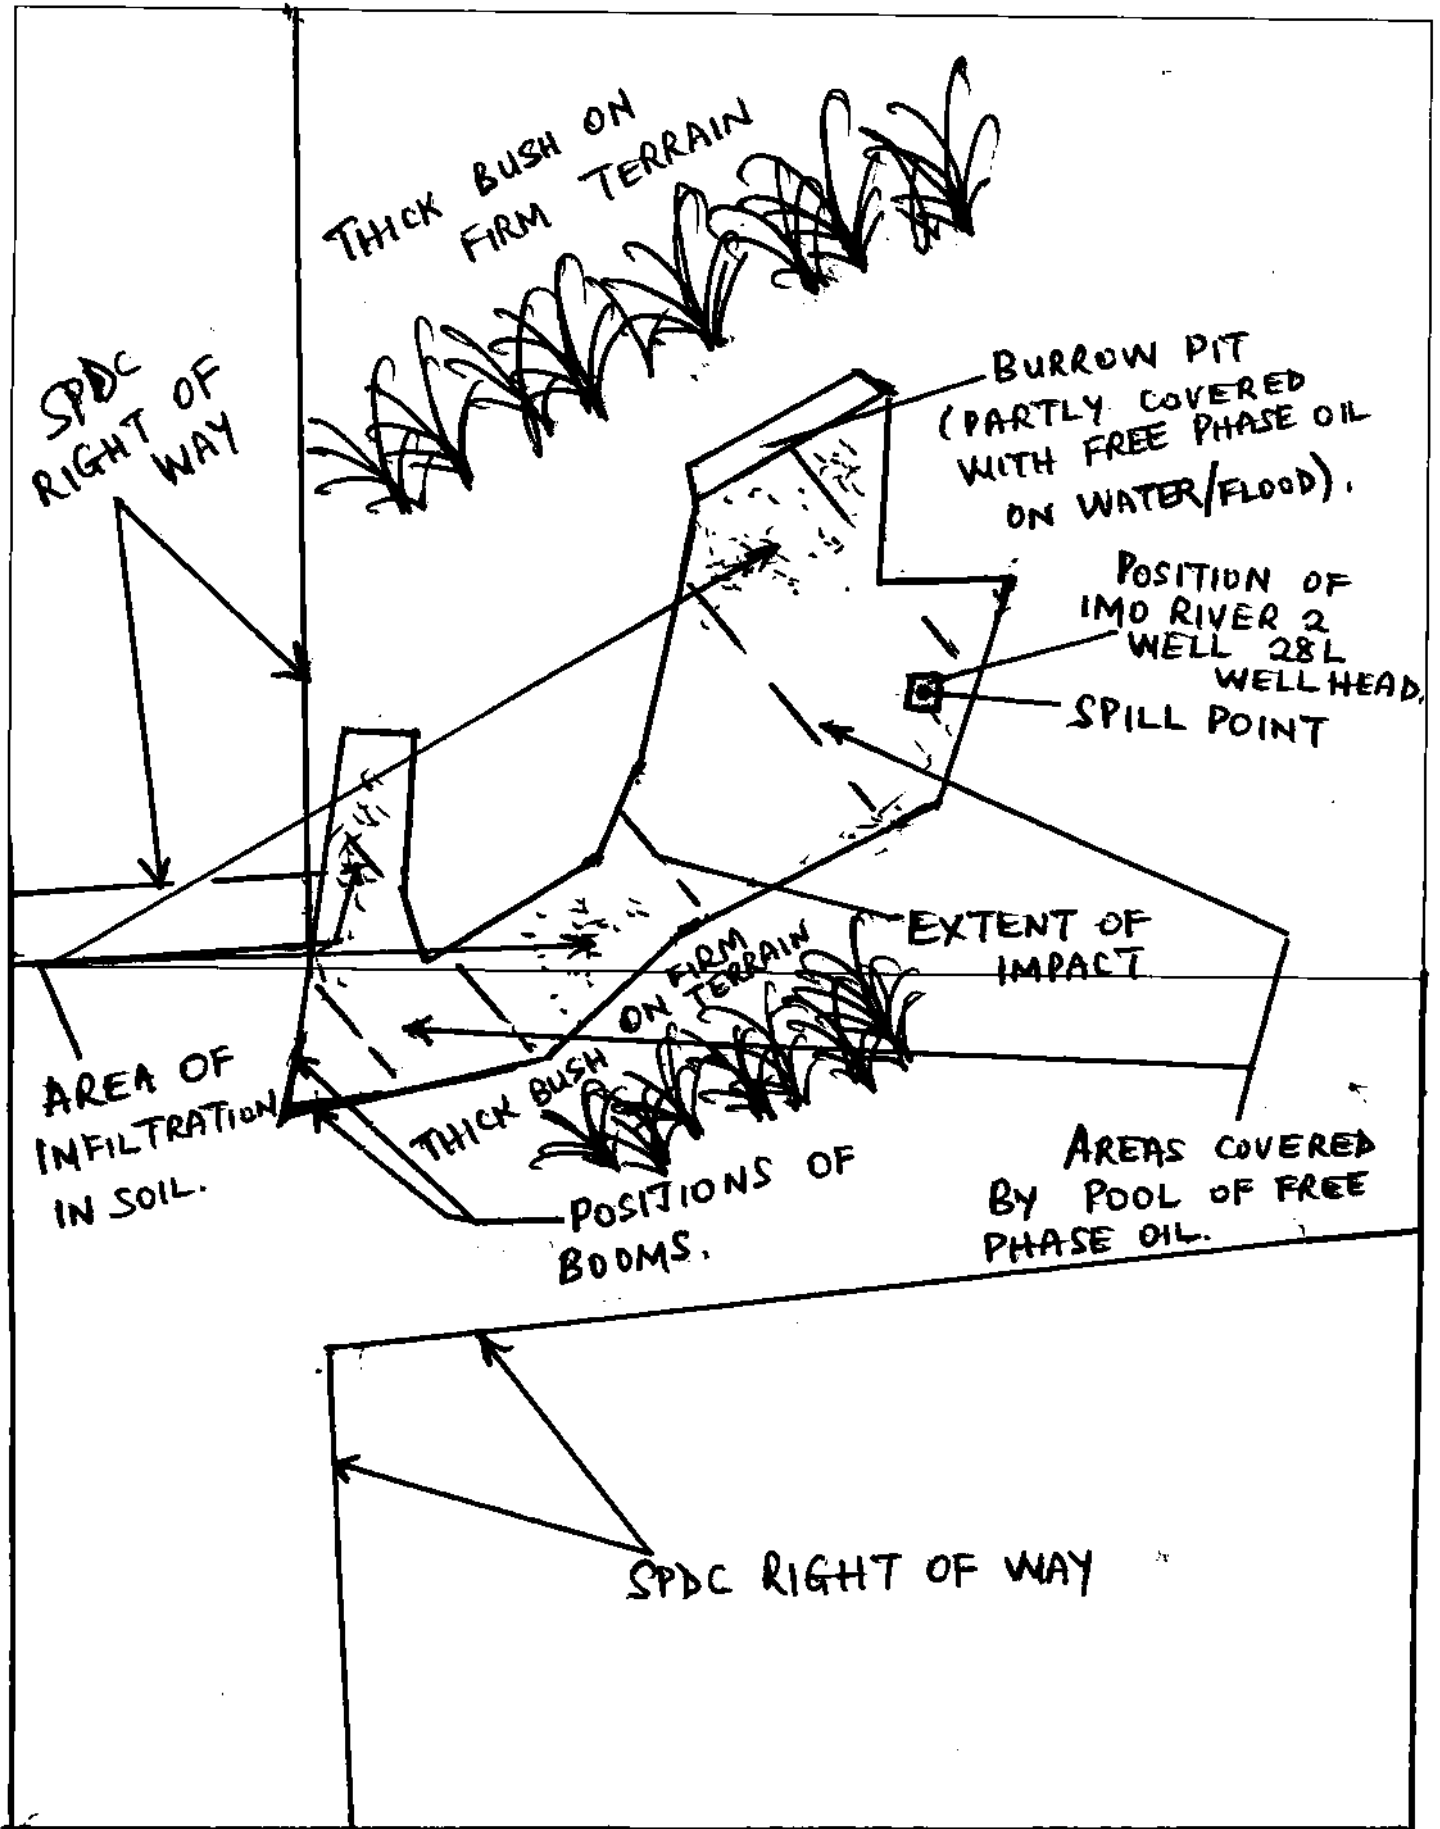
28. Appendix 1: Overview sketch of the site

Location: IMD RIVER 2 WELL 28L WELLHEAD AT UMVEDEKWARA (UDAGWA)
