THE SHELL PETROLEUM DEVELOPMENT COMPANY OF NIGERIA LIMITED.

JOINT INVESTIGATION REPORT FOR INCIDENT NO: 1132197 JIV report S/N: 0236

1. Spill incident Number: 1132197 2. Type of incident* OIL SPILL
 3. Name of Location 20" OTUMARA - ESCRAVOS PIPELINE
 4. Name of nearest community UGBOEEFUNGUNS. State: DELTA 6. LGA WARRI SOUTH - WEST
 7. Type of Production facility/Installation OIL PIPELINE 8. Asset owner/District PIPELINE

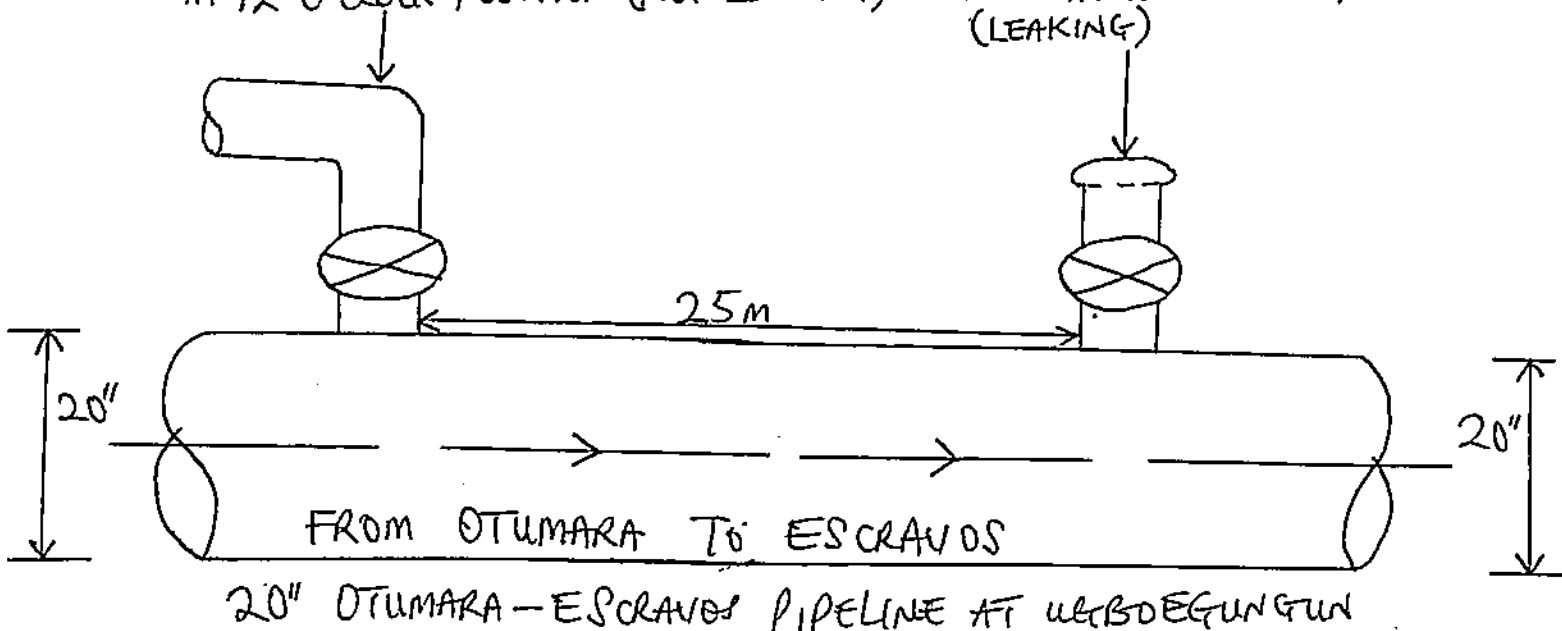
E. GRAPHIC DESCRIPTION OF LEAK POINT (while detail report of the leak point should be contained in the leak report, overview sketch of the site should be added as an appendix 1)

3" WELD-ON ILLEGAL HOT TAP VALVE AT 12 O'CLOCK POSITION (NOT LEAKING)

3" FAILED WELD-ON ILLEGAL HOT-TAP VALVE AT 12 O'CLOCK POSITION (LEAKING)
