THE SHELL PETROLEUM DEVELOPMENT COMPANY OF NIGERIA LIMITED.

JOINT INVESTIGATION REPORT FOR INCIDENT NO: 1132899 JIV report S/N: 0438

1. Spill incident Number: 1132899 2. Type of incident* OIL SPILL
 3. Name of Location 28" NKPOK4- BOMU PIPELINE
 4. Name of nearest community AKPAJO 5. State: RIVERS 6. LGA ELEME
 7. Type of Production facility/Installation OIL PIPELINE 8. Asset owner/District PIPELINE

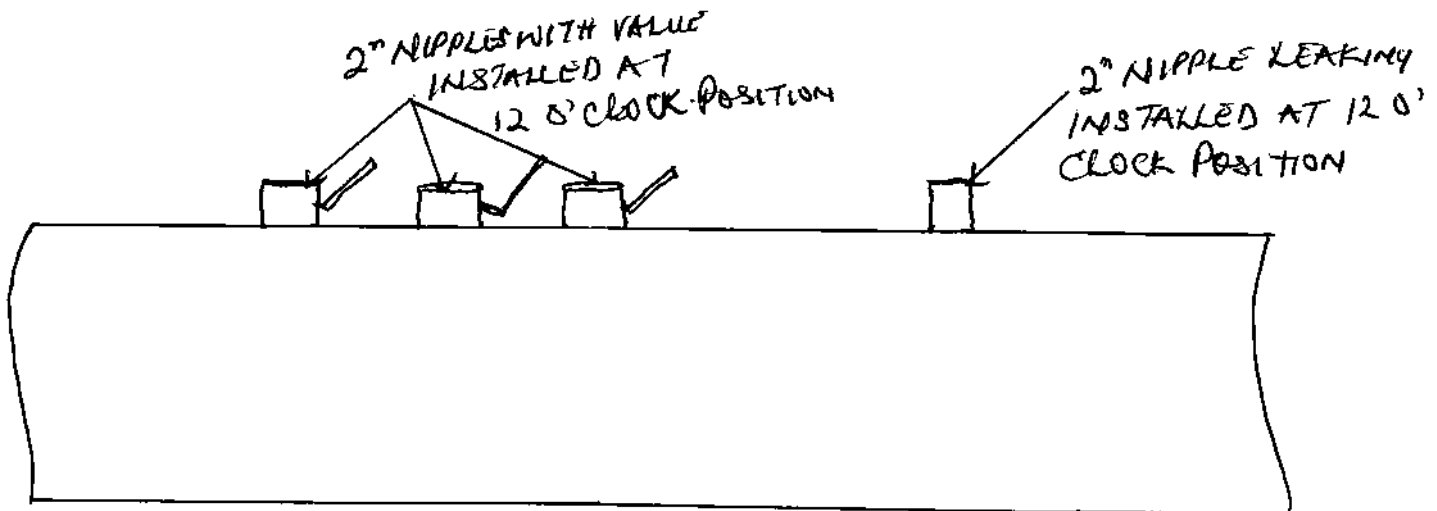
SECTION OF 28" NKPOKY-BOMU PIPELINE AT AKPAJO SHOWING 4 NOS. CRUDE OIL THEFT POINTS WITH ONE LEAKING

| <input checked="" type="checkbox"/> Failed Weld-on illegal hot tap valve, | <input type="checkbox"/> Failed Clamp | <input type="checkbox"/> Missing Pipeline/Flowline |
| <input checked="" type="checkbox"/> Crude oil theft (illegal bunkering) point, | | <input type="checkbox"/> Third party tampering with Clamp |

From NKPOKY To BOMU →

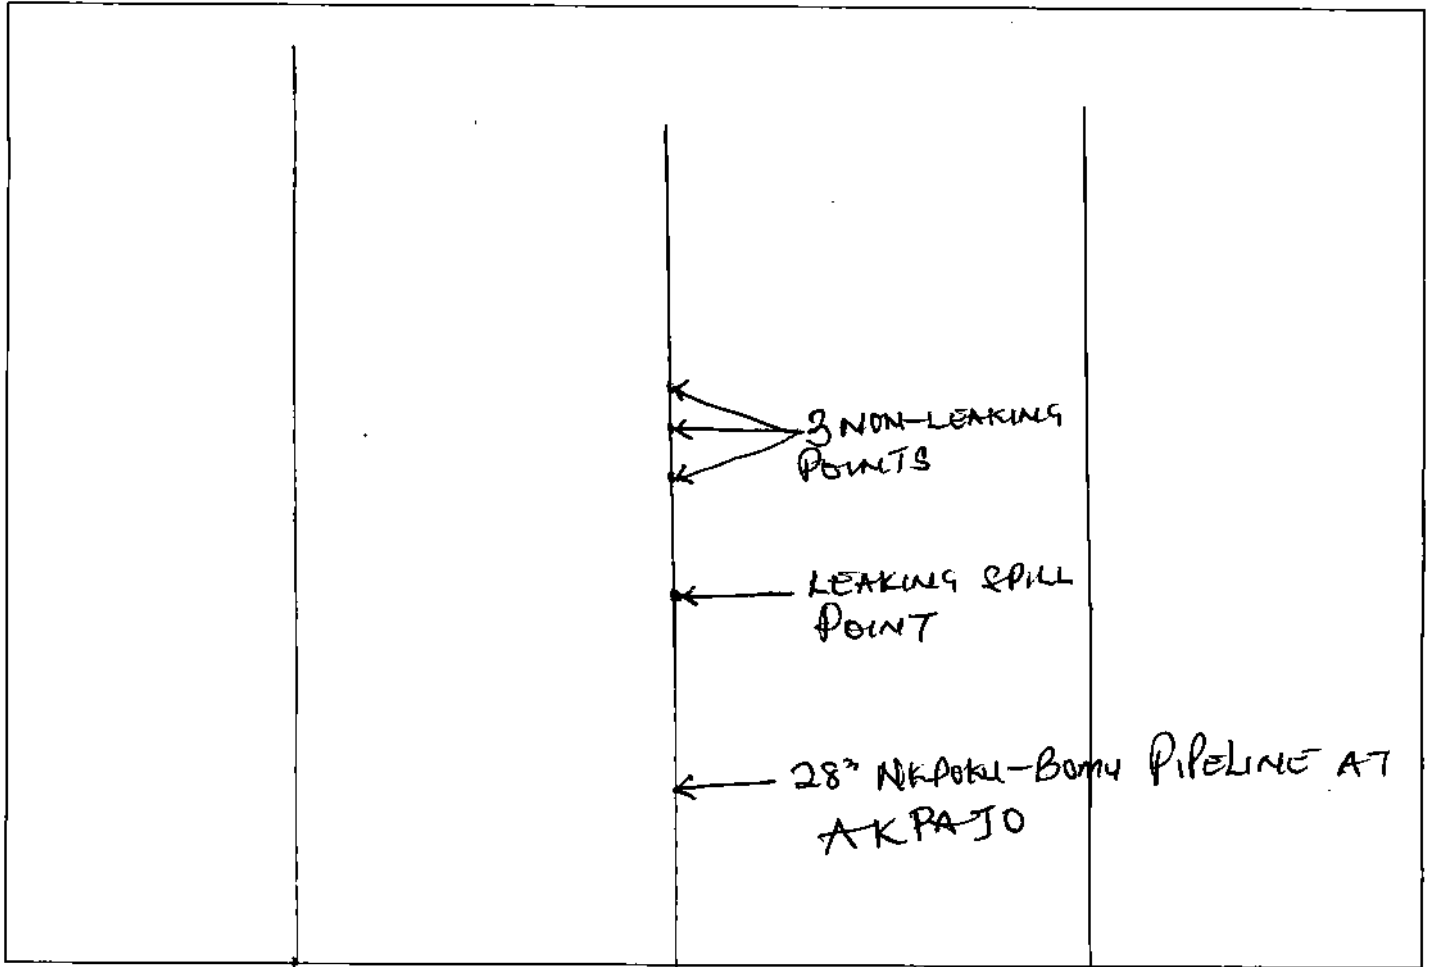
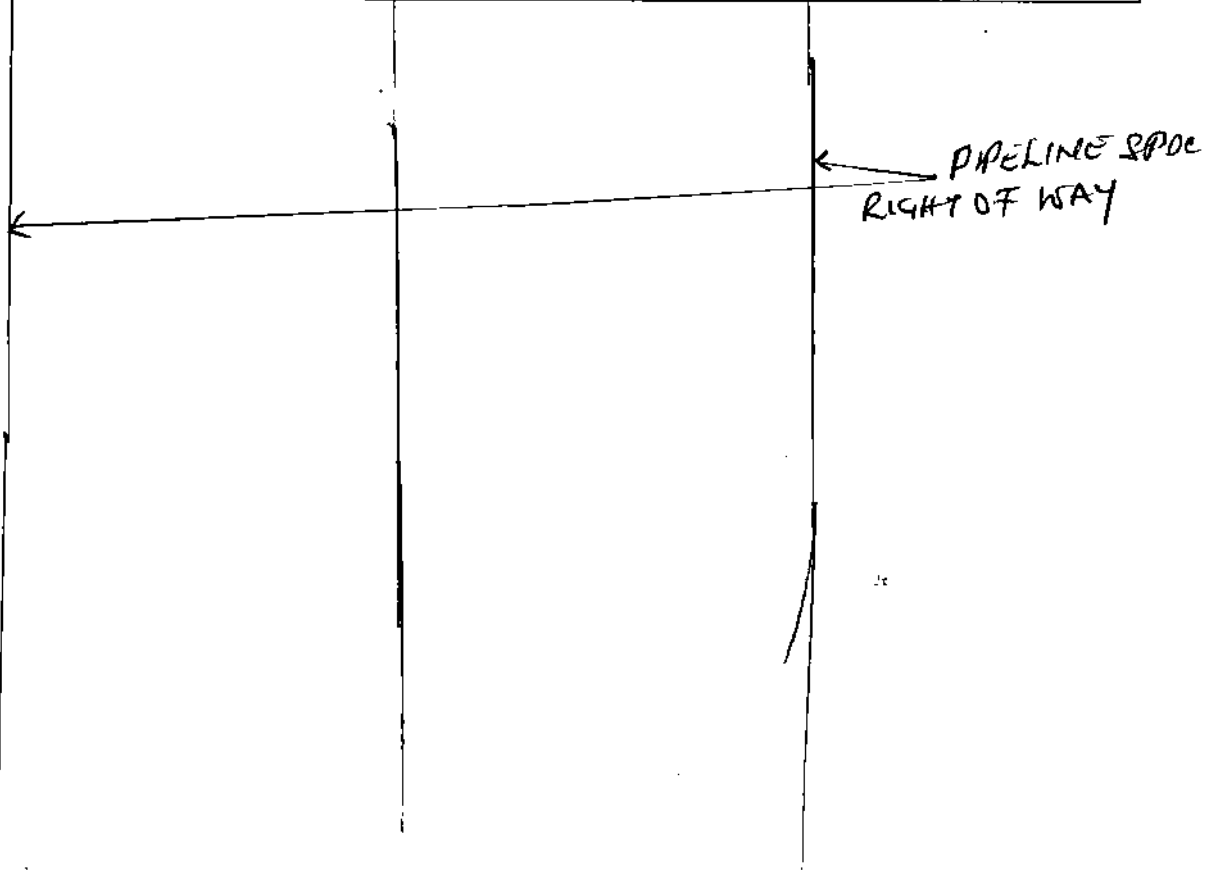
28. Appendix 1: Overview sketch of the site

Location: 28th Nkforu - Bony Pipeline AT AKPAJO
