THE SHELL PETROLEUM DEVELOPMENT COMPANY OF NIGERIA LIMITED.

JOINT INVESTIGATION REPORT FOR INCIDENT NO: 1143671 JIV report S/N: 0488

1. Spill incident Number: 1143671 2. Type of incident* OIL SPILL
 3. Name of Location 12" IMO RIVER 2 - OGALE PIPELINE
 4. Name of nearest community KOM-KOM 5. State: RIVERS 6. LGA OYIGBO
 7. Type of Production facility/Installation OIL PIPELINE 8. Asset owner/District PIPELINE

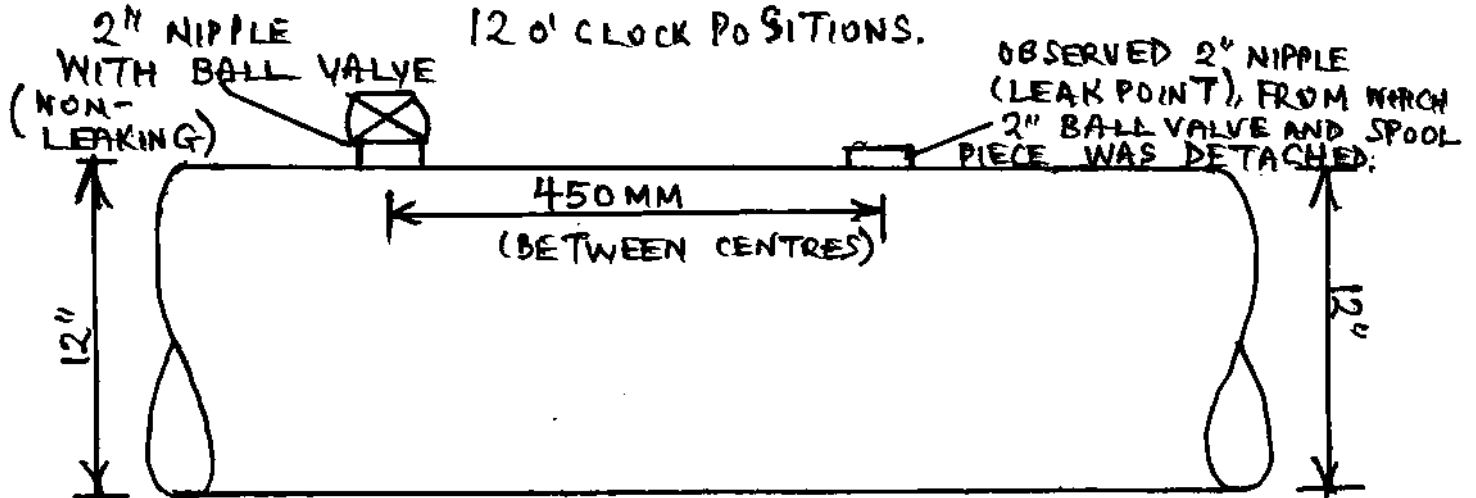
Additional observations around the spill point:
A HEAP OF TEN (10) SAND BAGS WAS OBSERVED BESIDE THE SPILL POINT. IN ADDITION, A DETACHED 2" BALL VALVE WITH SPOOL PIECE WAS OBSERVED IN THE DITCH AROUND THE SPILL POINT. SOIL AROUND SPILL POINT WAS REDDISH BROWN SILT WITH

| <input checked="" type="checkbox"/> Crude oil theft (illegal bunkering) point, | | <input type="checkbox"/> Third party tampering with Clamp |

SECTION OF 12" IMO RIVER 2 - OGALE PIPELINE AT KOM-KOM SHOWING 2 NO. CRUDE OIL THEFT POINTS AT 12 O' CLOCK POSITIONS.

RECOVERY OF FREE PHASE OIL WAS DONE SIMULTANEOUSLY WITH REPAIR OF THE AFFECTED SECTION OF PIPELINE.
