,0	INT INVESTIGATION REPORT FOR I	•	•	
	(Note: As practicable as possible the JII	report is to be signed in the	field by all the participating parties)

A. GENERAL INFORMATION:	·		
	1. Spill incident Number: 1140	4 15 2.Type	of incident* OIL SPILL	
	3. Name of Location 24" BON			
	4. Name of nearest community FREE	TOWN 5. State: Ru	VERY 6. LGA ANDOMI

JOINT INVESTIGATION REPORT FOR INCIDENT NO: 1140415 JIV report S/N: 0494

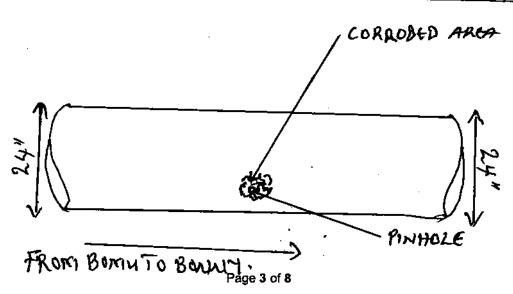
E. GRAPHIC DESCRIPTION OF LEAK POINT (while detail report of the leak point should be contained in the

HOWING POSITION OF CORROSION AT 5 O'CLOCK POSITION.
