THE SHELL PETROLEUM DEVELOPMENT COMPANY OF NIGERIA LIMITED.

JOINT INVESTIGATION REPORT FOR INCIDENT NO: 1145352 JIV report S/N: 0483

1. Spill incident Number: 1145352 2. Type of incident* OIL SPILL
 3. Name of Location 28" NKPOKU - BOMU TRANS NIGER PIPELINE
 4. Name of nearest community KPOGHOR 5. State: RIVERS 6. LGA GOKANA
 7. Type of Production facility/Installation OIL PIPELINE 8. Asset owner/District PIPELINE/LAND

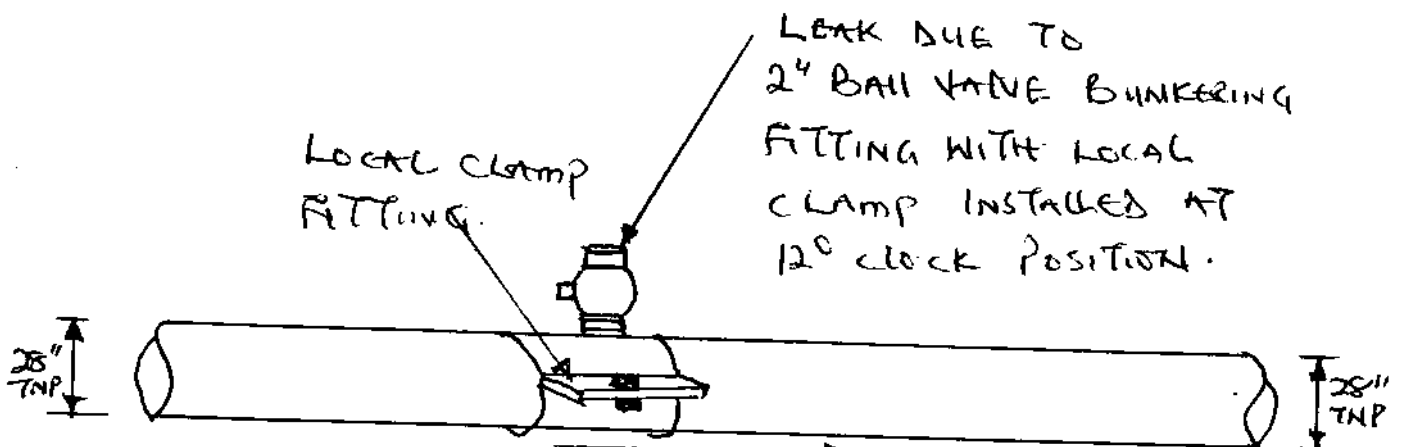
Additional observations around the spill point:
BUNKERING FITTING WAS INSTALLED WITH A LOCK CLAMP.

| <input checked="" type="checkbox"/> Crude oil theft (illegal bunkering) point, | | <input type="checkbox"/> Third party tampering with Clamp |

E. GRAPHIC DESCRIPTION OF LEAK POINT (while detail report of the leak point should be contained in the leak report, overview sketch of the site should be added as an appendix 1)

SECTIONAL VIEW OF 28" NKPOKLI - BOMU TRANS NIGER PIPELINE AT

KPOGOTER SHOWING CRUDE OIL THEFT POINTS

REPAIR DONE BY CLAMPING METHOD.
