THE SHELL PETROLEUM DEVELOPMENT COMPANY OF NIGERIA LIMITED.

JOINT INVESTIGATION REPORT FOR INCIDENT NO: 1142455 JIV report S/N: 0500

1. Spill incident Number: 1142455 2. Type of incident* OIL SPILL
 3. Name of Location 20" RUMUEKPE - NKPOKU PIPELINE
 4. Name of nearest community OMUSUNU-IBAA 5. State: RIVERS 6. LGA EMOHUA
 7. Type of Production facility/Installation OIL PIPELINE 8. Asset owner/District PIPELINE

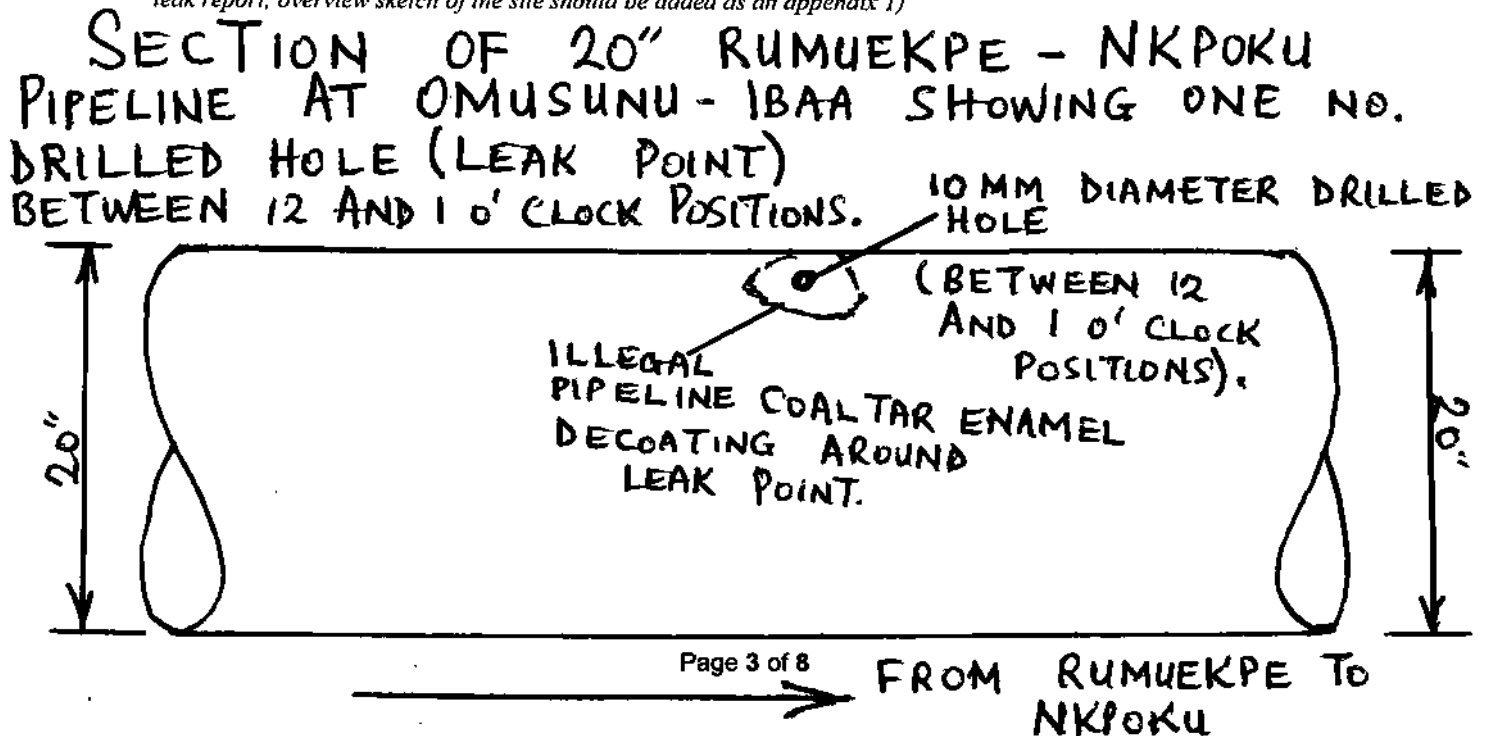
E. GRAPHIC DESCRIPTION OF LEAK POINT (while detail report of the leak point should be contained in the leak report, overview sketch of the site should be added as an appendix 1)

Additional observations around the spill point: **A DITCH WITH FREE-PHASE OIL WAS OBSERVED AT THE SPILL POINT ON ARRIVAL AT SITE. ON EXPOSURE OF AFFECTED PIPELINE SECTION, ILLEGAL DECOATING OF THE PIPELINE COALTAR ENAMEL COATING WAS NOTICED AROUND THE SPILL POINT.**

| <input checked="" type="checkbox"/> Drilled hole | <input type="checkbox"/> Hack saw cut | <input type="checkbox"/> Tear (_____). |

RECOVERY OF FREE PHASE OIL CONTAINED IN AN OBSERVED DITCH AT THE SPILL POINT WAS DONE, AFTER WHICH REPAIRS WERE CARRIED OUT ON THE AFFECTED SECTION OF PIPELINE.
