THE SHELL PETROLEUM DEVELOPMENT COMPANY OF NIGERIA LIMITED.

JOINT INVESTIGATION REPORT FOR INCIDENT NO: 1172032 JIV report S/N: 0537

1. Spill incident Number: 1172032 2. Type of incident* OIL SPILL
 3. Name of Location 8" MININTA - RUMUKEPE BULKLINE
 4. Name of nearest community RUMUKEPE 5. State: RIVERS 6. LGA EMOHUA.
 7. Type of Production facility/Installation BULKLINE 8. Asset owner/District LAND 2.

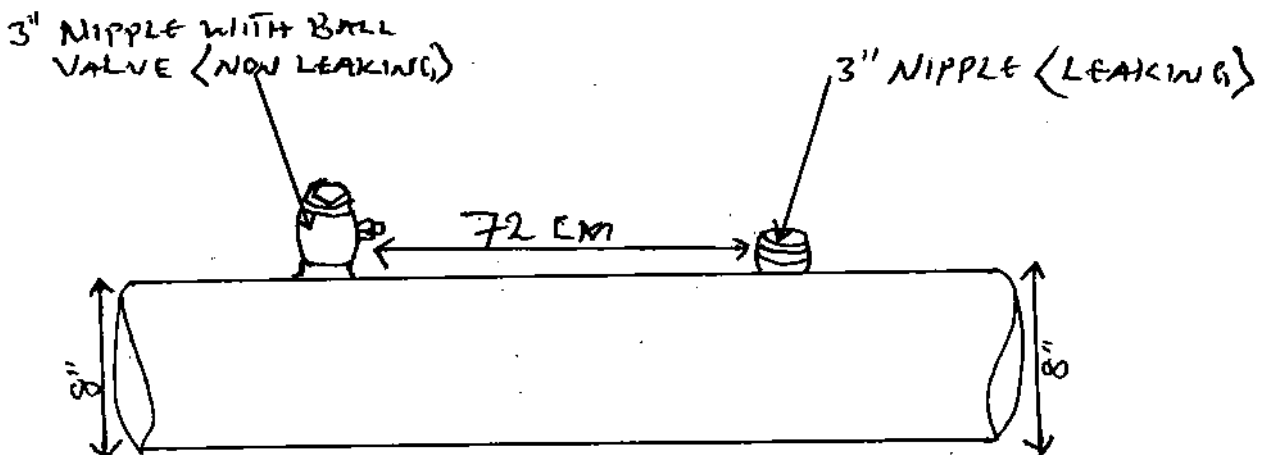
E. GRAPHIC DESCRIPTION OF LEAK POINT (while detail report of the leak point should be contained in the leak report, overview sketch of the site should be added as an appendix 1)

Additional observations around the spill point: ON EXCAVATION OF THE SPILL AREA LINER AND SAND BAGS STACKED OVER TWO NOS OF CRUDE OIL THEFT POINTS.

| <input checked="" type="checkbox"/> Failed Weld-on illegal hot tap valve, | <input type="checkbox"/> Failed Clamp | <input type="checkbox"/> Missing Pipeline/Flowline |
| <input checked="" type="checkbox"/> Crude oil theft (illegal bunkering) point, | | <input type="checkbox"/> Third party tampering with Clamp |

SECTION OF 8" MINIMIA - RUMUEKPE BULLLINE AT RUMUEKPE SHOWING POSITION OF 2 NOS OF CRUDE OIL TIEPI POINTS AT 12 O'CLOCK POSITION.
