THE SHELL PETROLEUM DEVELOPMENT COMPANY OF NIGERIA LIMITED.

JOINT INVESTIGATION REPORT FOR INCIDENT NO: 1175143 JIV report S/N: 0563

1. Spill incident Number: 1175143 2. Type of incident* OIL SPILL
 3. Name of Location OTUMARA WELL-22L FLOWLINE
 4. Name of nearest community UGBDEGUNGUN State: DELTA 6. LGA WARRI SOUTH WEST
 7. Type of Production facility/Installation FLOWLINE 8. Asset owner/District SWAMP WEST / OTUMARA

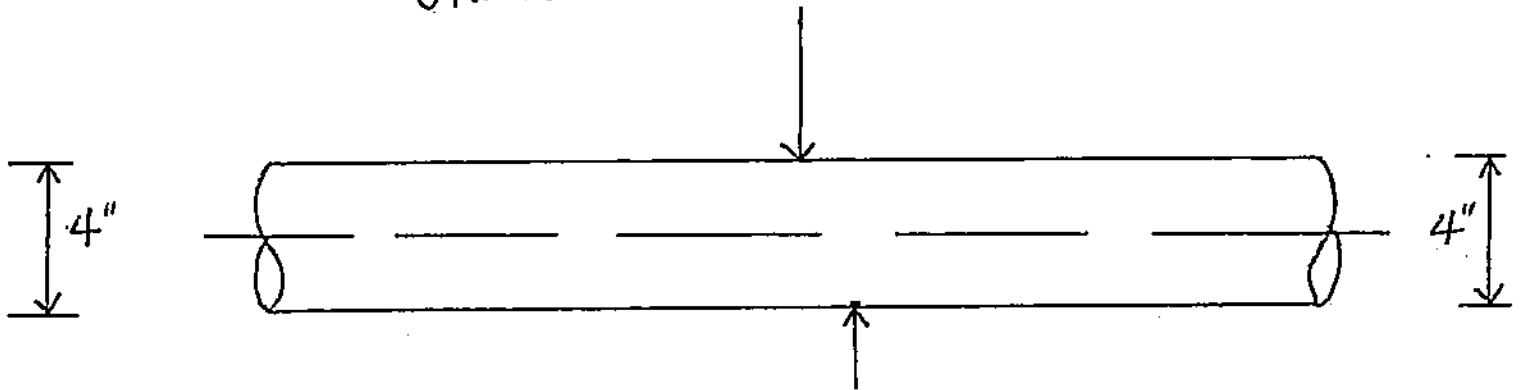
OTUMARA WELL-22L FLOWLINE

Additional observations around the spill point: THE TERRAIN WAS OBSERVED TO BE A TIDAL SWAMP AND THE LEAK POINT WAS SUBMERGED AT THE TIME OF JIV.

| <input checked="" type="checkbox"/> Corrosion (PIN-HOLE) | <input type="checkbox"/> Saver-pit over flow, | <input type="checkbox"/> Surge vessel overflow, |

PIN-HOLE LEAK AT 6 O'CLOCK POSITION

If yes to item 14, give brief description: REPAIR IS BEING PLANNED BY ASSET ENGINEERING.

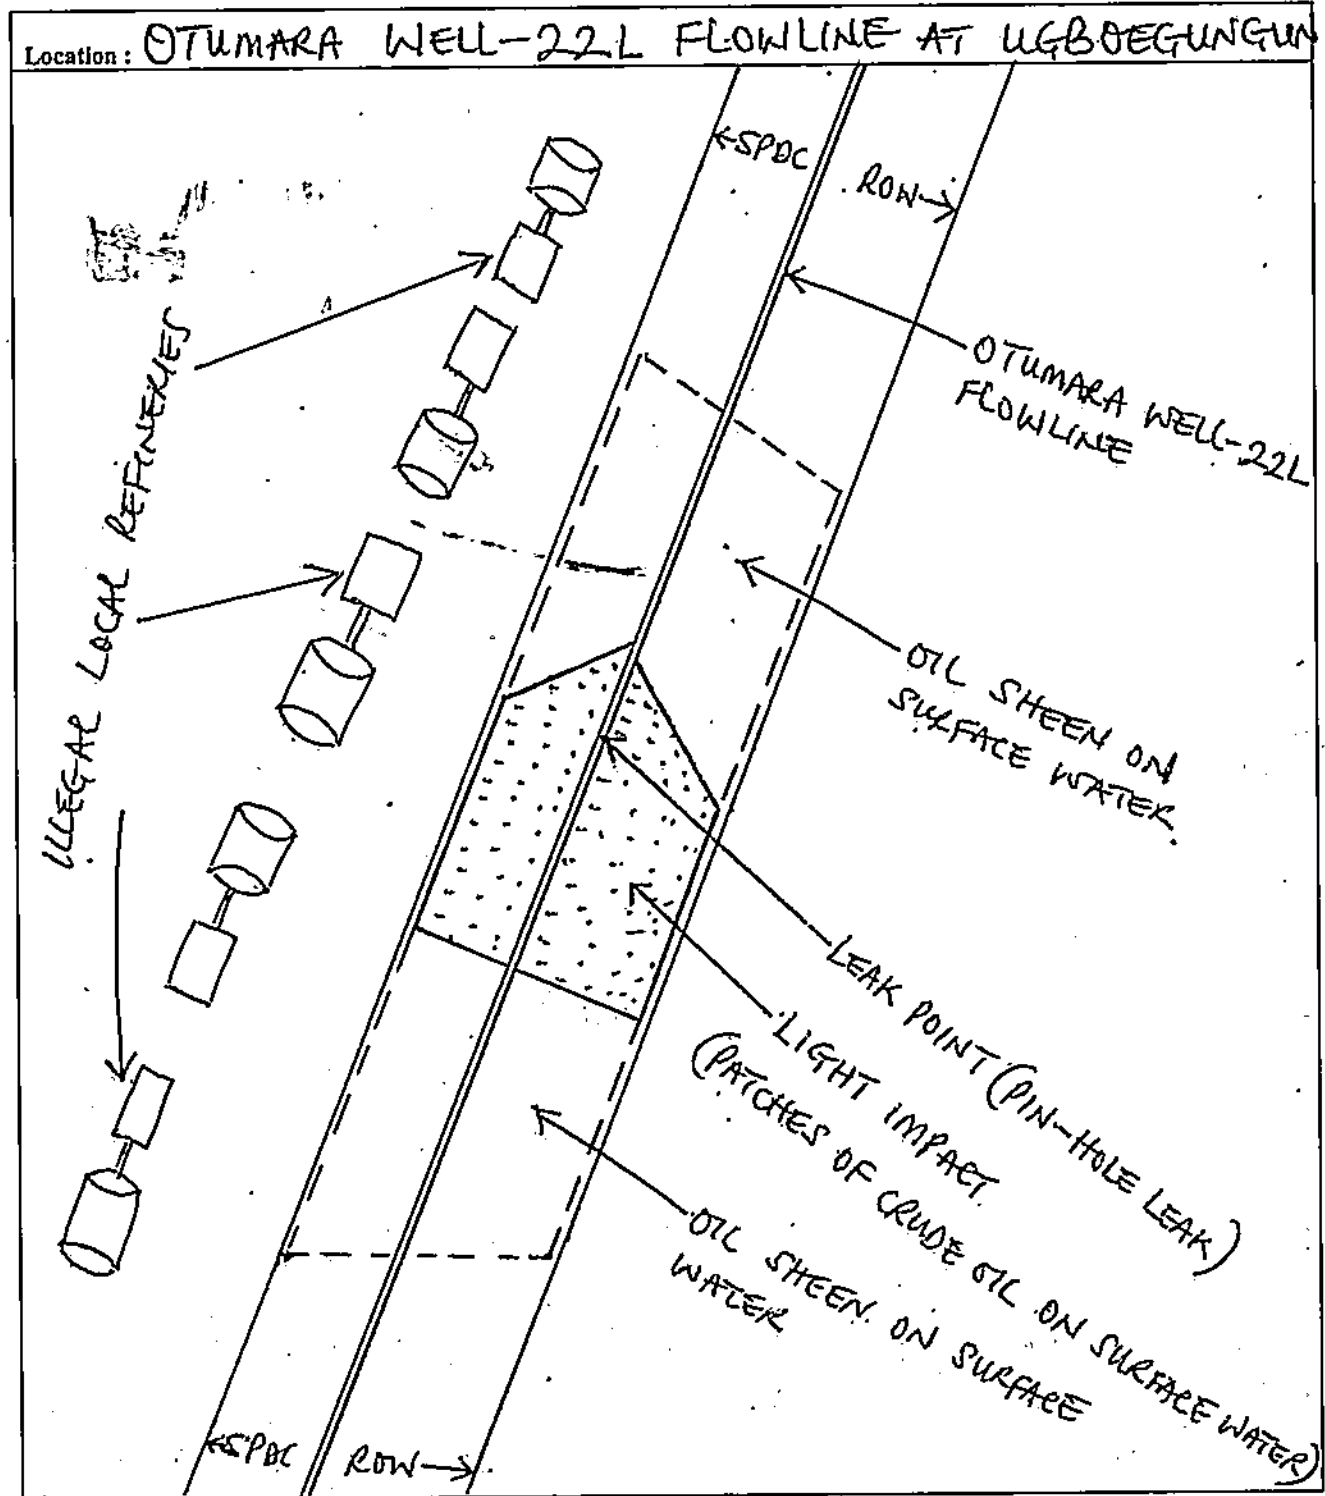
25. Appendix 1: Overview sketch of the site

AREAS AFFECTED BY CRUDE OIL SPILLAGE ALONG 4th OTUMARA WEIL 22L FLOWLINE @ OTUMARA

Area measurement
 Segment: 46.053014 Meters
 Perimeter: 325.854568 Meters
 Area: 0.293063 Hectares

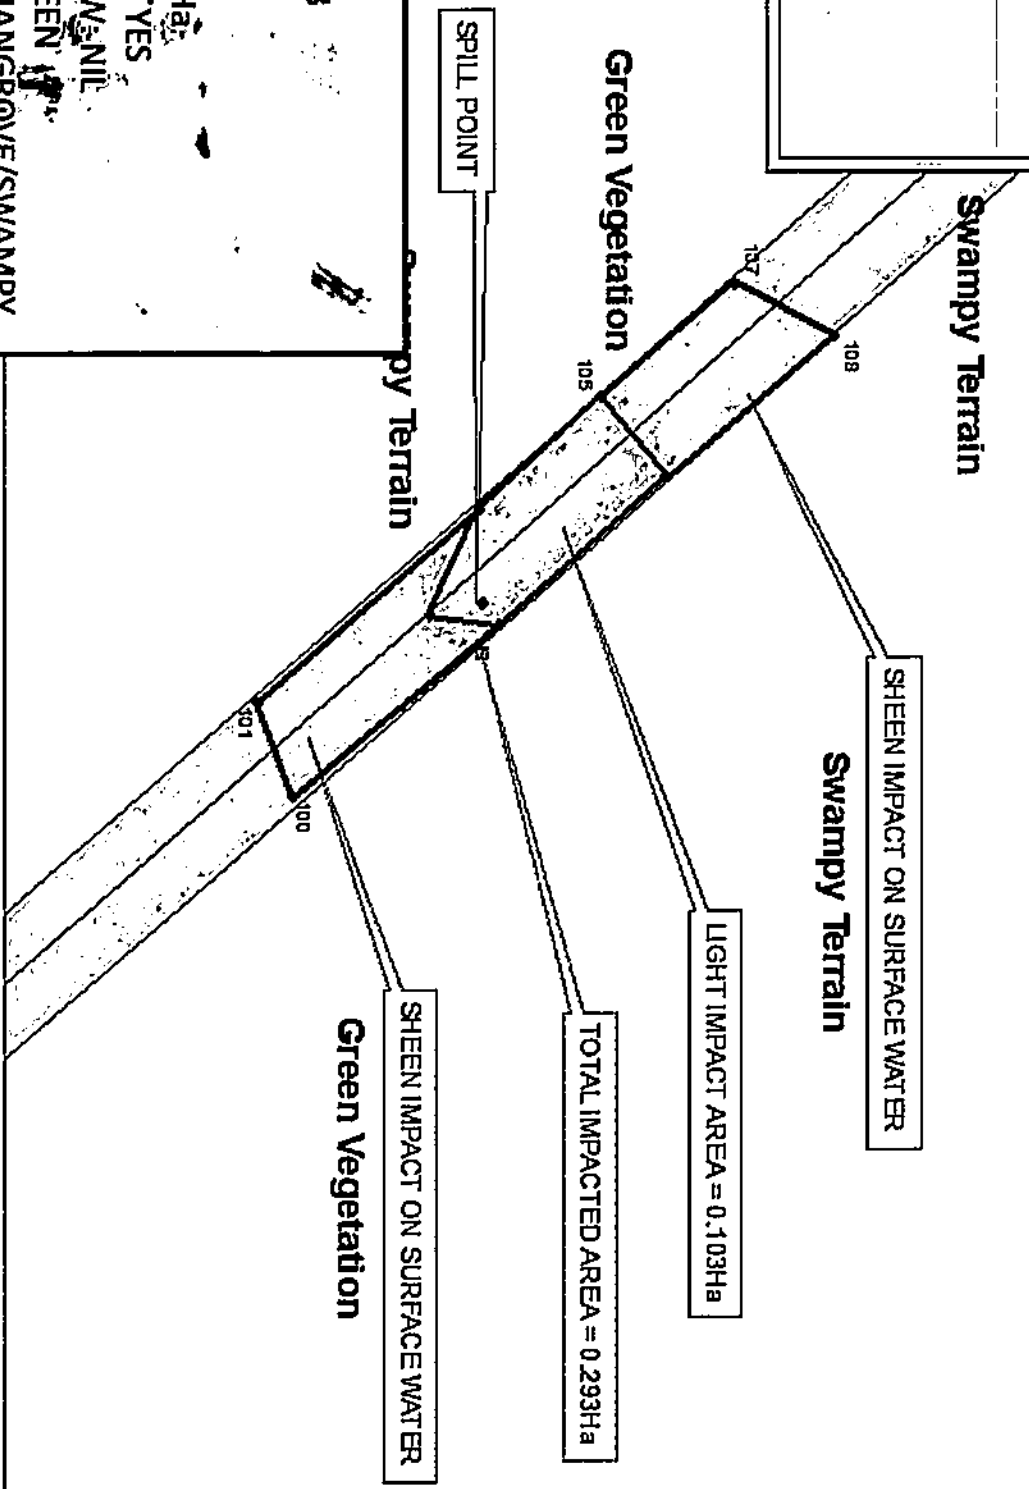
JIV DATA
 INC. NO. : 2014_1175143
 INC. DATE: 10/05/2014
 INV. DATE: 19/05/2014
 IMPACTED AREA : 0.293Ha
 AREA INSIDE SPDC ROW: YES
 AREA OUTSIDE SPDC ROW: NIL
 IMPACT TYPE: LIGHT/SHEEN
 VEGETATION/TERRAIN: MANGROVE/SWAMPY
 VISUAL CAUSE OF SPILL: CORROSION
 SPILL POINT COORD: 303730.1mE,
 180503.7mN (Minna West Belt)
 CSR: OSEM WEGIE STEPHEN
